## Profile/Photo Observation Report

Street:	<b>DUNLIN CT</b>	Flow Control:	<b>Not Controlled</b>
City:	<b>Hobart, IN</b>	Year Renewed:	
Location:	<b>Sidewalk</b>	Tape/Media #:	
Purpose:	<b>Maintenance Related</b>	Dia/Height:	<b>8"</b>
Use:	<b>Sanitary</b>	Material:	<b>PVC</b>
Drain Area:	<b>NA</b>	Lining:	
Category:	<b>NA</b>		
Comment:

Location Details:		Direction of Survey:	<b>Downstream</b>
US MH:	<b>M-709-016</b>	DS MH:	<b>M-709-017</b>
		Total Length Surveyed (ft):	<b>97.2</b>

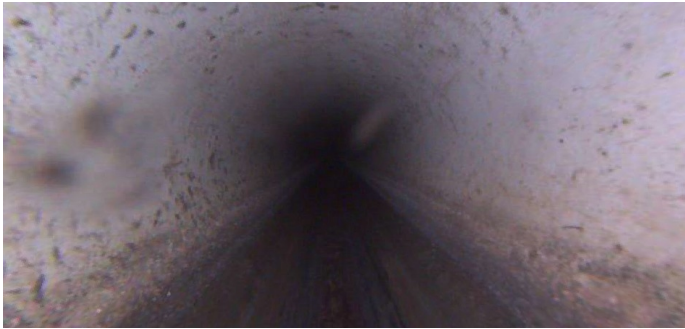
Code:	<b>MWL</b>
Description:	<b>Water Level</b>

Distance (ft):	<b>.0</b>
Structural Grade:	<b>0</b>
O&M Grade:	<b>0</b>
Clock Start/From:	
Clock To:	
1st Value:	
2nd Value:	
Value Percent:	<b>5.000</b>
Continuous Index:	
Within 8" of Joint:	<b>NO</b>
Remarks:

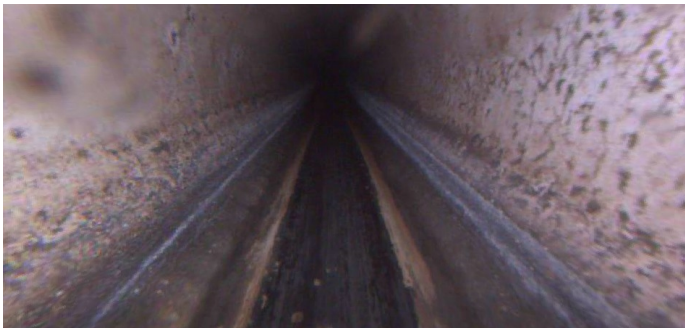
Code:	<b>DAGS</b>
Description:	<b>Deposits Attached Grease</b>

Distance (ft):	<b>4.9</b>
Structural Grade:	<b>0</b>
O&M Grade:	<b>2</b>
Clock Start/From:	<b>4</b>
Clock To:	<b>8</b>
1st Value:	
2nd Value:	
Value Percent:	<b>10.000</b>
Continuous Index:	<b>S01</b>
Within 8" of Joint:	<b>NO</b>
Remarks:

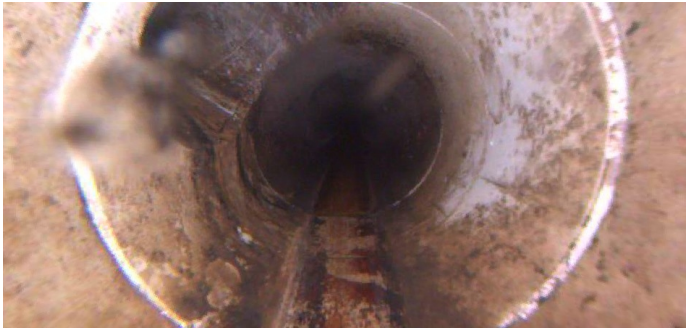
Code: **DAGS**  
Description: **Deposits Attached Grease**

Distance (ft): **12.3**  
Structural Grade: **0**  
O&M Grade: **2**  
Clock Start/From: **4**  
Clock To: **8**  
1st Value:  
2nd Value:  
Value Percent: **10.000**  
Continuous Index: **F01**  
Within 8" of Joint: **NO**  
Remarks: **Clock positions vary**

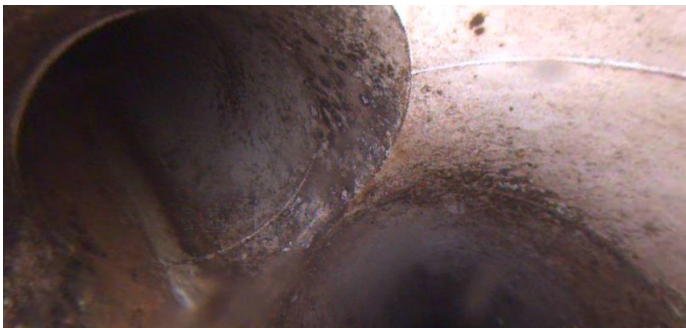
Code: **TF**  
Description: **Tap Factory**

Distance (ft): **12.8**  
Structural Grade: **0**  
O&M Grade: **0**  
Clock Start/From: **10**  
Clock To:  
1st Value: **4.000**  
2nd Value:  
Value Percent:  
Continuous Index:  
Within 8" of Joint:  
Remarks:

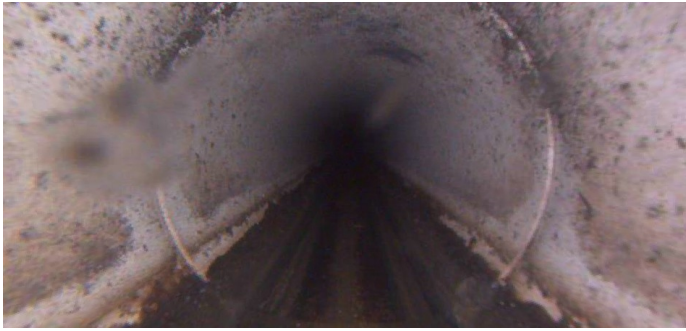
Code: **DAGS**  
Description: **Deposits Attached Grease**

Distance (ft): **26.9**  
Structural Grade: **0**  
O&M Grade: **2**  
Clock Start/From: **4**  
Clock To: **8**  
1st Value:  
2nd Value:  
Value Percent: **10.000**  
Continuous Index: **S02**  
Within 8" of Joint: **NO**  
Remarks:

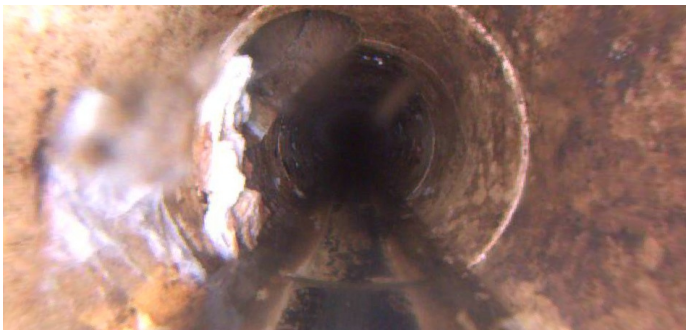
Code: **DAGS**  
Description: **Deposits Attached Grease**

Distance (ft): **50.5**  
Structural Grade: **0**  
O&M Grade: **2**  
Clock Start/From: **4**  
Clock To: **8**  
1st Value:  
2nd Value:  
Value Percent: **10.000**  
Continuous Index: **F02**  
Within 8" of Joint: **NO**  
Remarks: **Clock positions vary**

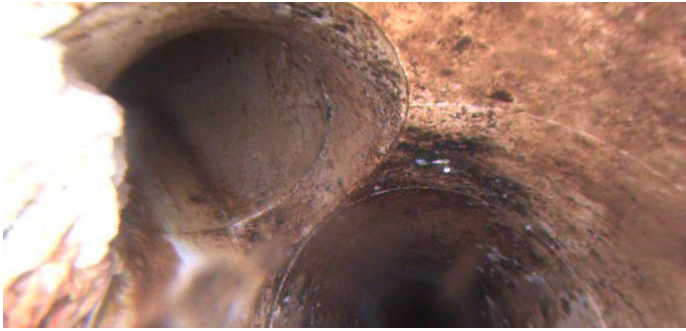
Code: **TF**  
Description: **Tap Factory**

Distance (ft): **51.0**  
Structural Grade: **0**  
O&M Grade: **0**  
Clock Start/From: **10**  
Clock To:  
1st Value: **4.000**  
2nd Value:  
Value Percent:  
Continuous Index:  
Within 8" of Joint:  
Remarks:

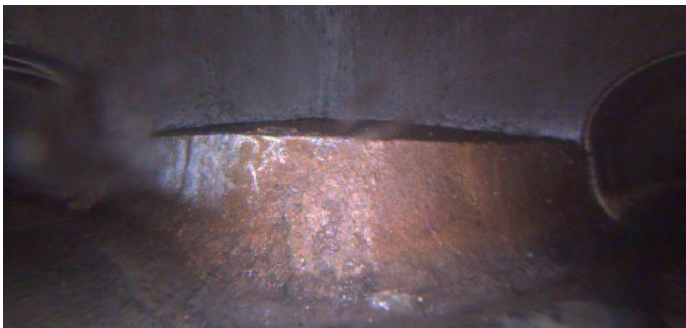
Code: **AMH**  
Description: **Manhole**

Distance (ft): **97.2**  
Structural Grade: **0**  
O&M Grade: **0**  
Clock Start/From:  
Clock To:  
1st Value:  
2nd Value:  
Value Percent:  
Continuous Index:  
Within 8" of Joint: **NO**  
Remarks: **M-709-017**
