## Profile/Photo Observation Report

Date:	<b>03/20/2018</b>	Weather:		Coding:	<b>PACP 6.0</b>
Pipe Length (ft):	<b>130.8</b>	Owner:	<b>NA</b>	Pre Clean:	<b>Not Known</b>
P.O.#:		Surveyor:	<b>John Kuglmaier</b>	PSR:	<b>P-709-019-018</b>
Customer:		Clean Date:	<b>01/01/1900</b>	Shape:	<b>C</b>

Street:	<b>DUNLIN CT</b>	Flow Control:	<b>Not Controlled</b>
City:	<b>Hobart, IN</b>	Year Renewed:	
Location:	<b>Yard</b>	Tape/Media #:	
Purpose:	<b>Maintenance Related</b>	Dia/Height:	<b>8"</b>
Use:	<b>Sanitary</b>	Material:	<b>PVC</b>
Drain Area:	<b>NA</b>	Lining:	
Category:	<b>NA</b>		
Comment:	<b>large Mud pile at 126'.</b>

Location Details:		Direction of Survey:	<b>Upstream</b>
US MH:	<b>M-709-018</b>	DS MH:	<b>M-709-019</b>
		Total Length Surveyed (ft):	<b>126.5</b>

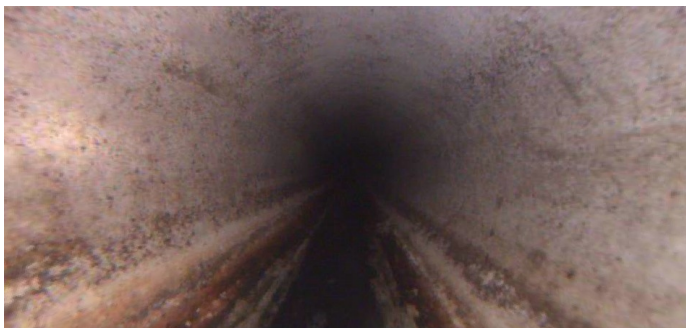
Code: **AMH**  
Description: **Manhole**

Distance (ft): **.0**  
Structural Grade: **0**  
O&M Grade: **0**  
Clock Start/From:  
Clock To:  
1st Value:  
2nd Value:  
Value Percent:  
Continuous Index:  
Within 8" of Joint: **NO**  
Remarks: **M-709-018**

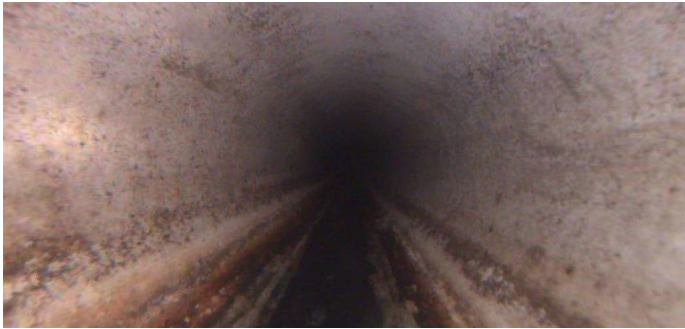
Code:	<b>MWL</b>
Description:	<b>Water Level</b>

Distance (ft):	<b>.0</b>
Structural Grade:	<b>0</b>
O&M Grade:	<b>0</b>
Clock Start/From:	
Clock To:	
1st Value:	
2nd Value:	
Value Percent:	<b>5.000</b>
Continuous Index:	
Within 8" of Joint:	<b>NO</b>
Remarks:

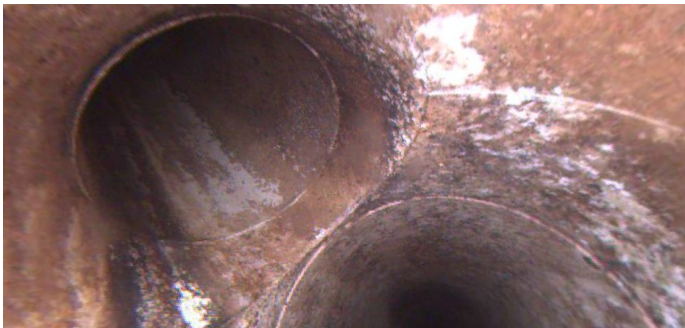
Code:	<b>TF</b>
Description:	<b>Tap Factory</b>

Distance (ft):	<b>25.3</b>
Structural Grade:	<b>0</b>
O&M Grade:	<b>0</b>
Clock Start/From:	<b>10</b>
Clock To:	
1st Value:	<b>4.000</b>
2nd Value:	
Value Percent:	
Continuous Index:	
Within 8" of Joint:	
Remarks:

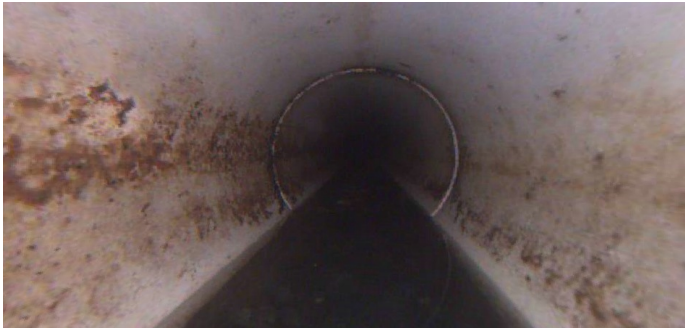
Code: **MWL**  
Description: **Water Level**

Distance (ft): **63.8**  
Structural Grade: **0**  
O&M Grade: **0**  
Clock Start/From:  
Clock To:  
1st Value:  
2nd Value:  
Value Percent: **15.000**  
Continuous Index:  
Within 8" of Joint: **NO**  
Remarks:

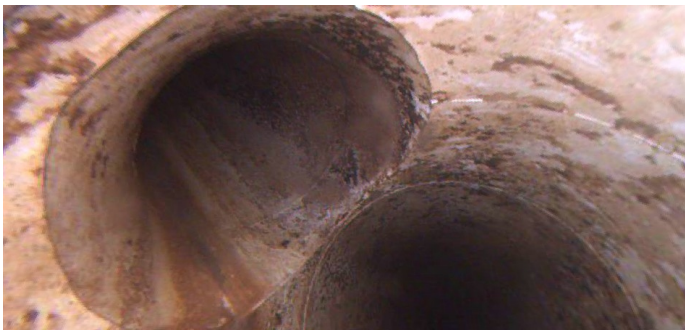
Code: **TF**  
Description: **Tap Factory**

Distance (ft): **97.8**  
Structural Grade: **0**  
O&M Grade: **0**  
Clock Start/From: **10**  
Clock To:  
1st Value: **4.000**  
2nd Value:  
Value Percent:  
Continuous Index:  
Within 8" of Joint:  
Remarks:

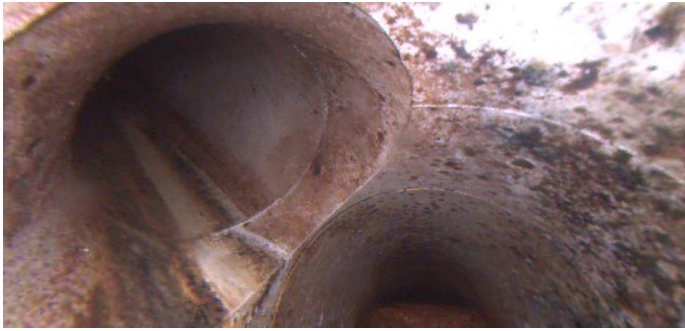
Code: **TF**  
Description: **Tap Factory**

Distance (ft): **124.2**  
Structural Grade: **0**  
O&M Grade: **0**  
Clock Start/From: **10**  
Clock To:  
1st Value: **4.000**  
2nd Value:  
Value Percent:  
Continuous Index:  
Within 8" of Joint:  
Remarks:

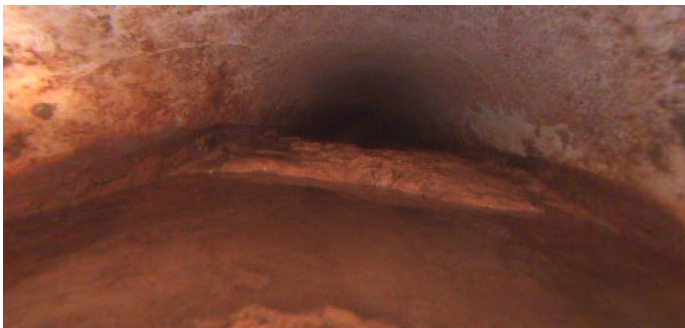
Code: **DSF**  
Description: **Deposits Settled Fine**

Distance (ft): **125.9**  
Structural Grade: **0**  
O&M Grade: **5**  
Clock Start/From: **3**  
Clock To: **9**  
1st Value:  
2nd Value:  
Value Percent: **50.000**  
Continuous Index:  
Within 8" of Joint: **NO**  
Remarks:

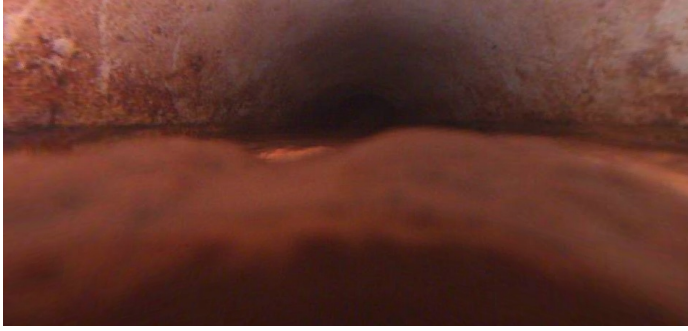
Code:	<b>MSA</b>
Description:	<b>Abandoned Survey</b>
Distance (ft):	<b>126.5</b>
Structural Grade:	<b>0</b>
O&M Grade:	<b>0</b>
Clock Start/From:	
Clock To:	
1st Value:	
2nd Value:	
Value Percent:	
Continuous Index:	
Within 8" of Joint:	<b>NO</b>
Remarks:	<b>DSF</b>
