## Profile/Photo Observation Report

Street:	<b>Oak</b>	Flow Control:	<b>Not Controlled</b>
City:	<b>Hobart, IN</b>	Year Renewed:	
Location:	<b>Yard</b>	Tape/Media #:	
Purpose:	<b>Maintenance Related</b>	Dia/Height:	<b>8"</b>
Use:	<b>Sanitary</b>	Material:	<b>PVC</b>
Drain Area:	<b>NA</b>	Lining:	
Category:	<b>NA</b>		
Comment:	<b>large Mud pile at 126'.</b>

Location Details:		Direction of Survey:	<b>Upstream</b>
US MH:	<b>M-709-018</b>	DS MH:	<b>M-709-019</b>
		Total Length Surveyed (ft):	<b>126.5</b>

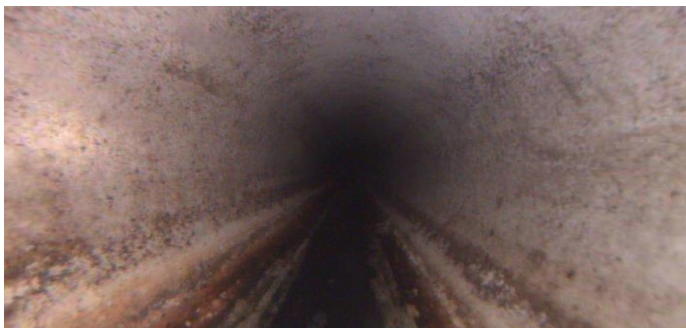
Code: **AMH**  
Description: **Manhole**

Distance (ft): **.0**  
Structural Grade: **0**  
O&M Grade: **0**  
Clock Start/From:  
Clock To:  
1st Value:  
2nd Value:  
Value Percent:  
Continuous Index:  
Within 8" of Joint: **NO**  
Remarks: **M-709-018**

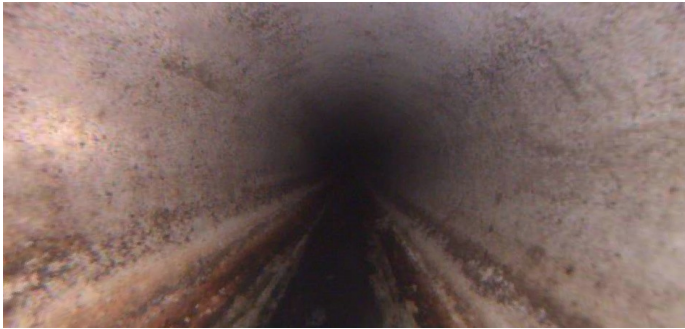
Code:	<b>MWL</b>
Description:	<b>Water Level</b>

Distance (ft):	<b>.0</b>
Structural Grade:	<b>0</b>
O&M Grade:	<b>0</b>
Clock Start/From:	
Clock To:	
1st Value:	
2nd Value:	
Value Percent:	<b>5.000</b>
Continuous Index:	
Within 8" of Joint:	<b>NO</b>
Remarks:

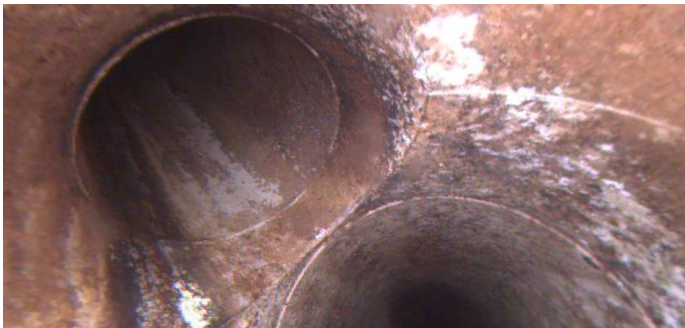
Code:	<b>TF</b>
Description:	<b>Tap Factory</b>

Distance (ft):	<b>25.3</b>
Structural Grade:	<b>0</b>
O&M Grade:	<b>0</b>
Clock Start/From:	<b>10</b>
Clock To:	
1st Value:	<b>4.000</b>
2nd Value:	
Value Percent:	
Continuous Index:	
Within 8" of Joint:	
Remarks:

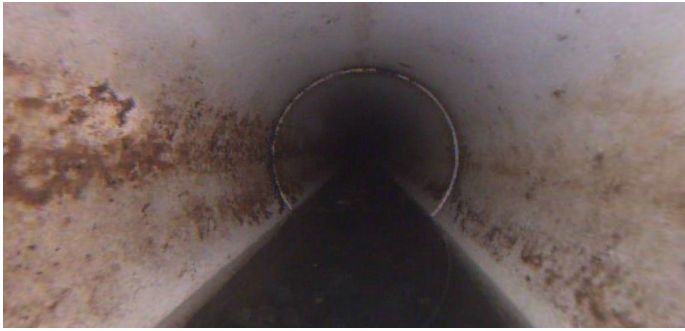
Code: **MWL**  
Description: **Water Level**

Distance (ft): **63.8**  
Structural Grade: **0**  
O&M Grade: **0**  
Clock Start/From:  
Clock To:  
1st Value:  
2nd Value:  
Value Percent: **15.000**  
Continuous Index:  
Within 8" of Joint: **NO**  
Remarks:

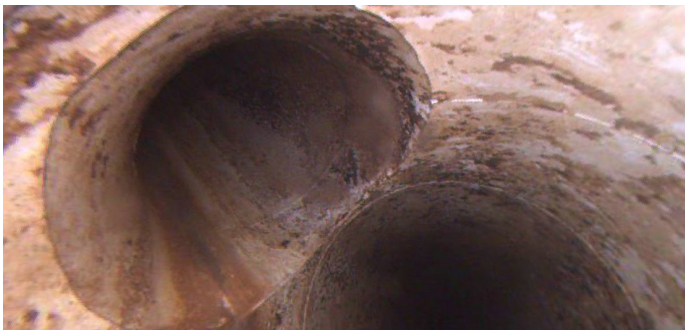
Code: **TF**  
Description: **Tap Factory**

Distance (ft): **97.8**  
Structural Grade: **0**  
O&M Grade: **0**  
Clock Start/From: **10**  
Clock To:  
1st Value: **4.000**  
2nd Value:  
Value Percent:  
Continuous Index:  
Within 8" of Joint:  
Remarks:

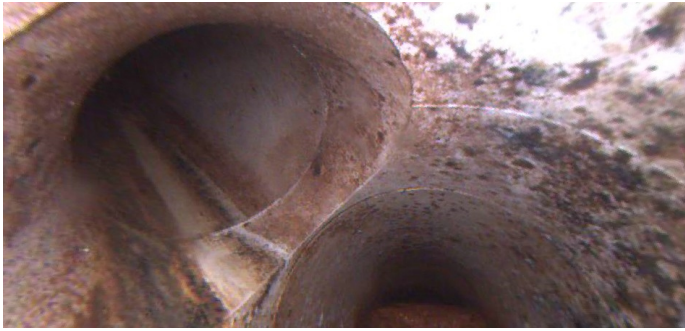
Code: **TF**  
Description: **Tap Factory**

Distance (ft): **124.2**  
Structural Grade: **0**  
O&M Grade: **0**  
Clock Start/From: **10**  
Clock To:  
1st Value: **4.000**  
2nd Value:  
Value Percent:  
Continuous Index:  
Within 8" of Joint:  
Remarks:

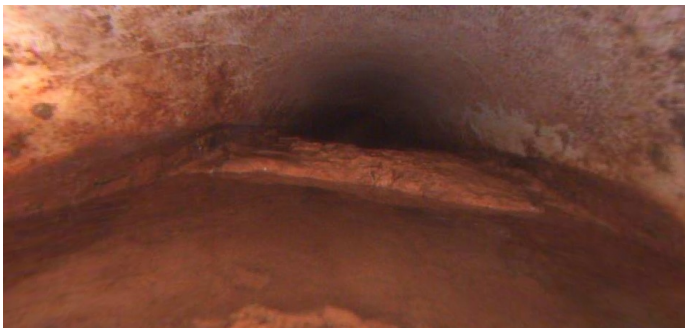
Code: **DSF**  
Description: **Deposits Settled Fine**

Distance (ft): **125.9**  
Structural Grade: **0**  
O&M Grade: **5**  
Clock Start/From: **3**  
Clock To: **9**  
1st Value:  
2nd Value:  
Value Percent: **50.000**  
Continuous Index:  
Within 8" of Joint: **NO**  
Remarks:

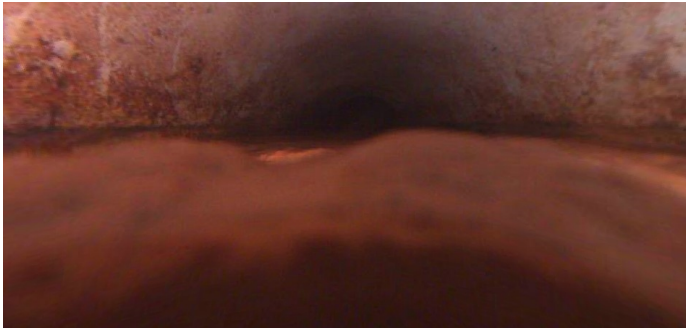
Code:	<b>MSA</b>
Description:	<b>Abandoned Survey</b>
Distance (ft):	<b>126.5</b>
Structural Grade:	<b>0</b>
O&M Grade:	<b>0</b>
Clock Start/From:	
Clock To:	
1st Value:	
2nd Value:	
Value Percent:	
Continuous Index:	
Within 8" of Joint:	<b>NO</b>
Remarks:	<b>DSF</b>
