## Profile/Photo Observation Report

Date:	<b>03/28/2018</b>	Weather:		Coding:	<b>PACP 6.0</b>
Pipe Length (ft):	<b>359.6</b>	Owner:	<b>NA</b>	Pre Clean:	<b>Not Known</b>
P.O.#:		Surveyor:	<b>Selasie Honu</b>	PSR:	<b>P-709-021-020</b>
Customer:		Clean Date:	<b>01/01/1900</b>	Shape:	<b>C</b>

Street:	<b>Avocet</b>	Flow Control:	<b>Not Controlled</b>
City:	<b>Hobart, IN</b>	Year Renewed:	
Location:	<b>Sidewalk</b>	Tape/Media #:	
Purpose:	<b>Maintenance Related</b>	Dia/Height:	<b>8"</b>
Use:	<b>Sanitary</b>	Material:	<b>PVC</b>
Drain Area:	<b>NA</b>	Lining:	
Category:	<b>NA</b>		
Comment:	<b>Flow direction wrong.</b>

Location Details:		Direction of Survey:	<b>Downstream</b>
US MH:	<b>M-709-020</b>	DS MH:	<b>M-709-021</b>
		Total Length Surveyed (ft):	<b>355.3</b>

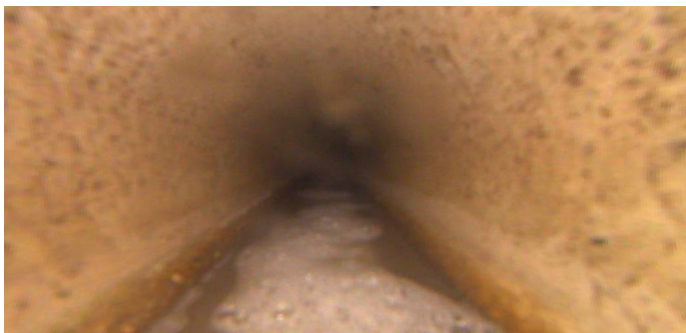
Code: **AMH**  
Description: **Manhole**

Distance (ft): **.0**  
Structural Grade: **0**  
O&M Grade: **0**  
Clock Start/From:  
Clock To:  
1st Value:  
2nd Value:  
Value Percent:  
Continuous Index:  
Within 8" of Joint: **NO**  
Remarks: **M-709-020**

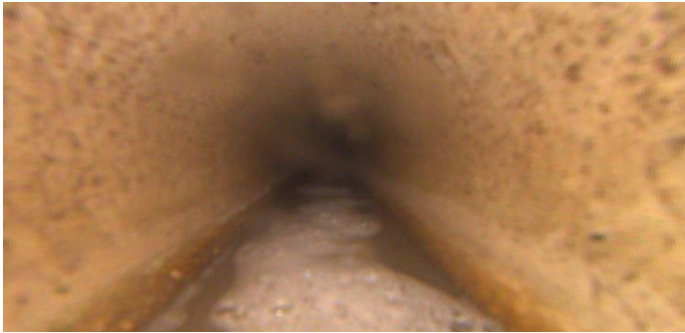
Code:	<b>MWL</b>
Description:	<b>Water Level</b>

Distance (ft):	<b>.0</b>
Structural Grade:	<b>0</b>
O&M Grade:	<b>0</b>
Clock Start/From:	
Clock To:	
1st Value:	
2nd Value:	
Value Percent:	<b>5.000</b>
Continuous Index:	
Within 8" of Joint:	<b>NO</b>
Remarks:

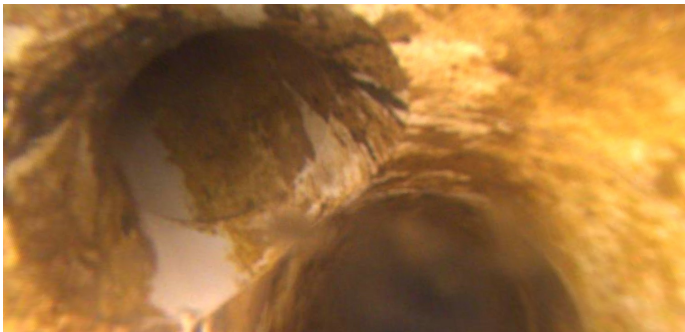
Code:	<b>TF</b>
Description:	<b>Tap Factory</b>

Distance (ft):	<b>45.8</b>
Structural Grade:	<b>0</b>
O&M Grade:	<b>0</b>
Clock Start/From:	<b>11</b>
Clock To:	
1st Value:	<b>4.000</b>
2nd Value:	
Value Percent:	
Continuous Index:	
Within 8" of Joint:	
Remarks:

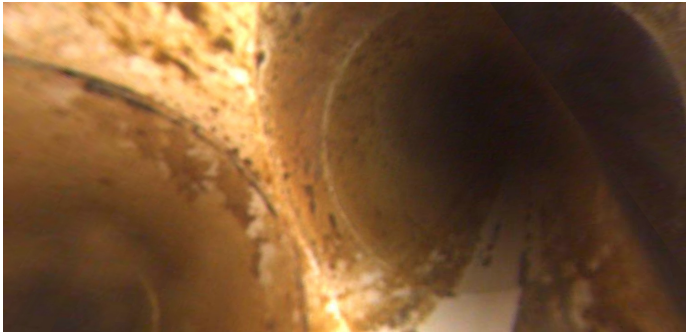
Code: **TF**  
Description: **Tap Factory**

Distance (ft): **144.2**  
Structural Grade: **0**  
O&M Grade: **0**  
Clock Start/From: **2**  
Clock To:  
1st Value: **4.000**  
2nd Value:  
Value Percent:  
Continuous Index:  
Within 8" of Joint:  
Remarks:

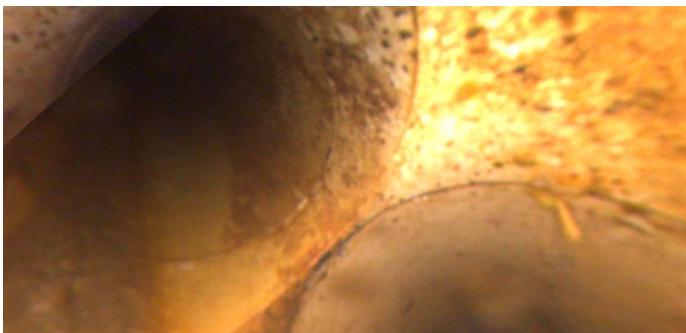
Code: **TF**  
Description: **Tap Factory**

Distance (ft): **145.8**  
Structural Grade: **0**  
O&M Grade: **0**  
Clock Start/From: **10**  
Clock To:  
1st Value: **4.000**  
2nd Value:  
Value Percent:  
Continuous Index:  
Within 8" of Joint:  
Remarks:

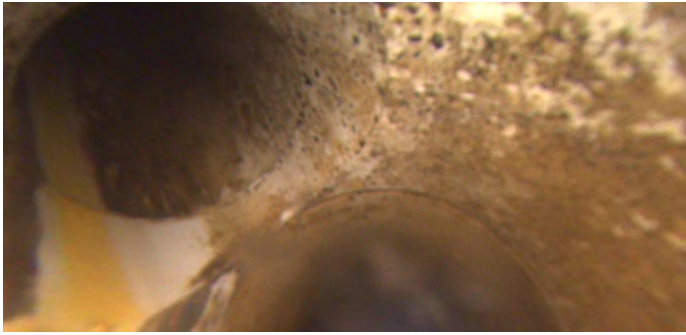
Code: **TF**  
Description: **Tap Factory**

Distance (ft): **306.6**  
Structural Grade: **0**  
O&M Grade: **0**  
Clock Start/From: **10**  
Clock To:  
1st Value: **4.000**  
2nd Value:  
Value Percent:  
Continuous Index:  
Within 8" of Joint:  
Remarks:

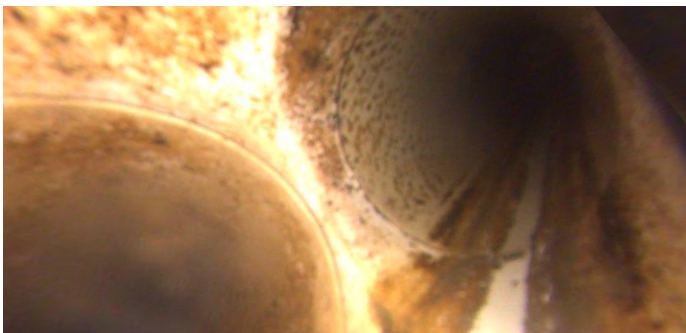
Code: **TF**  
Description: **Tap Factory**

Distance (ft): **308.5**  
Structural Grade: **0**  
O&M Grade: **0**  
Clock Start/From: **2**  
Clock To:  
1st Value: **4.000**  
2nd Value:  
Value Percent:  
Continuous Index:  
Within 8" of Joint:  
Remarks:

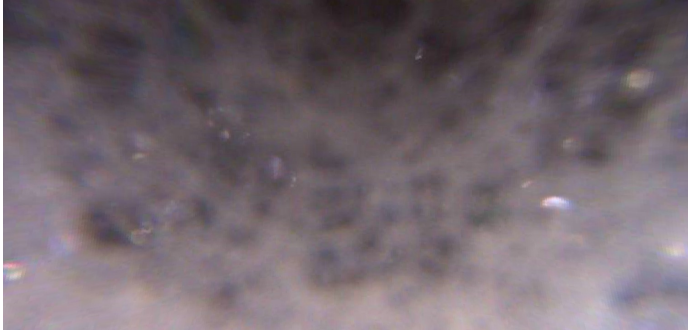
Code:	<b>AMH</b>
Description:	<b>Manhole</b>
Distance (ft):	<b>355.3</b>
Structural Grade:	<b>0</b>
O&M Grade:	<b>0</b>
Clock Start/From:	
Clock To:	
1st Value:	
2nd Value:	
Value Percent:	
Continuous Index:	
Within 8" of Joint:	<b>NO</b>
Remarks:	<b>M-709-021</b>
