Profile/Photo Observation Report

Street:	AVOCET CIR	Flow Control:	Not Controlled
City:	Hobart, IN	Year Renewed:	
Location:	Sidewalk	Tape/Media #:	
Purpose:	Maintenance Related	Dia/Height:	12"
Use:	Sanitary	Material:	PVC
Drain Area:	NA	Lining:	Cured in Place
Category:	NA		
Comment:	Flow direction wrong.

Location Details:		Direction of Survey:	Downstream
US MH:	M-709-023	DS MH:	M-709-022
		Total Length Surveyed (ft):	130.8

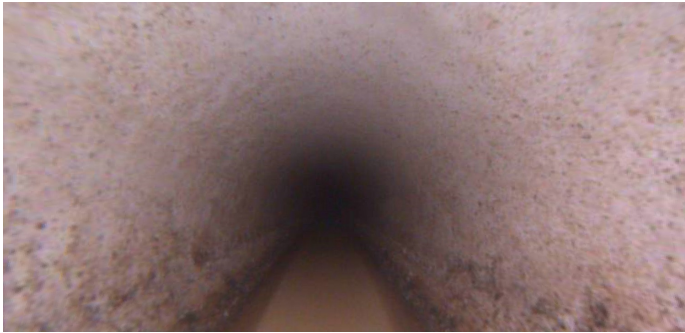
Code:	MWL
Description:	Water Level

Distance (ft):	.0
Structural Grade:	0
O&M Grade:	0
Clock Start/From:	
Clock To:	
1st Value:	
2nd Value:	
Value Percent:	5.000
Continuous Index:	
Within 8" of Joint:	NO
Remarks:

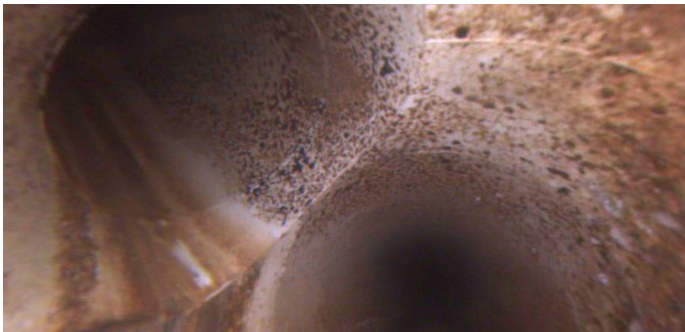
Code:	TF
Description:	Tap Factory

Distance (ft):	22.5
Structural Grade:	0
O&M Grade:	0
Clock Start/From:	10
Clock To:	
1st Value:	4.000
2nd Value:	
Value Percent:	
Continuous Index:	
Within 8" of Joint:	
Remarks:

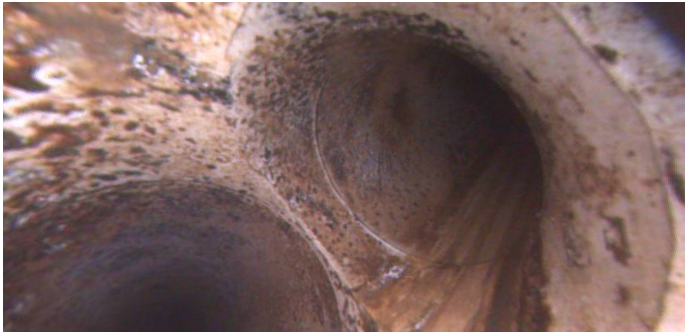
Code: **TF**
Description: **Tap Factory**

Distance (ft): **77.6**
Structural Grade: **0**
O&M Grade: **0**
Clock Start/From: **2**
Clock To:
1st Value: **4.000**
2nd Value:
Value Percent:
Continuous Index:
Within 8" of Joint:
Remarks:

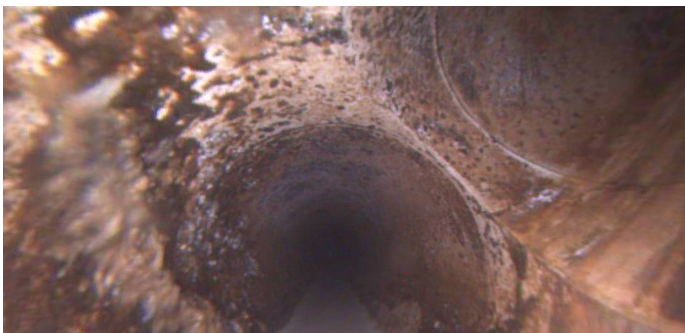
Code: **DAGS**
Description: **Deposits Attached Grease**

Distance (ft): **77.6**
Structural Grade: **0**
O&M Grade: **2**
Clock Start/From: **8**
Clock To: **10**
1st Value:
2nd Value:
Value Percent: **5.000**
Continuous Index:
Within 8" of Joint: **NO**
Remarks:

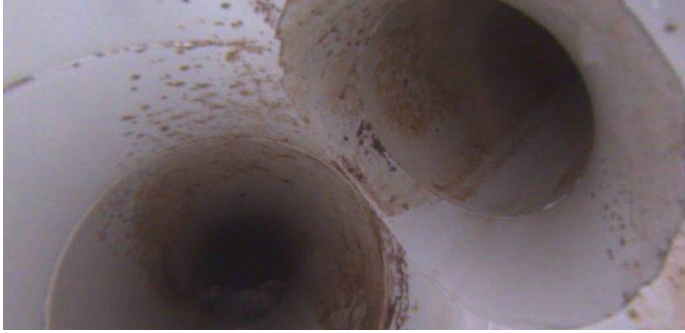
Code: **TF**
Description: **Tap Factory**

Distance (ft): **121.0**
Structural Grade: **0**
O&M Grade: **0**
Clock Start/From: **2**
Clock To:
1st Value: **4.000**
2nd Value:
Value Percent:
Continuous Index:
Within 8" of Joint:
Remarks:

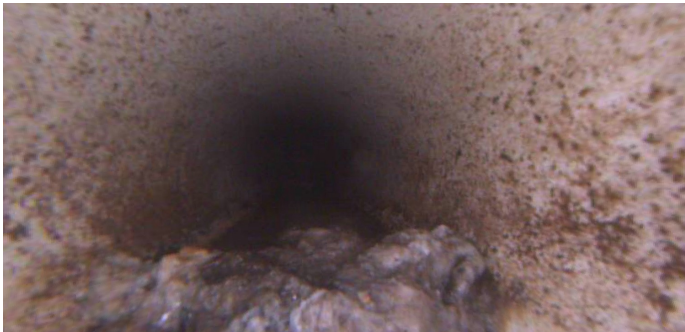
Code: **DSZ**
Description: **Deposits Settled Other**

Distance (ft): **122.9**
Structural Grade: **0**
O&M Grade: **3**
Clock Start/From: **4**
Clock To: **8**
1st Value:
2nd Value:
Value Percent: **20.000**
Continuous Index:
Within 8" of Joint: **NO**
Remarks: **misc**
