Profile/Photo Observation Report

Date:	04/01/2018	Weather:		Coding:	PACP 6.0
Pipe Length (ft):	204.9	Owner:	NA	Pre Clean:	Not Known
P.O.#:		Surveyor:	Jen Costello	PSR:	P-709-025-026
Customer:		Clean Date:	01/01/1900	Shape:	C

Street:	AVOCET CIR	Flow Control:	Not Controlled
City:	Hobart, IN	Year Renewed:	
Location:	Sidewalk	Tape/Media #:	
Purpose:	Maintenance Related	Dia/Height:	8"
Use:	Sanitary	Material:	PVC
Drain Area:	NA	Lining:	Cured in Place
Category:	NA		
Comment:

Location Details:		Direction of Survey:	Upstream
US MH:	M-709-026	DS MH:	M-709-025
		Total Length Surveyed (ft):	197.4

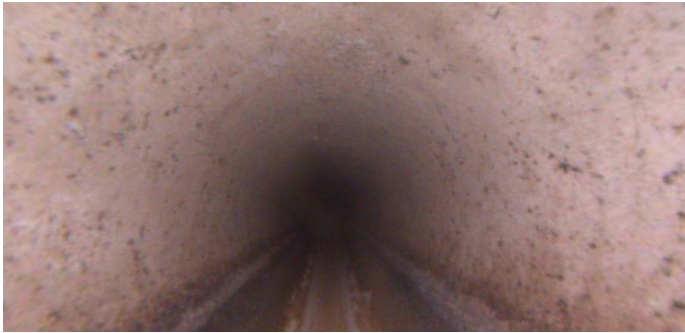
Code:	MWL
Description:	Water Level

Distance (ft):	.0
Structural Grade:	0
O&M Grade:	0
Clock Start/From:	
Clock To:	
1st Value:	
2nd Value:	
Value Percent:	5.000
Continuous Index:	
Within 8" of Joint:	NO
Remarks:

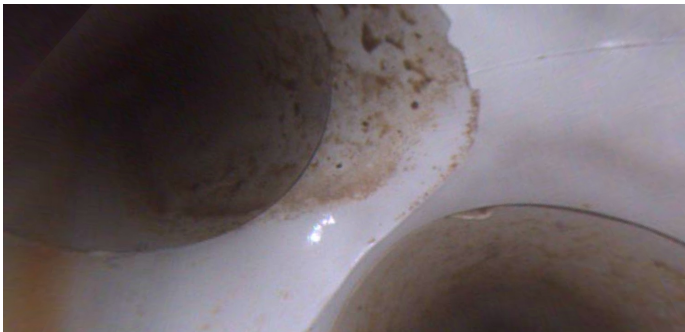
Code:	TF
Description:	Tap Factory

Distance (ft):	71.0
Structural Grade:	0
O&M Grade:	0
Clock Start/From:	10
Clock To:	
1st Value:	4.000
2nd Value:	
Value Percent:	
Continuous Index:	
Within 8" of Joint:	
Remarks:

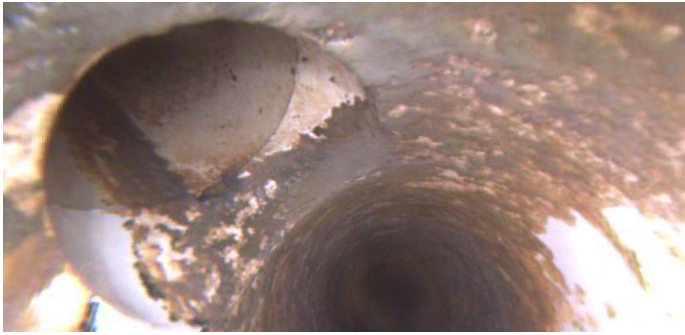
Code: **TF**
Description: **Tap Factory**

Distance (ft): **172.3**
Structural Grade: **0**
O&M Grade: **0**
Clock Start/From: **10**
Clock To:
1st Value: **4.000**
2nd Value:
Value Percent:
Continuous Index:
Within 8" of Joint:
Remarks:

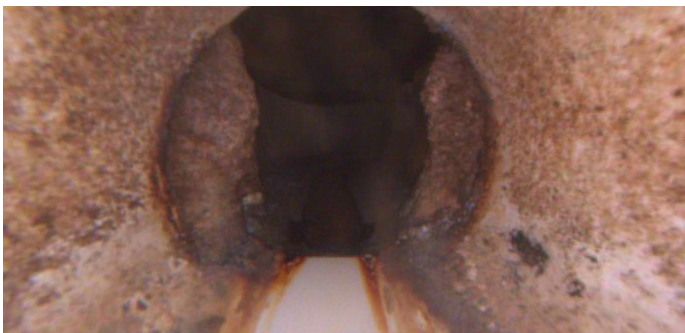
Code: **DAE**
Description: **Deposits Attached Encrustation**

Distance (ft): **195.0**
Structural Grade: **0**
O&M Grade: **3**
Clock Start/From: **8**
Clock To: **4**
1st Value:
2nd Value:
Value Percent: **20.000**
Continuous Index:
Within 8" of Joint: **YES**
Remarks:

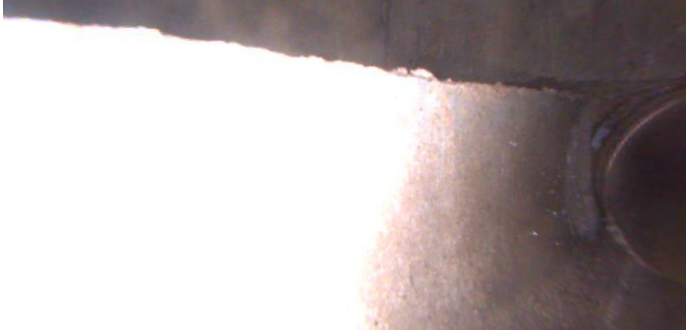
Code: **AMH**
Description: **Manhole**

Distance (ft): **197.4**
Structural Grade: **0**
O&M Grade: **0**
Clock Start/From:
Clock To:
1st Value:
2nd Value:
Value Percent:
Continuous Index:
Within 8" of Joint: **NO**
Remarks: **M-709-026**
