## Profile/Photo Observation Report

Date:	<b>10/20/2021</b>	Weather:		Coding:	<b>PACP 6.0</b>
Pipe Length (ft):		Owner:	<b>Hobart, IN</b>	Pre Clean:	<b>Not Known</b>
P.O.#:	<b>922_1</b>	Surveyor:	<b>M. Pielacha</b>	PSR:	<b>P-709-027-028</b>
Customer:	<b>Hobart, IN</b>	Clean Date:		Shape:	<b>C</b>

Location Details:		Direction of Survey:	<b>Upstream</b>
US MH:	<b>M-709-28</b>	DS MH:	<b>M-709-27</b>
		Total Length Surveyed (ft):	<b>331.9</b>

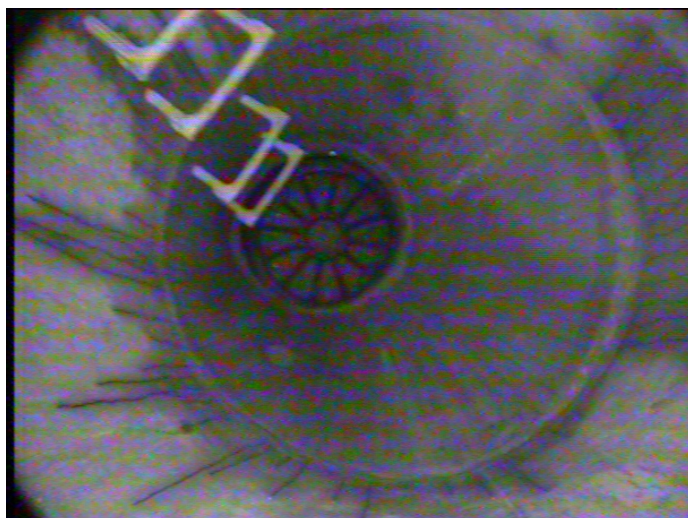
Code: **AMH**  
Description: **Manhole**

Distance (ft): **.0**  
Structural Grade: **0**  
O&M Grade: **0**  
Clock Start/From:  
Clock To:  
1st Value:  
2nd Value:  
Value Percent:  
Continuous Index:  
Within 8" of Joint: **NO**  
Remarks: **M-709-27**

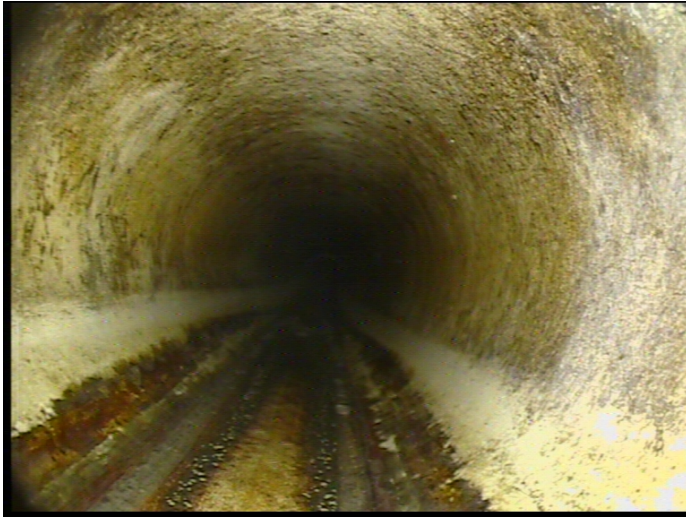
Code: **MWL**  
Description: **Water Level**

Distance (ft): **.0**  
Structural Grade: **0**  
O&M Grade: **0**  
Clock Start/From:  
Clock To:  
1st Value:  
2nd Value:  
Value Percent: **5.000**  
Continuous Index:  
Within 8" of Joint: **NO**  
Remarks:

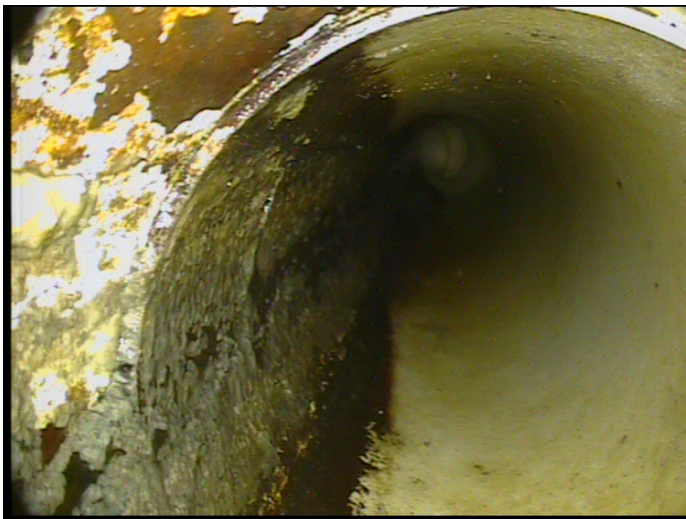
Code: **TF**  
Description: **Tap Factory**

Distance (ft): **33.2**  
Structural Grade: **0**  
O&M Grade: **0**  
Clock Start/From: **10**  
Clock To:  
1st Value: **4.000**  
2nd Value:  
Value Percent:  
Continuous Index:  
Within 8" of Joint: **NO**  
Remarks:

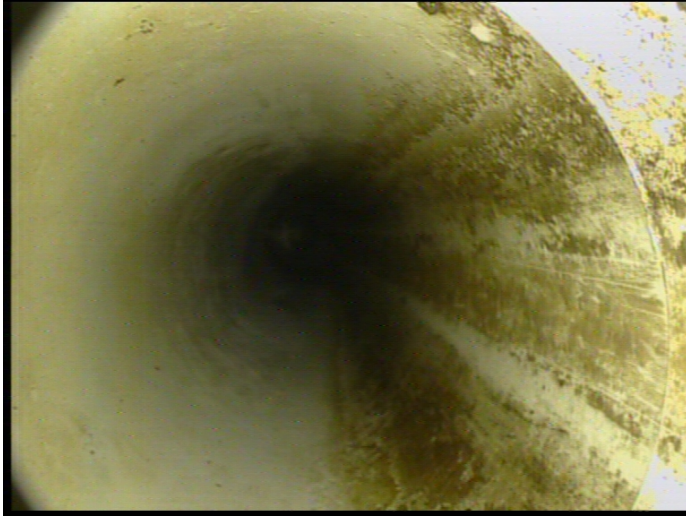
Code: **TF**  
Description: **Tap Factory**

Distance (ft): **117.0**  
Structural Grade: **0**  
O&M Grade: **0**  
Clock Start/From: **2**  
Clock To:  
1st Value: **4.000**  
2nd Value:  
Value Percent:  
Continuous Index:  
Within 8" of Joint: **NO**  
Remarks:

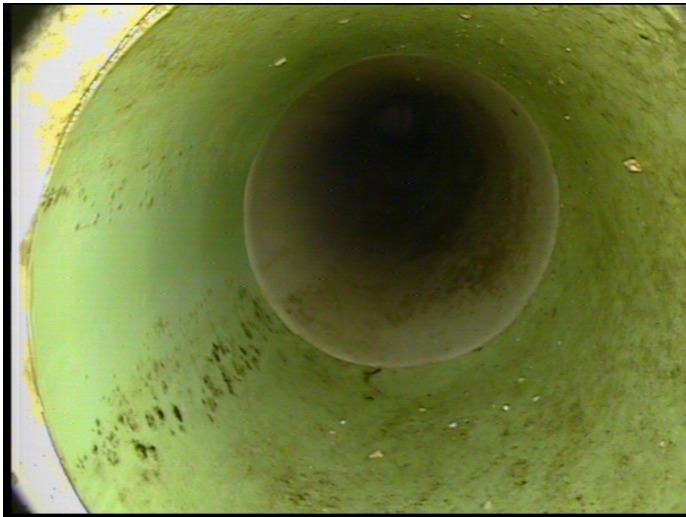
Code: **TF**  
Description: **Tap Factory**

Distance (ft): **137.7**  
Structural Grade: **0**  
O&M Grade: **0**  
Clock Start/From: **10**  
Clock To:  
1st Value: **4.000**  
2nd Value:  
Value Percent:  
Continuous Index:  
Within 8" of Joint: **NO**  
Remarks:

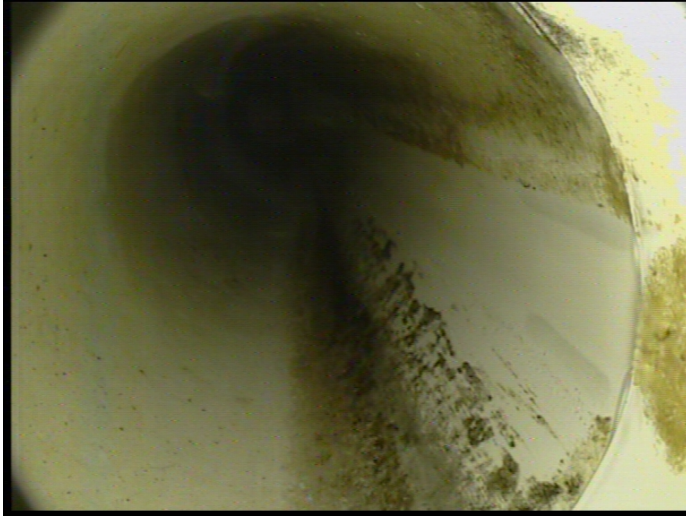
Code: **TFA**  
Description: **Tap Factory Active**

Distance (ft): **214.5**  
Structural Grade: **0**  
O&M Grade: **0**  
Clock Start/From: **2**  
Clock To:  
1st Value: **4.000**  
2nd Value:  
Value Percent:  
Continuous Index:  
Within 8" of Joint: **NO**  
Remarks:

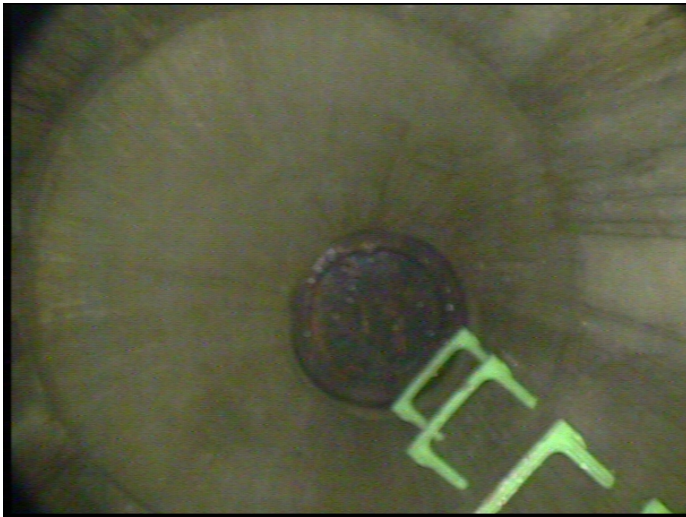
Code: **AMH**  
Description: **Manhole**

Distance (ft): **331.9**  
Structural Grade: **0**  
O&M Grade: **0**  
Clock Start/From:  
Clock To:  
1st Value:  
2nd Value:  
Value Percent:  
Continuous Index:  
Within 8" of Joint: **NO**  
Remarks: **M-709-28**
