Profile/Photo Observation Report

Date:	03/19/2018	Weather:		Coding:	PACP 6.0
Pipe Length (ft):	114.5	Owner:	NA	Pre Clean:	Not Known
P.O.#:		Surveyor:	John Kuglmaier	PSR:	P-709-032-031
Customer:		Clean Date:	01/01/1900	Shape:	C

Street:	Oak	Flow Control:	Not Controlled
City:	Hobart, IN	Year Renewed:	
Location:	Yard	Tape/Media #:	
Purpose:	Maintenance Related	Dia/Height:	8"
Use:	Sanitary	Material:	PVC
Drain Area:	NA	Lining:	
Category:	NA		
Comment:

Location Details:		Direction of Survey:	Upstream
US MH:	M-709-032	DS MH:	M-709-031
		Total Length Surveyed (ft):	113.0

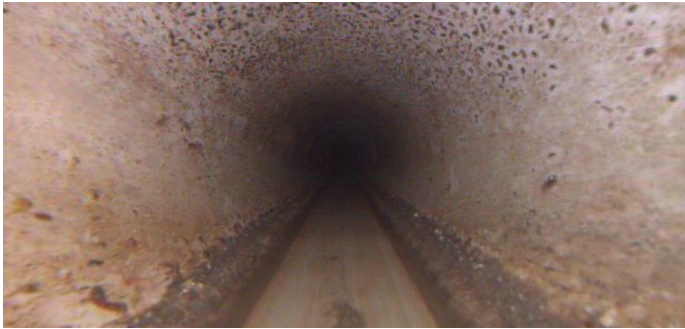
Code:	MWL
Description:	Water Level

Distance (ft):	.0
Structural Grade:	0
O&M Grade:	0
Clock Start/From:	
Clock To:	
1st Value:	
2nd Value:	
Value Percent:	10.000
Continuous Index:	
Within 8" of Joint:	NO
Remarks:

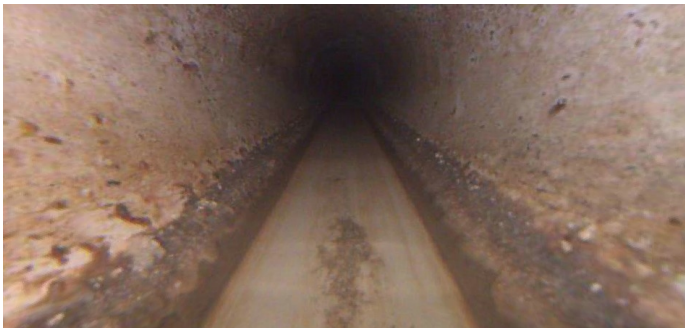
Code:	DAGS
Description:	Deposits Attached Grease

Distance (ft):	.0
Structural Grade:	0
O&M Grade:	2
Clock Start/From:	4
Clock To:	8
1st Value:	
2nd Value:	
Value Percent:	10.000
Continuous Index:	S01
Within 8" of Joint:	NO
Remarks:

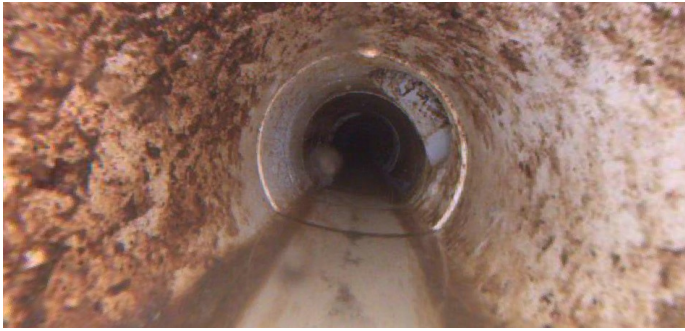
Code: **DAGS**
Description: **Deposits Attached Grease**

Distance (ft): **22.9**
Structural Grade: **0**
O&M Grade: **2**
Clock Start/From: **4**
Clock To: **8**
1st Value:
2nd Value:
Value Percent: **10.000**
Continuous Index: **F01**
Within 8" of Joint: **NO**
Remarks: **Clock positions vary**

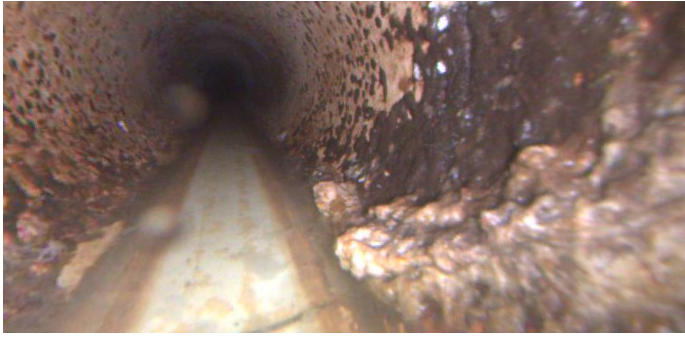
Code: **DAGS**
Description: **Deposits Attached Grease**

Distance (ft): **67.5**
Structural Grade: **0**
O&M Grade: **2**
Clock Start/From: **2**
Clock To: **4**
1st Value:
2nd Value:
Value Percent: **10.000**
Continuous Index:
Within 8" of Joint: **NO**
Remarks:

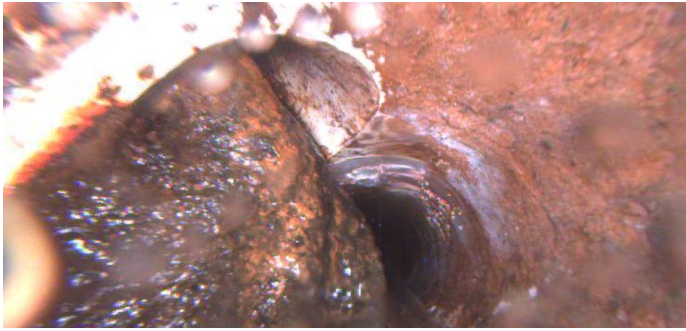
Code: **TFD**
Description: **Tap Factory Defective**

Distance (ft): **104.3**
Structural Grade: **0**
O&M Grade: **2**
Clock Start/From: **11**
Clock To:
1st Value: **4.000**
2nd Value:
Value Percent:
Continuous Index:
Within 8" of Joint:
Remarks: **Blockage**

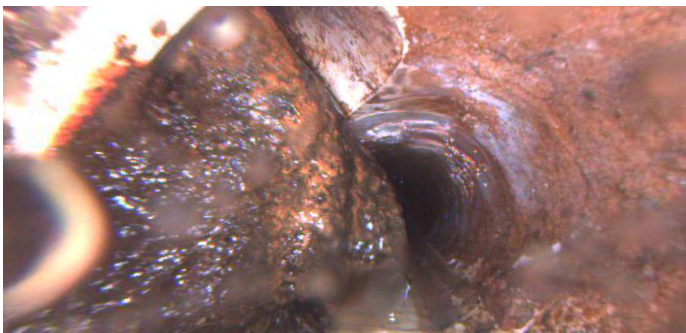
Code: **DAE**
Description: **Deposits Attached Encrustation**

Distance (ft): **104.3**
Structural Grade: **0**
O&M Grade: **5**
Clock Start/From: **6**
Clock To: **11**
1st Value:
2nd Value:
Value Percent: **40.000**
Continuous Index:
Within 8" of Joint: **NO**
Remarks:
