Profile/Photo Observation Report

Street:	MERGANSE ST	Flow Control:	Not Controlled
City:	Hobart, IN	Year Renewed:	
Location:	Sidewalk	Tape/Media #:	
Purpose:	Maintenance Related	Dia/Height:	8"
Use:	Sanitary	Material:	PVC
Drain Area:	NA	Lining:	
Category:	NA		
Comment:	12" pipe

Location Details:		Direction of Survey:	Downstream
US MH:	M-709-036	DS MH:	M-709-007
		Total Length Surveyed (ft):	6.6

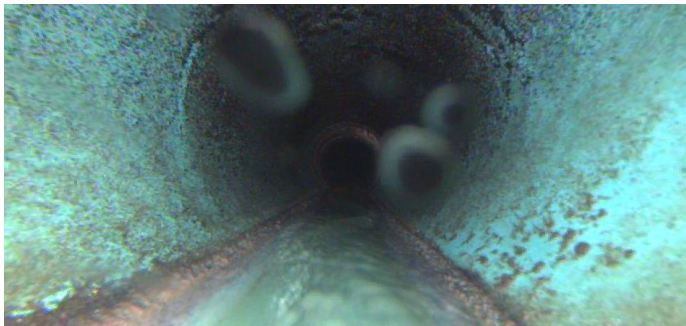
Code: **AMH**
Description: **Manhole**

Distance (ft): **.0**
Structural Grade: **0**
O&M Grade: **0**
Clock Start/From:
Clock To:
1st Value:
2nd Value:
Value Percent:
Continuous Index:
Within 8" of Joint: **NO**
Remarks: **M-709-036**

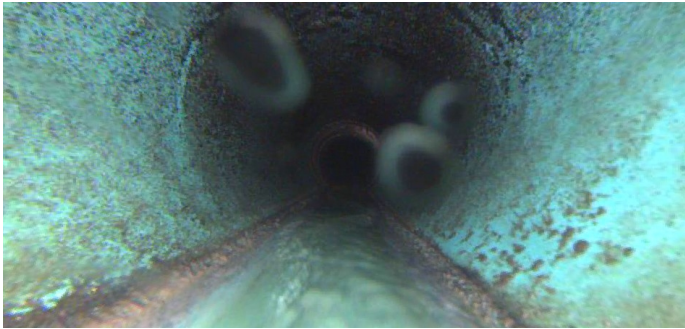
Code:	MWL
Description:	Water Level

Distance (ft):	.0
Structural Grade:	0
O&M Grade:	0
Clock Start/From:	
Clock To:	
1st Value:	
2nd Value:	
Value Percent:	10.000
Continuous Index:	
Within 8" of Joint:	NO
Remarks:

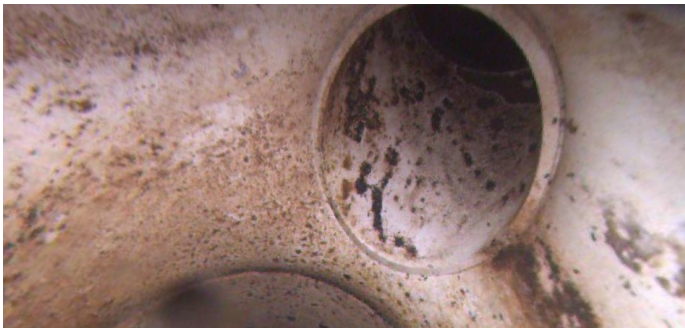
Code:	TF
Description:	Tap Factory

Distance (ft):	4.7
Structural Grade:	0
O&M Grade:	0
Clock Start/From:	1
Clock To:	
1st Value:	4.000
2nd Value:	
Value Percent:	
Continuous Index:	
Within 8" of Joint:	
Remarks:

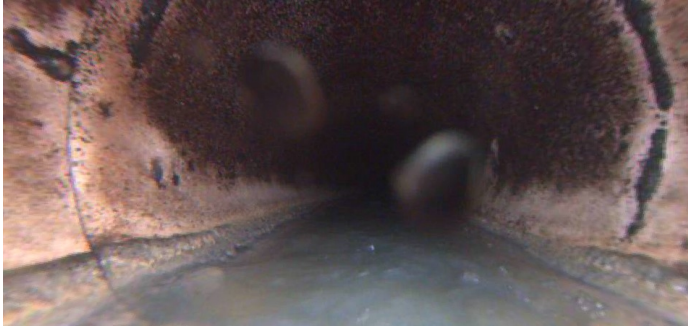
Code:	MSA
Description:	Abandoned Survey
Distance (ft):	6.6
Structural Grade:	0
O&M Grade:	0
Clock Start/From:	
Clock To:	
1st Value:	
2nd Value:	
Value Percent:	
Continuous Index:	
Within 8" of Joint:	NO
Remarks:	Unknown
