Profile/Photo Observation Report

Date:	10/15/2021	Weather:		Coding:	PACP 6.0
Pipe Length (ft):		Owner:	Hobart, IN	Pre Clean:	Not Known
P.O.#:	810_1	Surveyor:	M. Pielacha	PSR:	P-802-001-002
Customer:	Hobart, IN	Clean Date:		Shape:	C

Street:	Off East 37th Avenue	Flow Control:	
City:	Hobart, IN	Year Renewed:	
Location:	Alley	Tape/Media #:	810
Purpose:	Routine Assessment	Dia/Height:	6"
Use:	Sanitary	Material:	SP
Drain Area:		Lining:	
Category:	NA		
Comment:			
Location Details:		Direction of Survey:	Upstream
US MH:	M-802-1	DS MH:	M-802-2
		Total Length Surveyed (ft):	19.6

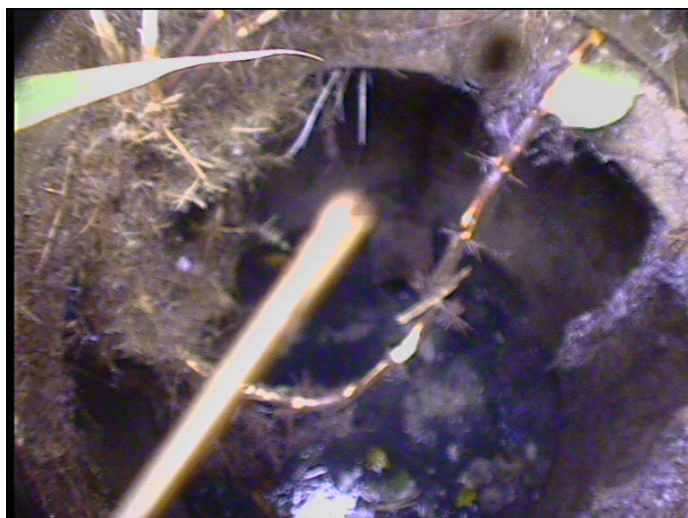
Code: **AMH**
Description: **Manhole**

Distance (ft): **.0**
Structural Grade: **0**
O&M Grade: **0**
Clock Start/From:
Clock To:
1st Value:
2nd Value:
Value Percent:
Continuous Index:
Within 8" of Joint: **NO**
Remarks: **M-802-2**

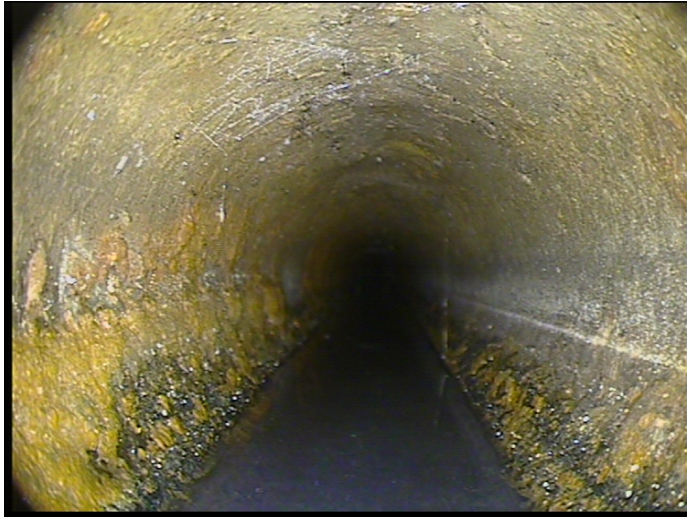
Code: **MWL**
Description: **Water Level**

Distance (ft): **.0**
Structural Grade: **0**
O&M Grade: **0**
Clock Start/From:
Clock To:
1st Value:
2nd Value:
Value Percent: **5.000**
Continuous Index:
Within 8" of Joint: **NO**
Remarks:

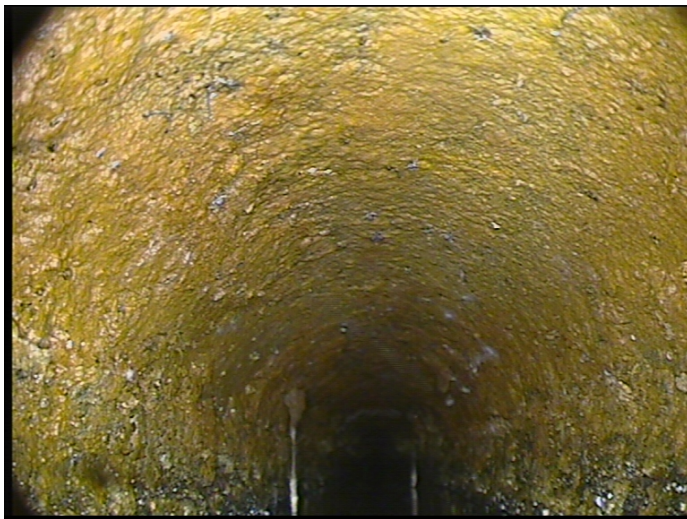
Code: **SRI**
Description: **Surface Roughness Increased**

Distance (ft): **9.8**
Structural Grade: **1**
O&M Grade: **0**
Clock Start/From: **8**
Clock To: **4**
1st Value:
2nd Value:
Value Percent:
Continuous Index: **S01**
Within 8" of Joint: **YES**
Remarks:

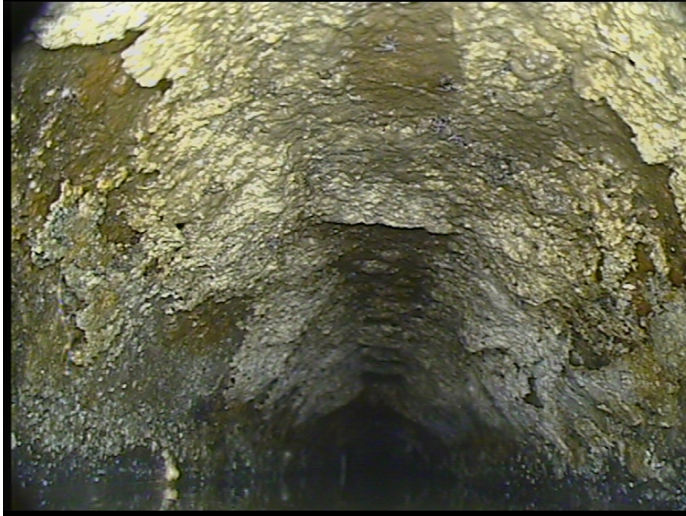
Code: **SRI**
Description: **Surface Roughness Increased**

Distance (ft): **19.6**
Structural Grade: **1**
O&M Grade: **0**
Clock Start/From: **8**
Clock To: **4**
1st Value:
2nd Value:
Value Percent:
Continuous Index: **F01**
Within 8" of Joint: **NO**
Remarks:

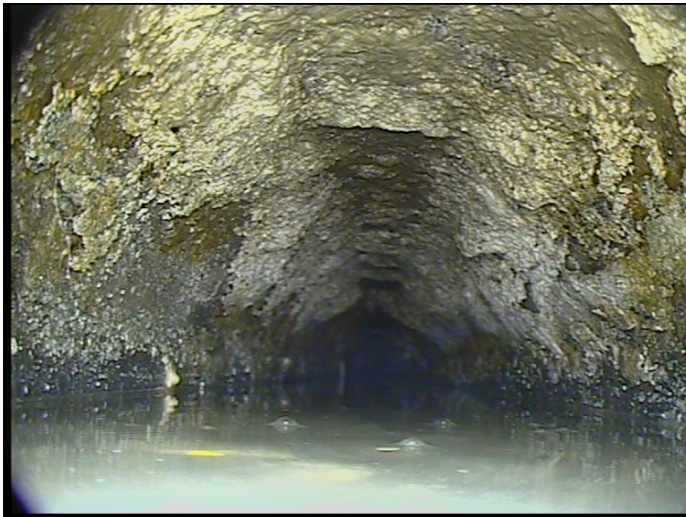
Code: **OBZ**
Description: **Obstacle Other**

Distance (ft): **19.6**
Structural Grade: **0**
O&M Grade: **2**
Clock Start/From: **6**
Clock To:
1st Value:
2nd Value:
Value Percent: **5.000**
Continuous Index:
Within 8" of Joint: **NO**
Remarks: **Under water debris**

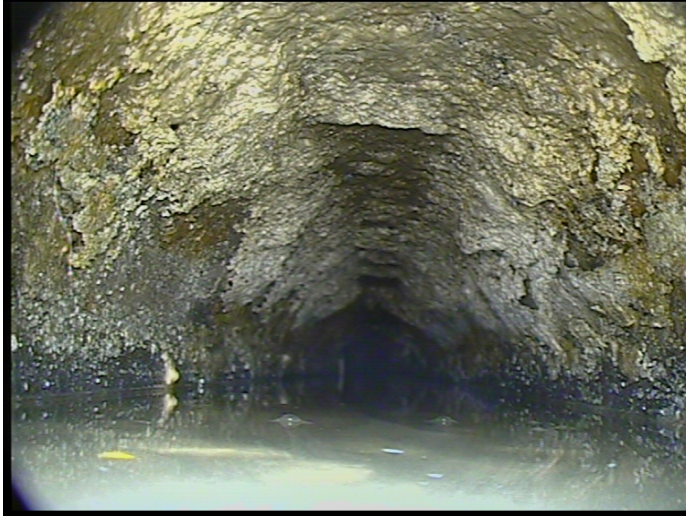
Code:	MSA
Description:	Abandoned Survey
Distance (ft):	19.6
Structural Grade:	0
O&M Grade:	0
Clock Start/From:	
Clock To:	
1st Value:	
2nd Value:	
Value Percent:	
Continuous Index:	
Within 8" of Joint:	NO
Remarks:	Under water debris.
