## Profile/Photo Observation Report

Street:	<b>e 37th ave</b>	Flow Control:	<b>Not Controlled</b>
City:	<b>Hobart, IN</b>	Year Renewed:	
Location:	<b>Other</b>	Tape/Media #:	
Purpose:	<b>Not Known</b>	Dia/Height:	<b>10"</b>
Use:	<b>Sanitary</b>	Material:	<b>PVC</b>
Drain Area:	<b>NA</b>	Lining:	
Category:	<b>NA</b>		
Comment:

Location Details:		Direction of Survey:	<b>Downstream</b>
US MH:	<b>M-802-003</b>	DS MH:	<b>M-802-005</b>
		Total Length Surveyed (ft):	<b>103.2</b>

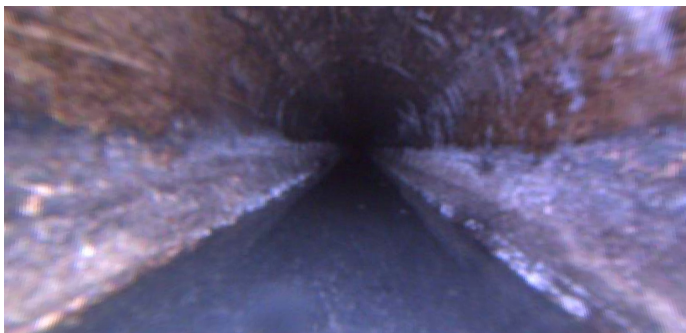
Code: **AMH**  
Description: **Manhole**

Distance (ft): **.0**  
Structural Grade: **0**  
O&M Grade: **0**  
Clock Start/From:  
Clock To:  
1st Value:  
2nd Value:  
Value Percent:  
Continuous Index:  
Within 8" of Joint: **NO**  
Remarks: **M-802-003**

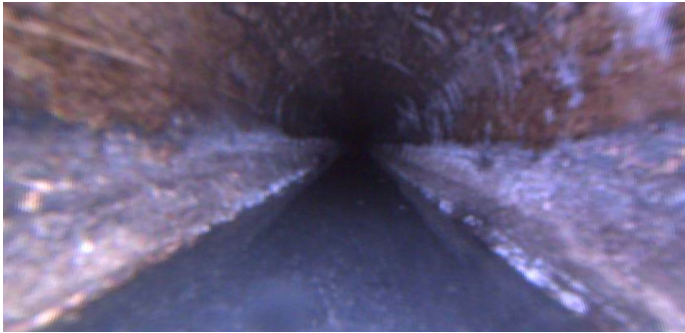
Code:	<b>MWL</b>
Description:	<b>Water Level</b>

Distance (ft):	<b>.0</b>
Structural Grade:	<b>0</b>
O&M Grade:	<b>0</b>
Clock Start/From:	
Clock To:	
1st Value:	
2nd Value:	
Value Percent:	<b>10.000</b>
Continuous Index:	
Within 8" of Joint:	<b>NO</b>
Remarks:

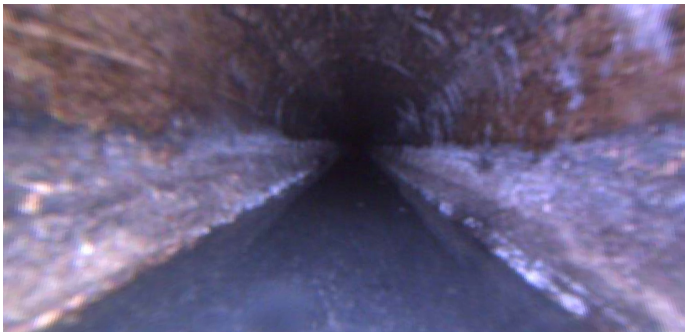
Code:	<b>DAGS</b>
Description:	<b>Deposits Attached Grease</b>

Distance (ft):	<b>.0</b>
Structural Grade:	<b>0</b>
O&M Grade:	<b>2</b>
Clock Start/From:	<b>7</b>
Clock To:	<b>5</b>
1st Value:	
2nd Value:	
Value Percent:	<b>5.000</b>
Continuous Index:	<b>S01</b>
Within 8" of Joint:	<b>YES</b>
Remarks:	<b>WANDER</b>

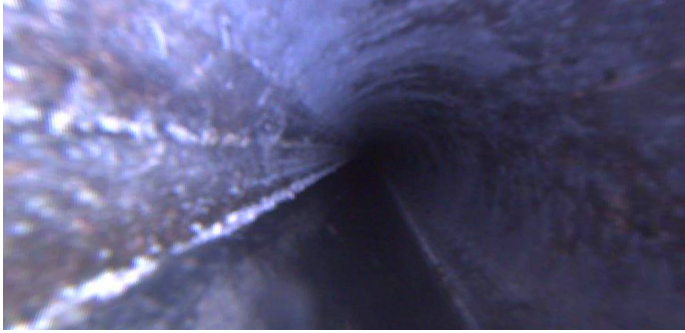
Code: **MSA**  
Description: **Abandoned Survey**

Distance (ft): **103.2**  
Structural Grade: **0**  
O&M Grade: **0**  
Clock Start/From:  
Clock To:  
1st Value:  
2nd Value:  
Value Percent:  
Continuous Index:  
Within 8" of Joint: **NO**  
Remarks: **ROBOT HAS STOPPED; POSSIBLE  
TURNED OVER**

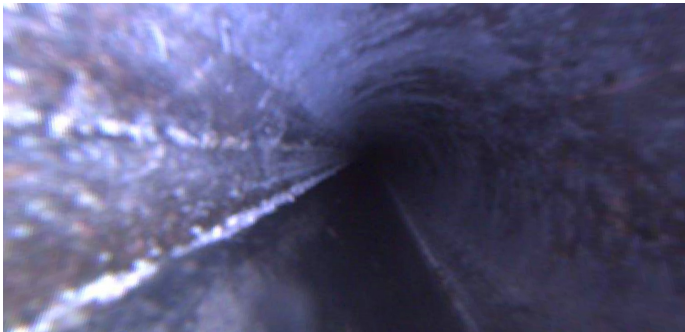
Code: **DAGS**  
Description: **Deposits Attached Grease**

Distance (ft): **103.2**  
Structural Grade: **0**  
O&M Grade: **2**  
Clock Start/From: **7**  
Clock To: **5**  
1st Value:  
2nd Value:  
Value Percent: **5.000**  
Continuous Index: **F01**  
Within 8" of Joint: **YES**  
Remarks: **WANDER**
