## Profile/Photo Observation Report

Street:	<b>N HOBART RD</b>	Flow Control:	<b>Not Controlled</b>
City:	<b>Hobart, IN</b>	Year Renewed:	
Location:	<b>Main Highway - Suburban/Rural</b>	Tape/Media #:	
Purpose:	<b>Resurvey</b>	Dia/Height:	<b>10"</b>
Use:	<b>Sanitary</b>	Material:	<b>VCP</b>
Drain Area:	<b>NA</b>	Lining:	
Category:	<b>NA</b>		
Comment:

Location Details:		Direction of Survey:	<b>Downstream</b>
US MH:	<b>M-802-006</b>	DS MH:	<b>M-802-005</b>
		Total Length Surveyed (ft):	<b>212.6</b>

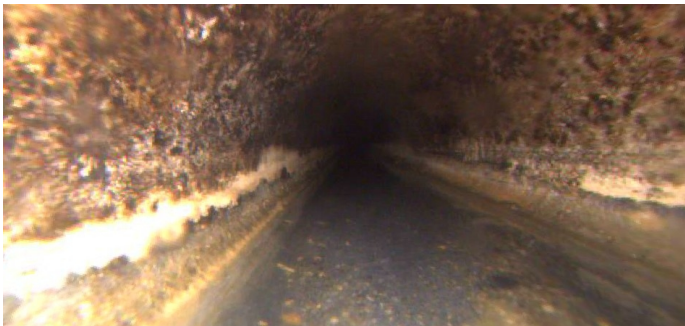
Code: **AMH**  
Description: **Manhole**

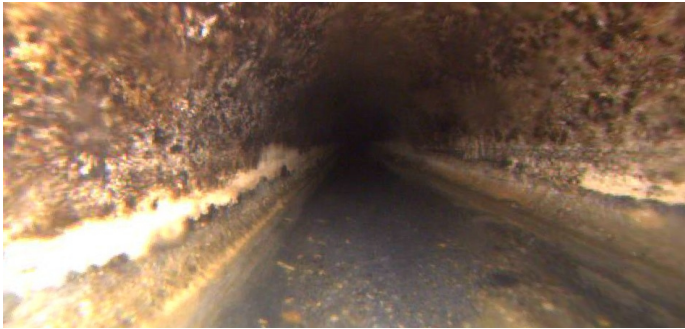
Code:	<b>MWL</b>
Description:	<b>Water Level</b>

Distance (ft):	<b>.0</b>
Structural Grade:	<b>0</b>
O&M Grade:	<b>0</b>
Clock Start/From:	
Clock To:	
1st Value:	
2nd Value:	
Value Percent:	<b>20.000</b>
Continuous Index:	
Within 8" of Joint:	<b>NO</b>
Remarks:

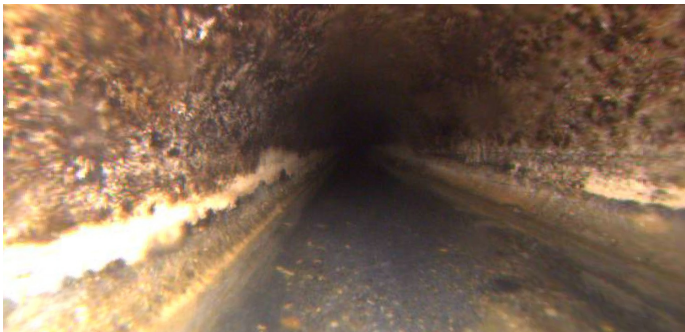
Code:	<b>DAGS</b>
Description:	<b>Deposits Attached Grease</b>

Distance (ft):	<b>.0</b>
Structural Grade:	<b>0</b>
O&M Grade:	<b>2</b>
Clock Start/From:	<b>8</b>
Clock To:	<b>4</b>
1st Value:	
2nd Value:	
Value Percent:	<b>5.000</b>
Continuous Index:	<b>S01</b>
Within 8" of Joint:	<b>NO</b>
Remarks:

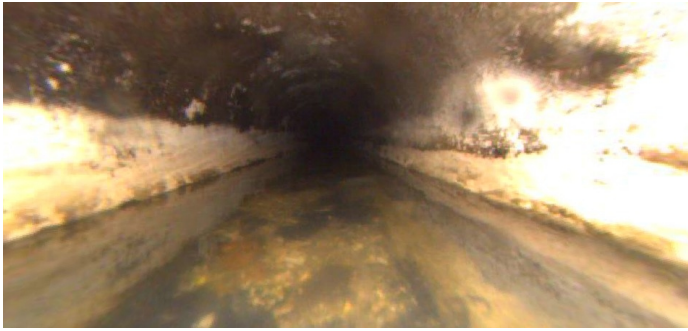
Code: **MWL**  
Description: **Water Level**

Distance (ft): **48.2**  
Structural Grade: **0**  
O&M Grade: **0**  
Clock Start/From:  
Clock To:  
1st Value:  
2nd Value:  
Value Percent: **30.000**  
Continuous Index:  
Within 8" of Joint: **NO**  
Remarks:

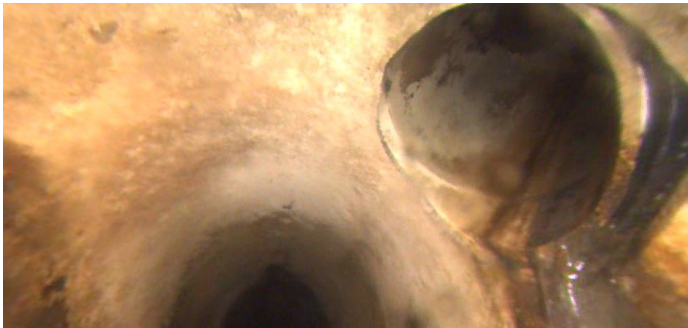
Code: **TBI**  
Description: **Tap Break-in Intruding**

Distance (ft): **76.3**  
Structural Grade: **0**  
O&M Grade: **2**  
Clock Start/From: **2**  
Clock To:  
1st Value: **4.000**  
2nd Value: **1.000**  
Value Percent:  
Continuous Index:  
Within 8" of Joint:  
Remarks:

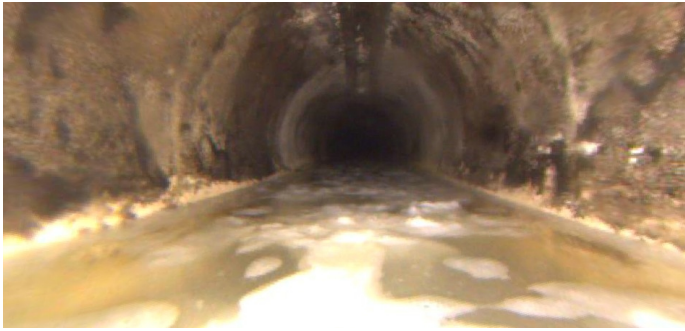
Code: **MWL**  
Description: **Water Level**

Distance (ft): **98.7**  
Structural Grade: **0**  
O&M Grade: **0**  
Clock Start/From:  
Clock To:  
1st Value:  
2nd Value:  
Value Percent: **40.000**  
Continuous Index:  
Within 8" of Joint: **NO**  
Remarks:

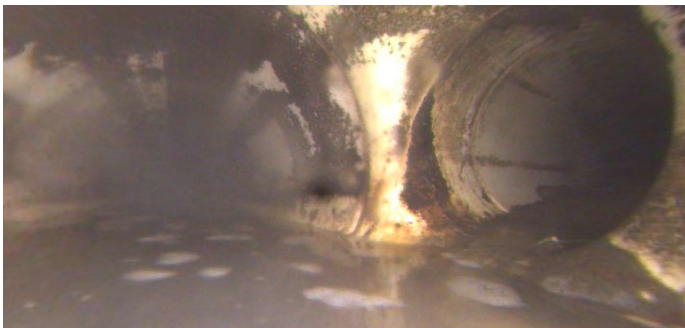
Code: **TF**  
Description: **Tap Factory**

Distance (ft): **118.5**  
Structural Grade: **0**  
O&M Grade: **0**  
Clock Start/From: **3**  
Clock To:  
1st Value: **4.000**  
2nd Value:  
Value Percent:  
Continuous Index:  
Within 8" of Joint:  
Remarks:

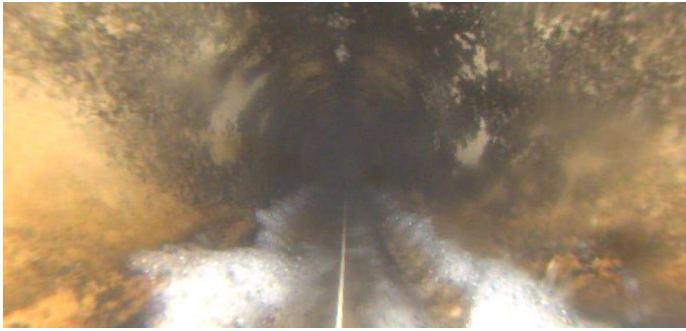
Code: **MGO**  
Description: **General Observation**

Distance (ft): **162.2**  
Structural Grade: **0**  
O&M Grade: **0**  
Clock Start/From:  
Clock To:  
1st Value:  
2nd Value:  
Value Percent:  
Continuous Index:  
Within 8" of Joint: **NO**  
Remarks: **Switching to rear camera**

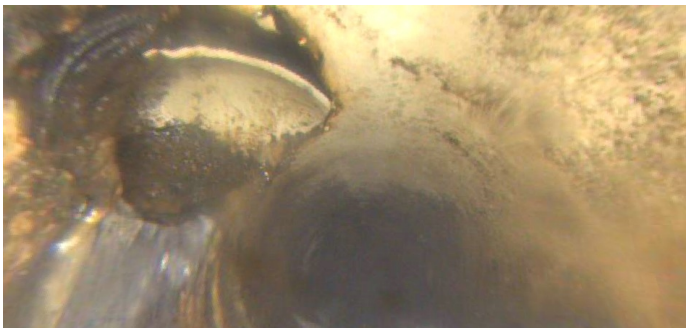
Code: **TBI**  
Description: **Tap Break-in Intruding**

Distance (ft): **163.3**  
Structural Grade: **0**  
O&M Grade: **2**  
Clock Start/From: **2**  
Clock To:  
1st Value: **4.000**  
2nd Value: **1.000**  
Value Percent:  
Continuous Index:  
Within 8" of Joint:  
Remarks:

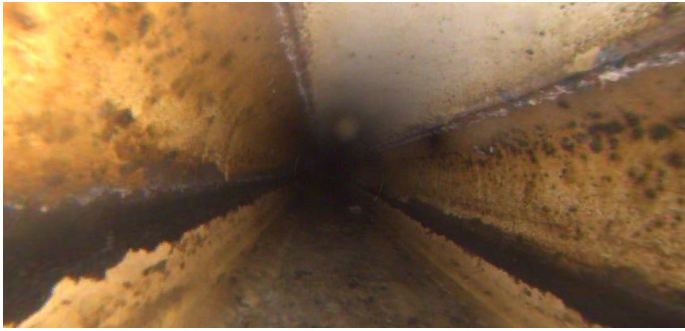
Code: **MGO**  
Description: **General Observation**

Distance (ft): **208.9**  
Structural Grade: **0**  
O&M Grade: **0**  
Clock Start/From:  
Clock To:  
1st Value:  
2nd Value:  
Value Percent:  
Continuous Index:  
Within 8" of Joint: **NO**  
Remarks: **Switching to front camera**

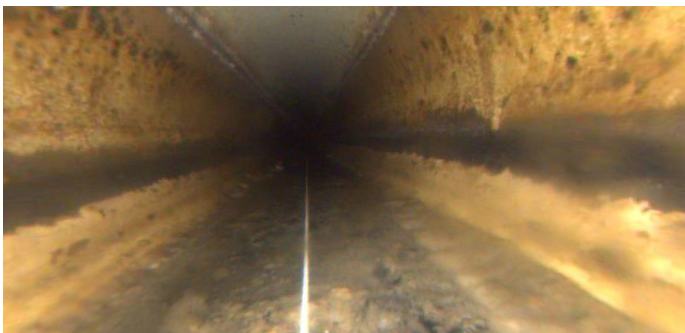
Code: **DAGS**  
Description: **Deposits Attached Grease**

Distance (ft): **210.4**  
Structural Grade: **0**  
O&M Grade: **2**  
Clock Start/From: **8**  
Clock To: **4**  
1st Value:  
2nd Value:  
Value Percent: **5.000**  
Continuous Index: **F01**  
Within 8" of Joint: **NO**  
Remarks:

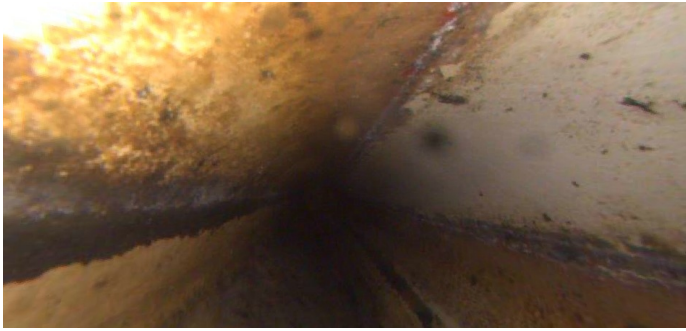
Code:	<b>MSA</b>
Description:	<b>Abandoned Survey</b>
Distance (ft):	<b>212.6</b>
Structural Grade:	<b>0</b>
O&M Grade:	<b>0</b>
Clock Start/From:	
Clock To:	
1st Value:	
2nd Value:	
Value Percent:	
Continuous Index:	
Within 8" of Joint:	<b>NO</b>
Remarks:	<b>Unknown</b>
