Profile/Photo Observation Report

Date:	03/20/2018	Weather:		Coding:	PACP 6.0
Pipe Length (ft):	301.4	Owner:	NA	Pre Clean:	Not Known
P.O.#:		Surveyor:	John Kuglmaier	PSR:	P-802-005-006
Customer:		Clean Date:	01/01/1900	Shape:	C

Street:	N Hobart Rd	Flow Control:	Not Controlled
City:	Hobart, IN	Year Renewed:	
Location:	Main Highway - Suburban/Rural	Tape/Media #:	
Purpose:	Resurvey	Dia/Height:	10"
Use:	Sanitary	Material:	VCP
Drain Area:	NA	Lining:	
Category:	NA		
Comment:

Location Details:		Direction of Survey:	Downstream
US MH:	M-802-006	DS MH:	M-802-005
		Total Length Surveyed (ft):	212.6

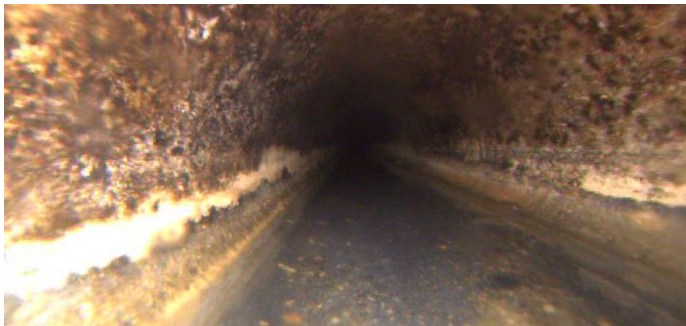
Code: **AMH**
Description: **Manhole**

Distance (ft): **.0**
Structural Grade: **0**
O&M Grade: **0**
Clock Start/From:
Clock To:
1st Value:
2nd Value:
Value Percent:
Continuous Index:
Within 8" of Joint: **NO**
Remarks: **M-802-006**

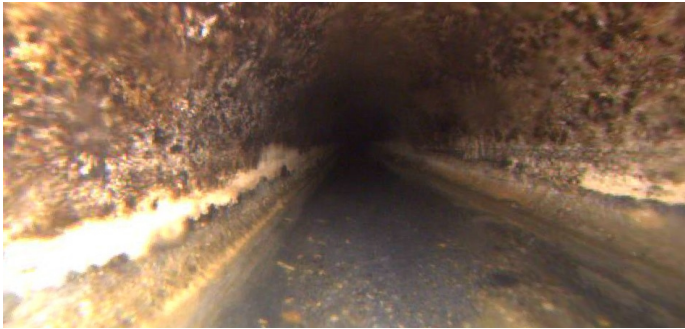
Code:	MWL
Description:	Water Level

Distance (ft):	.0
Structural Grade:	0
O&M Grade:	0
Clock Start/From:	
Clock To:	
1st Value:	
2nd Value:	
Value Percent:	20.000
Continuous Index:	
Within 8" of Joint:	NO
Remarks:

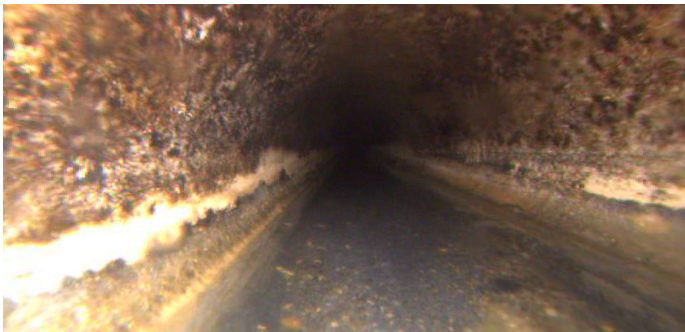
Code:	DAGS
Description:	Deposits Attached Grease

Distance (ft):	.0
Structural Grade:	0
O&M Grade:	2
Clock Start/From:	8
Clock To:	4
1st Value:	
2nd Value:	
Value Percent:	5.000
Continuous Index:	S01
Within 8" of Joint:	NO
Remarks:

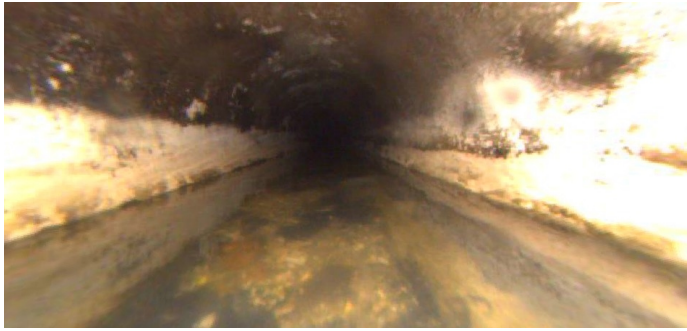
Code: **MWL**
Description: **Water Level**

Distance (ft): **48.2**
Structural Grade: **0**
O&M Grade: **0**
Clock Start/From:
Clock To:
1st Value:
2nd Value:
Value Percent: **30.000**
Continuous Index:
Within 8" of Joint: **NO**
Remarks:

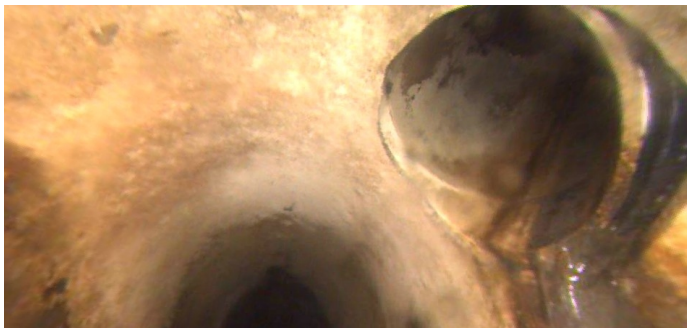
Code: **TBI**
Description: **Tap Break-in Intruding**

Distance (ft): **76.3**
Structural Grade: **0**
O&M Grade: **2**
Clock Start/From: **2**
Clock To:
1st Value: **4.000**
2nd Value: **1.000**
Value Percent:
Continuous Index:
Within 8" of Joint:
Remarks:

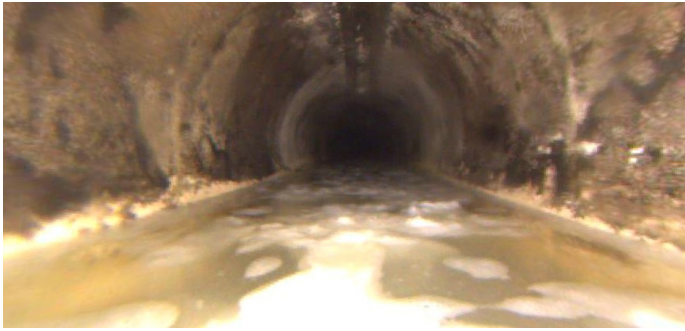
Code: **MWL**
Description: **Water Level**

Distance (ft): **98.7**
Structural Grade: **0**
O&M Grade: **0**
Clock Start/From:
Clock To:
1st Value:
2nd Value:
Value Percent: **40.000**
Continuous Index:
Within 8" of Joint: **NO**
Remarks:

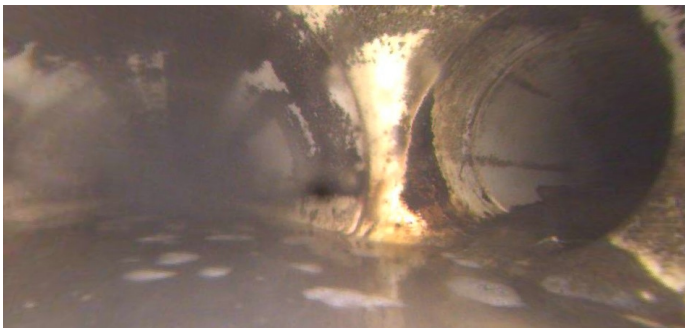
Code: **TF**
Description: **Tap Factory**

Distance (ft): **118.5**
Structural Grade: **0**
O&M Grade: **0**
Clock Start/From: **3**
Clock To:
1st Value: **4.000**
2nd Value:
Value Percent:
Continuous Index:
Within 8" of Joint:
Remarks:

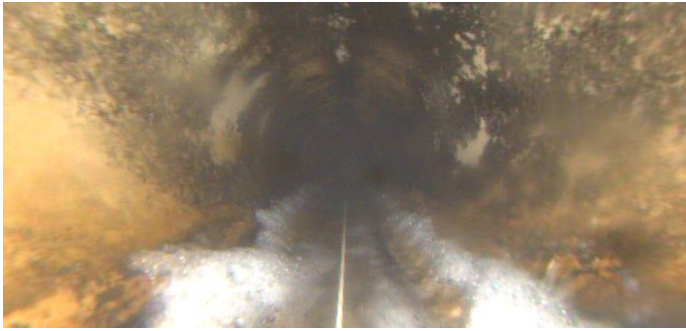
Code: **MGO**
Description: **General Observation**

Distance (ft): **162.2**
Structural Grade: **0**
O&M Grade: **0**
Clock Start/From:
Clock To:
1st Value:
2nd Value:
Value Percent:
Continuous Index:
Within 8" of Joint: **NO**
Remarks: **Switching to rear camera**

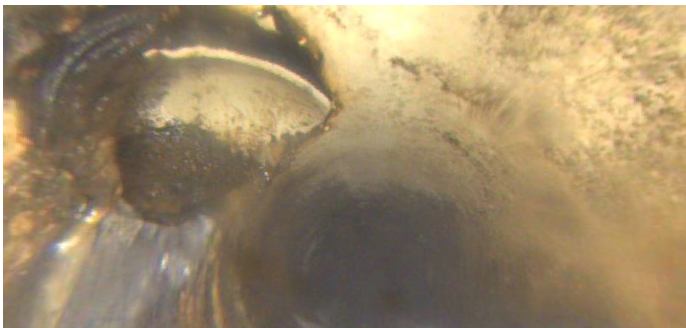
Code: **TBI**
Description: **Tap Break-in Intruding**

Distance (ft): **163.3**
Structural Grade: **0**
O&M Grade: **2**
Clock Start/From: **2**
Clock To:
1st Value: **4.000**
2nd Value: **1.000**
Value Percent:
Continuous Index:
Within 8" of Joint:
Remarks:

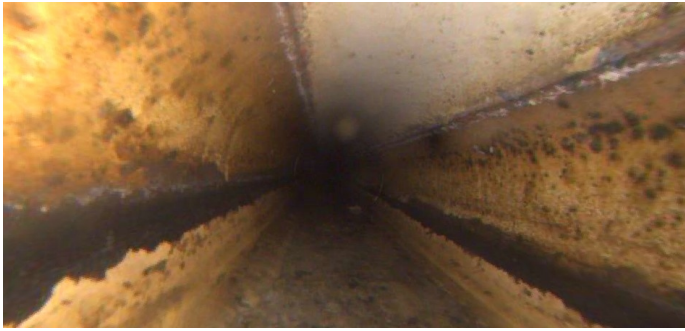
Code: **MGO**
Description: **General Observation**

Distance (ft): **208.9**
Structural Grade: **0**
O&M Grade: **0**
Clock Start/From:
Clock To:
1st Value:
2nd Value:
Value Percent:
Continuous Index:
Within 8" of Joint: **NO**
Remarks: **Switching to front camera**

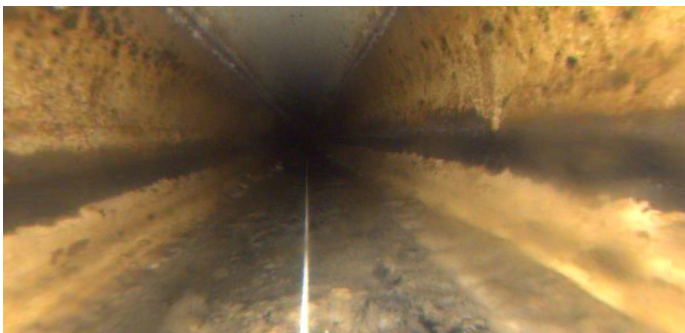
Code: **DAGS**
Description: **Deposits Attached Grease**

Distance (ft): **210.4**
Structural Grade: **0**
O&M Grade: **2**
Clock Start/From: **8**
Clock To: **4**
1st Value:
2nd Value:
Value Percent: **5.000**
Continuous Index: **F01**
Within 8" of Joint: **NO**
Remarks:

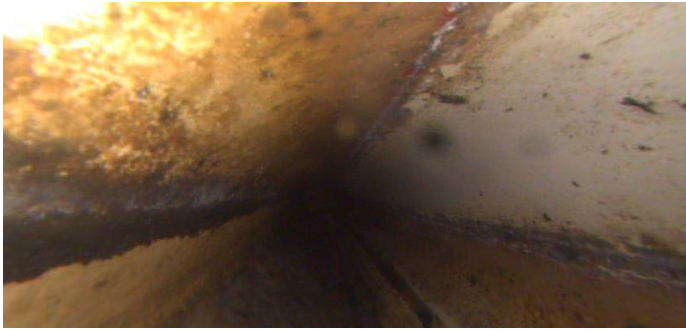
Code:	MSA
Description:	Abandoned Survey
Distance (ft):	212.6
Structural Grade:	0
O&M Grade:	0
Clock Start/From:	
Clock To:	
1st Value:	
2nd Value:	
Value Percent:	
Continuous Index:	
Within 8" of Joint:	NO
Remarks:	Unknown
