## Profile/Photo Observation Report

Date:	<b>03/20/2018</b>	Weather:		Coding:	<b>PACP 6.0</b>
Pipe Length (ft):	<b>304.6</b>	Owner:	<b>NA</b>	Pre Clean:	<b>Not Known</b>
P.O.#:		Surveyor:	<b>John Kuglmaier</b>	PSR:	<b>P-802-006-007</b>
Customer:		Clean Date:	<b>01/01/1900</b>	Shape:	<b>C</b>

Street:	<b>N Hobart Rd</b>	Flow Control:	<b>Not Controlled</b>
City:	<b>Hobart, IN</b>	Year Renewed:	
Location:	<b>Main Highway - Suburban/Rural</b>	Tape/Media #:	
Purpose:	<b>Resurvey</b>	Dia/Height:	<b>10"</b>
Use:	<b>Sanitary</b>	Material:	<b>PVC</b>
Drain Area:	<b>NA</b>	Lining:	
Category:	<b>NA</b>		
Comment:

Location Details:		Direction of Survey:	<b>Downstream</b>
US MH:	<b>M-802-006</b>	DS MH:	<b>M-802-007</b>
		Total Length Surveyed (ft):	<b>299.2</b>

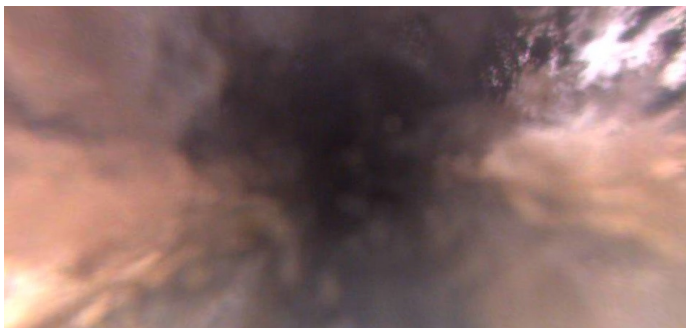
Code: **AMH**  
Description: **Manhole**

Distance (ft): **.0**  
Structural Grade: **0**  
O&M Grade: **0**  
Clock Start/From:  
Clock To:  
1st Value:  
2nd Value:  
Value Percent:  
Continuous Index:  
Within 8" of Joint: **NO**  
Remarks: **M-802-006**

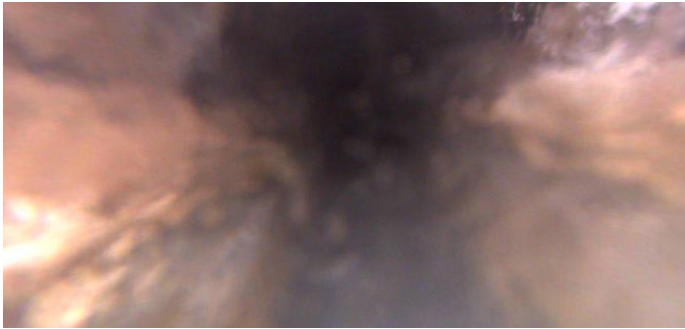
Code:	<b>MWL</b>
Description:	<b>Water Level</b>

Distance (ft):	<b>.0</b>
Structural Grade:	<b>0</b>
O&M Grade:	<b>0</b>
Clock Start/From:	
Clock To:	
1st Value:	
2nd Value:	
Value Percent:	<b>5.000</b>
Continuous Index:	
Within 8" of Joint:	<b>NO</b>
Remarks:

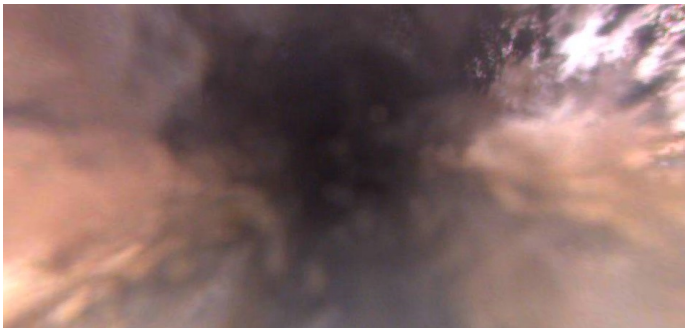
Code:	<b>DAZ</b>
Description:	<b>Deposits Attached Other</b>

Distance (ft):	<b>.0</b>
Structural Grade:	<b>0</b>
O&M Grade:	<b>3</b>
Clock Start/From:	<b>7</b>
Clock To:	<b>5</b>
1st Value:	
2nd Value:	
Value Percent:	<b>15.000</b>
Continuous Index:	<b>S01</b>
Within 8" of Joint:	<b>NO</b>
Remarks:	<b>Mixed materials</b>

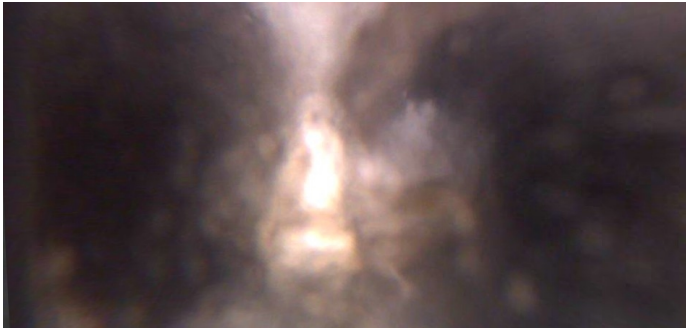
Code: **TF**  
Description: **Tap Factory**

Distance (ft): **29.6**  
Structural Grade: **0**  
O&M Grade: **0**  
Clock Start/From: **9**  
Clock To:  
1st Value: **4.000**  
2nd Value:  
Value Percent:  
Continuous Index:  
Within 8" of Joint:  
Remarks:

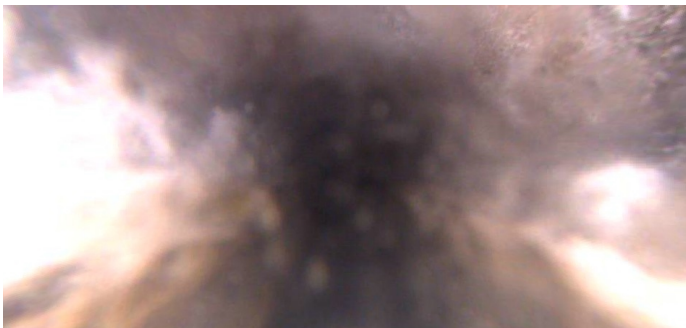
Code: **DAZ**  
Description: **Deposits Attached Other**

Distance (ft): **30.3**  
Structural Grade: **0**  
O&M Grade: **3**  
Clock Start/From: **7**  
Clock To: **5**  
1st Value:  
2nd Value:  
Value Percent: **15.000**  
Continuous Index: **F01**  
Within 8" of Joint: **NO**  
Remarks: **Mixed materials / Clock positions vary**

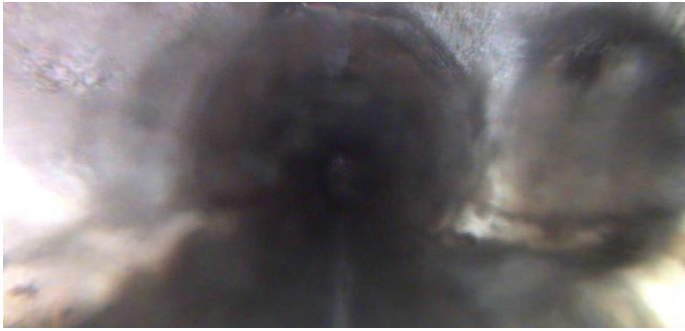
Code: **MGO**  
Description: **General Observation**

Distance (ft): **30.3**  
Structural Grade: **0**  
O&M Grade: **0**  
Clock Start/From:  
Clock To:  
1st Value:  
2nd Value:  
Value Percent:  
Continuous Index:  
Within 8" of Joint: **NO**  
Remarks: **Switching to rear camera**

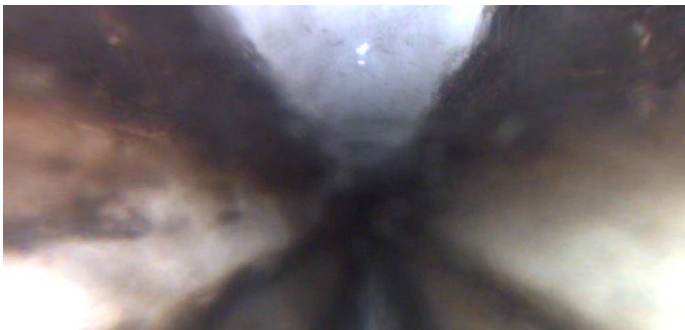
Code: **DAGS**  
Description: **Deposits Attached Grease**

Distance (ft): **146.9**  
Structural Grade: **0**  
O&M Grade: **2**  
Clock Start/From: **3**  
Clock To: **8**  
1st Value:  
2nd Value:  
Value Percent: **10.000**  
Continuous Index: **S02**  
Within 8" of Joint: **NO**  
Remarks:

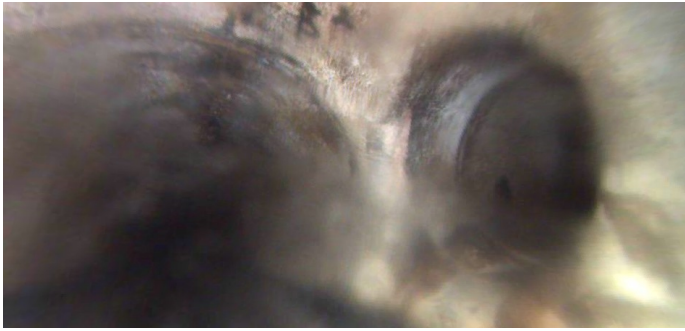
Code: **TF**  
Description: **Tap Factory**

Distance (ft): **177.8**  
Structural Grade: **0**  
O&M Grade: **0**  
Clock Start/From: **10**  
Clock To:  
1st Value: **4.000**  
2nd Value:  
Value Percent:  
Continuous Index:  
Within 8" of Joint:  
Remarks:

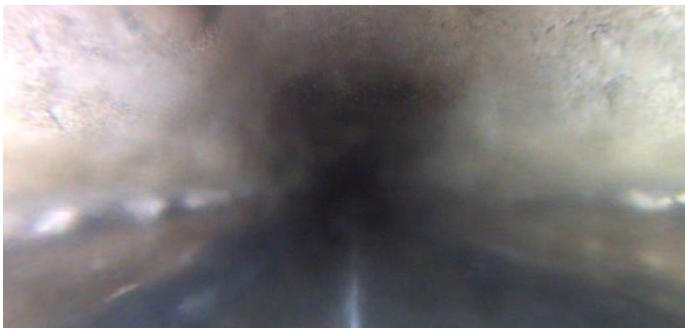
Code: **DAGS**  
Description: **Deposits Attached Grease**

Distance (ft): **293.1**  
Structural Grade: **0**  
O&M Grade: **2**  
Clock Start/From: **3**  
Clock To: **8**  
1st Value:  
2nd Value:  
Value Percent: **10.000**  
Continuous Index: **F02**  
Within 8" of Joint: **NO**  
Remarks: **Clock positions vary**

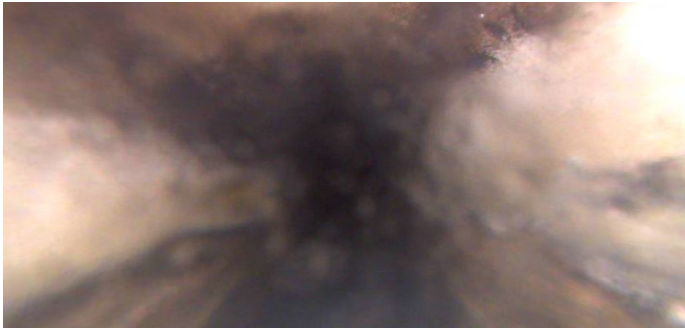
Code: **MGO**  
Description: **General Observation**

Distance (ft): **293.1**  
Structural Grade: **0**  
O&M Grade: **0**  
Clock Start/From:  
Clock To:  
1st Value:  
2nd Value:  
Value Percent:  
Continuous Index:  
Within 8" of Joint: **NO**  
Remarks: **Switching to front camera**

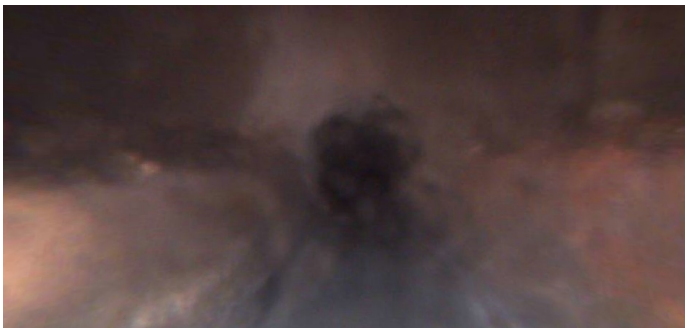
Code: **AMH**  
Description: **Manhole**

Distance (ft): **299.2**  
Structural Grade: **0**  
O&M Grade: **0**  
Clock Start/From:  
Clock To:  
1st Value:  
2nd Value:  
Value Percent:  
Continuous Index:  
Within 8" of Joint: **NO**  
Remarks: **M-802-007**
