## Profile/Photo Observation Report

Street:	<b>N HOBART RD</b>	Flow Control:	<b>Not Controlled</b>
City:	<b>Hobart, IN</b>	Year Renewed:	
Location:	<b>Other</b>	Tape/Media #:	
Purpose:	<b>Not Known</b>	Dia/Height:	<b>10"</b>
Use:	<b>Sanitary</b>	Material:	<b>VCP</b>
Drain Area:	<b>NA</b>	Lining:	
Category:	<b>NA</b>		
Comment:

Location Details:		Direction of Survey:	<b>Downstream</b>
US MH:	<b>M-802-007</b>	DS MH:	<b>M-802-008</b>
		Total Length Surveyed (ft):	<b>12.2</b>

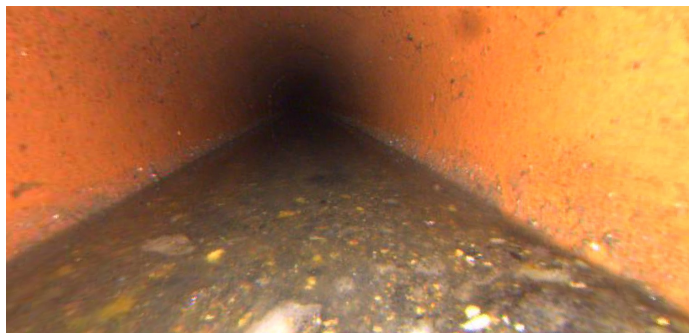
Code: **AMH**  
 Description: **Manhole**  
 Distance (ft): **.0**  
 Structural Grade: **0**  
 O&M Grade: **0**  
 Clock Start/From:  
 Clock To:  
 1st Value:  
 2nd Value:  
 Value Percent:  
 Continuous Index:  
 Within 8" of Joint: **NO**  
 Remarks: **M-802-008**

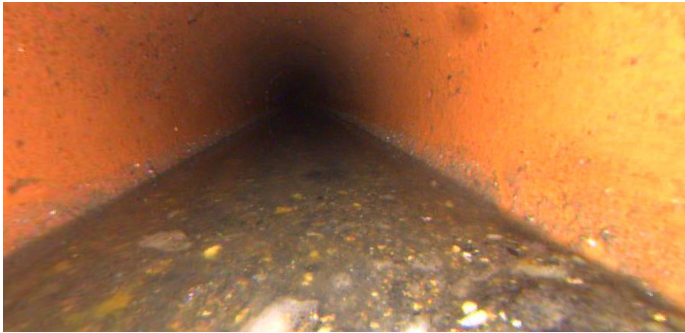
Code:	<b>MWL</b>
Description:	<b>Water Level</b>

Distance (ft):	<b>.0</b>
Structural Grade:	<b>0</b>
O&M Grade:	<b>0</b>
Clock Start/From:	
Clock To:	
1st Value:	
2nd Value:	
Value Percent:	<b>20.000</b>
Continuous Index:	
Within 8" of Joint:	<b>NO</b>
Remarks:

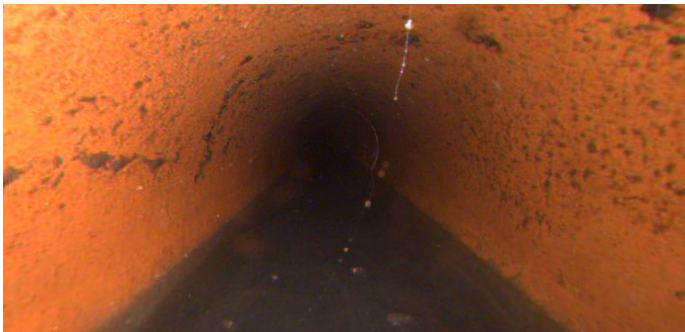
Code:	<b>MSA</b>
Description:	<b>Abandoned Survey</b>

Distance (ft):	<b>12.2</b>
Structural Grade:	<b>0</b>
O&M Grade:	<b>0</b>
Clock Start/From:	
Clock To:	
1st Value:	
2nd Value:	
Value Percent:	
Continuous Index:	
Within 8" of Joint:	<b>NO</b>
Remarks:	<b>DEBRIS UNDER WATER</b>
