Profile/Photo Observation Report

| Street: | e 34th In | Flow Control: | Not Controlled |
| City: | Hobart, IN | Year Renewed: | |

| US MH: | M-802-007 | DS MH: | M-802-008 |

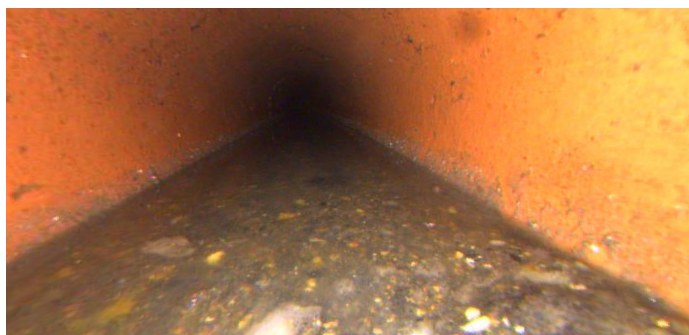
Code: **AMH**
 Description: **Manhole**

Distance (ft): **.0**
 Structural Grade: **0**
 O&M Grade: **0**
 Clock Start/From:
 Clock To:
 1st Value:
 2nd Value:
 Value Percent:
 Continuous Index:
 Within 8" of Joint: **NO**
 Remarks: **M-802-008**

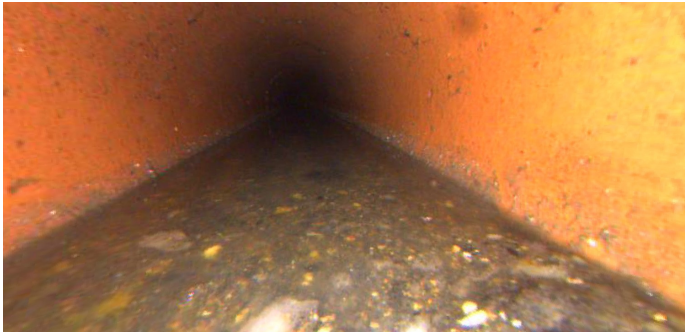
| Code: | MWL |
| Description: | Water Level |

| Value Percent: | 20.000 |

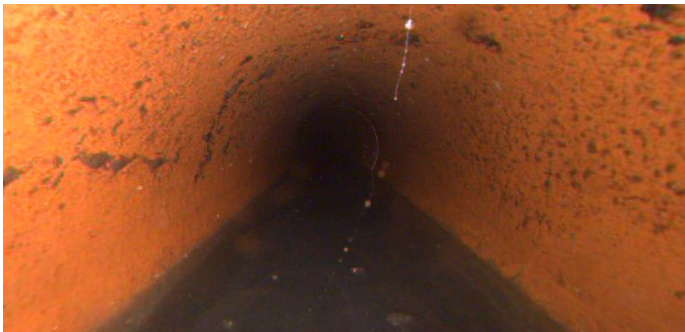
| Code: | MSA |
| Description: | Abandoned Survey |

| Distance (ft): | 12.2 |
| Remarks: | DEBRIS UNDER WATER |
