## Profile/Photo Observation Report

Street:	<b>N Hobart Rd</b>	Flow Control:	<b>Not Controlled</b>
City:	<b>Hobart, IN</b>	Year Renewed:	
Location:	<b>Main Highway - Suburban/Rural</b>	Tape/Media #:	
Purpose:	<b>Resurvey</b>	Dia/Height:	<b>10"</b>
Use:	<b>Sanitary</b>	Material:	<b>VCP</b>
Drain Area:	<b>NA</b>	Lining:	
Category:	<b>NA</b>		
Comment:

Location Details:		Direction of Survey:	<b>Downstream</b>
US MH:	<b>M-802-008</b>	DS MH:	<b>M-902-068</b>
		Total Length Surveyed (ft):	<b>44.4</b>

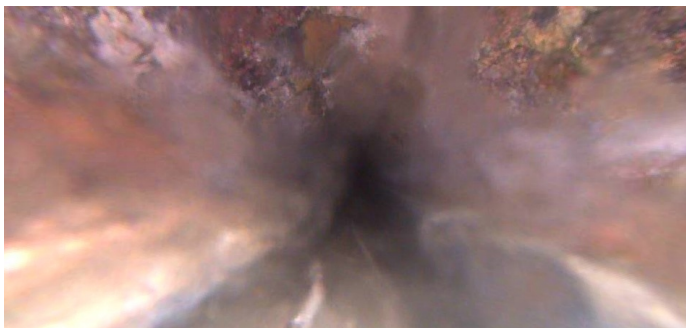
Code: **AMH**  
Description: **Manhole**

Distance (ft): **.0**  
Structural Grade: **0**  
O&M Grade: **0**  
Clock Start/From:  
Clock To:  
1st Value:  
2nd Value:  
Value Percent:  
Continuous Index:  
Within 8" of Joint: **NO**  
Remarks: **M-802-008**

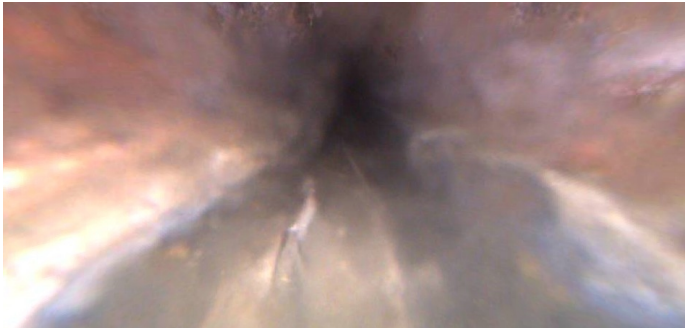
Code:	<b>MWL</b>
Description:	<b>Water Level</b>

Distance (ft):	<b>.0</b>
Structural Grade:	<b>0</b>
O&M Grade:	<b>0</b>
Clock Start/From:	
Clock To:	
1st Value:	
2nd Value:	
Value Percent:	<b>20.000</b>
Continuous Index:	
Within 8" of Joint:	<b>NO</b>
Remarks:

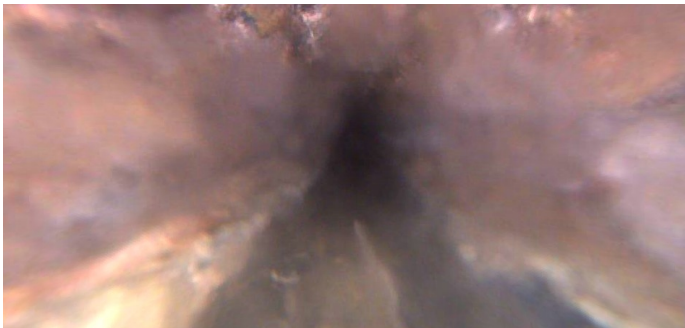
Code:	<b>DAZ</b>
Description:	<b>Deposits Attached Other</b>

Distance (ft):	<b>1.4</b>
Structural Grade:	<b>0</b>
O&M Grade:	<b>3</b>
Clock Start/From:	<b>8</b>
Clock To:	<b>4</b>
1st Value:	
2nd Value:	
Value Percent:	<b>15.000</b>
Continuous Index:	<b>S01</b>
Within 8" of Joint:	<b>NO</b>
Remarks:	<b>Mixed materials</b>

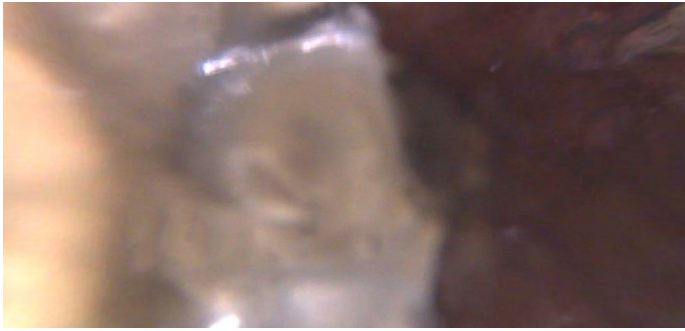
Code: **MSA**  
Description: **Abandoned Survey**

Distance (ft): **44.4**  
Structural Grade: **0**  
O&M Grade: **0**  
Clock Start/From:  
Clock To:  
1st Value:  
2nd Value:  
Value Percent:  
Continuous Index:  
Within 8" of Joint: **NO**  
Remarks: **DAZ**

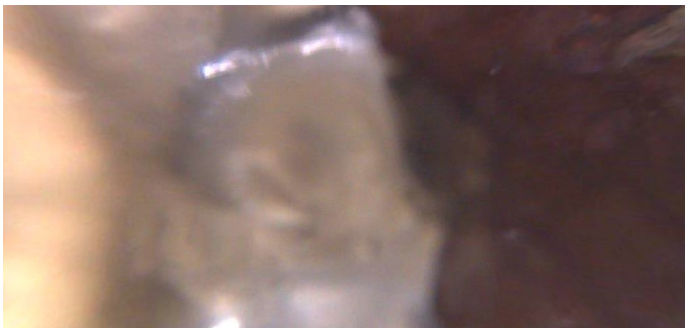
Code: **DAZ**  
Description: **Deposits Attached Other**

Distance (ft): **44.4**  
Structural Grade: **0**  
O&M Grade: **3**  
Clock Start/From: **8**  
Clock To: **4**  
1st Value:  
2nd Value:  
Value Percent: **15.000**  
Continuous Index: **F01**  
Within 8" of Joint: **NO**  
Remarks: **Mixed materials / Clock positions vary**
