## Profile/Photo Observation Report

| Street: | <b>37th ave</b> | Flow Control: | <b>Not Controlled</b> |
| City: | <b>Hobart, IN</b> | Year Renewed: | |

| US MH: | <b>M-802-008</b> | DS MH: | <b>M-902-068</b> |

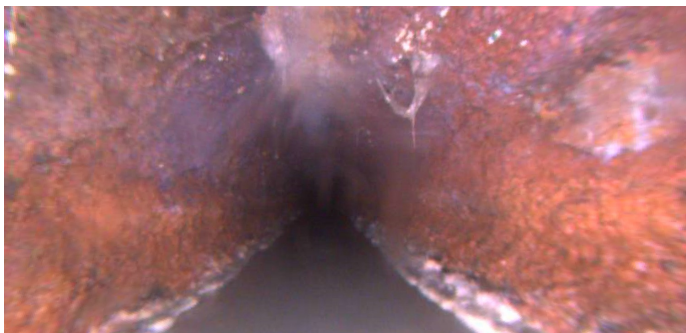
Code: **DAE**  
Description: **Deposits Attached Encrustation**

Distance (ft): **.0**  
Structural Grade: **0**  
O&M Grade: **2**  
Clock Start/From: **8**  
Clock To: **4**  
1st Value:  
2nd Value:  
Value Percent: **10.000**  
Continuous Index: **S01**  
Within 8" of Joint: **NO**  
Remarks:

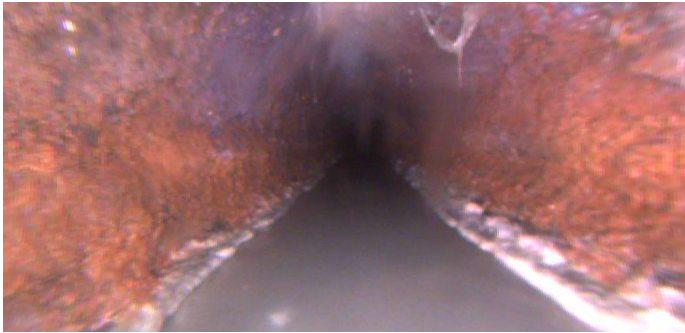
| Code: | <b>AMH</b> |
| Description: | <b>Manhole</b> |

| Remarks: | <b>M-902-068</b> |

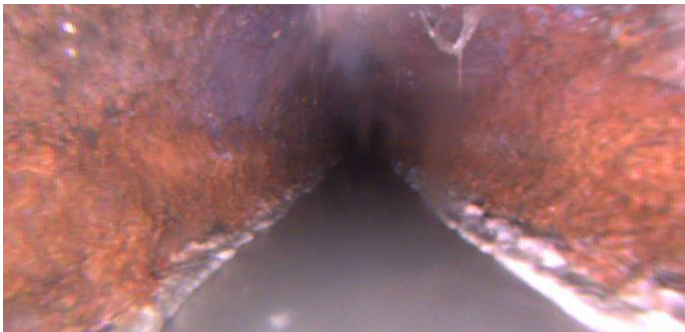
| Code: | <b>MWL</b> |
| Description: | <b>Water Level</b> |

| Value Percent: | <b>5.000</b> |

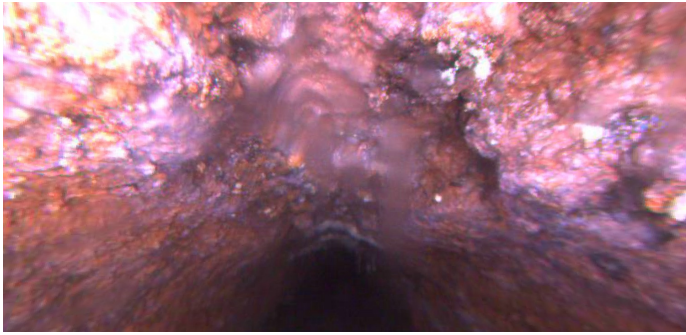
Code: **DAE**  
Description: **Deposits Attached Encrustation**

Distance (ft): **28.2**  
Structural Grade: **0**  
O&M Grade: **2**  
Clock Start/From: **8**  
Clock To: **4**  
1st Value:  
2nd Value:  
Value Percent: **10.000**  
Continuous Index: **F01**  
Within 8" of Joint: **NO**  
Remarks:

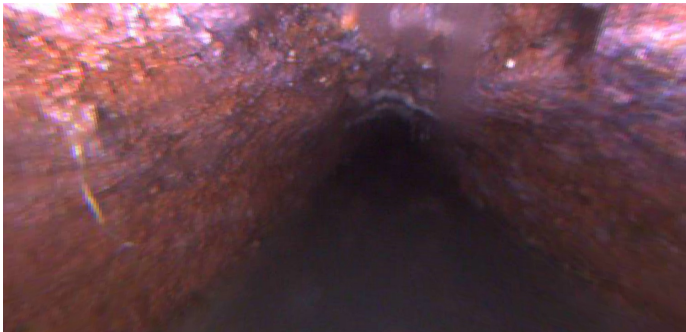
Code: **MSA**  
Description: **Abandoned Survey**

Distance (ft): **28.2**  
Structural Grade: **0**  
O&M Grade: **0**  
Clock Start/From:  
Clock To:  
1st Value:  
2nd Value:  
Value Percent:  
Continuous Index:  
Within 8" of Joint: **NO**  
Remarks: **DAE**
