Profile/Photo Observation Report

Date:	04/23/2018	Weather:		Coding:	PACP 4.2
Pipe Length (ft):	.0	Owner:	City of Hobart	Pre Clean:	No Pre-Cleaning
P.O.#:	2004	Surveyor:	SAN	PSR:	P-802-022-010
Customer:	Red Zone	Clean Date:		Shape:	C

Street:	E Randolph St	Flow Control:	Not Controlled
City:	Hobart In	Year Renewed:	
Location:	Parking Lot	Tape/Media #:	Deliverable 1
Purpose:	Routine Assessment	Dia/Height:	6"
Use:	Sanitary	Material:	PVC
Drain Area:	Northeast	Lining:	
Category:	NA		
Comment:	427-3/Incomplete due to grease and no reverse due to blockage downstream.		
Location Details:	Lot behind strip mall	Direction of Survey:	Downstream
US MH:	M-802-022	DS MH:	M-802-010
		Total Length Surveyed (ft):	79.8

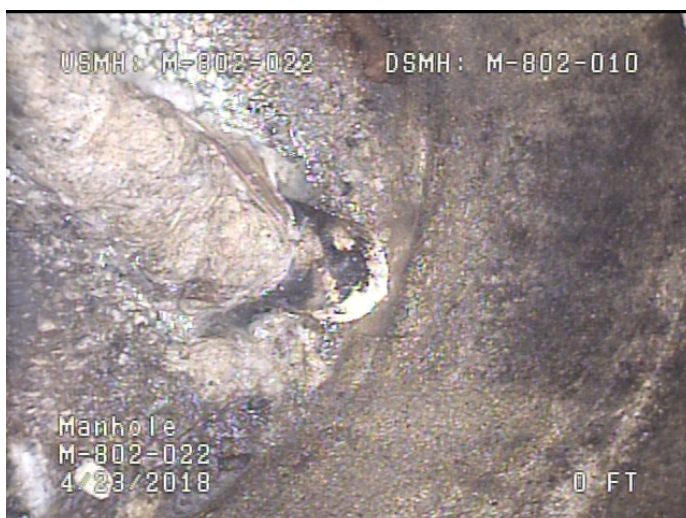
Code:	AMH
Description:	Manhole
Distance (ft):	.0
Structural Grade:	0
O&M Grade:	0
Clock Start/From:	
Clock To:	
1st Value:	
2nd Value:	
Value Percent:	
Continuous Index:	
Within 8" of Joint:	NO
Remarks:	M-802-022

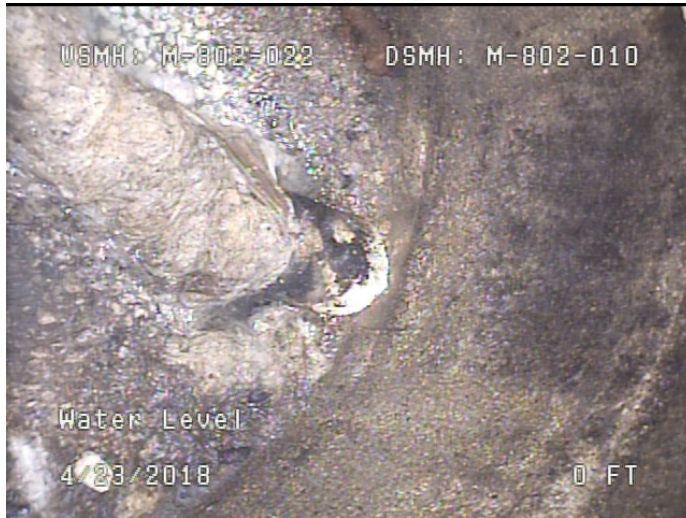
Code: **MWL**
Description: **Water Level**

Distance (ft): **.0**
Structural Grade: **0**
O&M Grade: **0**
Clock Start/From:
Clock To:
1st Value:
2nd Value:
Value Percent: **5.000**
Continuous Index:
Within 8" of Joint: **NO**
Remarks:

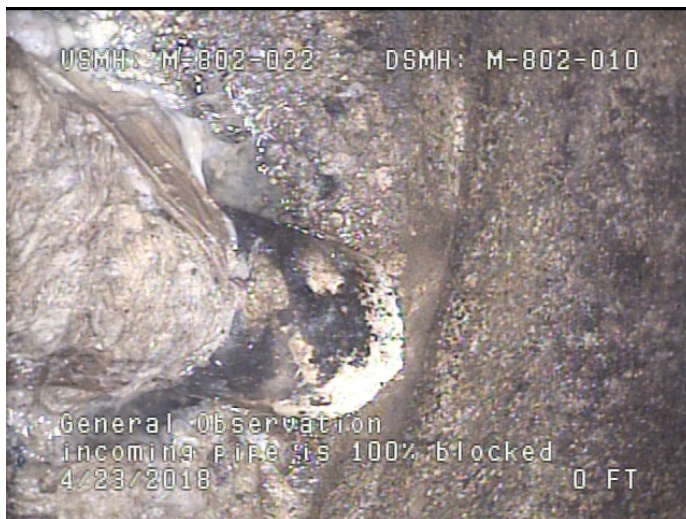
Code: **MGO**
Description: **General Observation**

Distance (ft): **.0**
Structural Grade: **0**
O&M Grade: **0**
Clock Start/From:
Clock To:
1st Value:
2nd Value:
Value Percent:
Continuous Index:
Within 8" of Joint: **NO**
Remarks: **incoming pipe is 100% blocked**

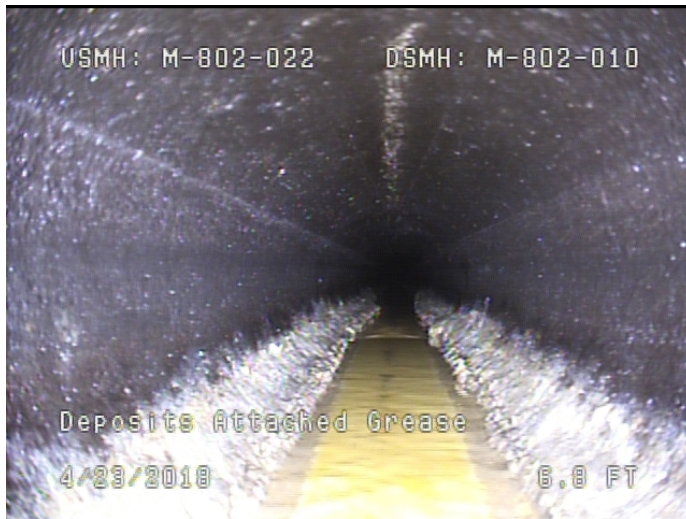
Code:	DAGS
Description:	Deposits Attached Grease
Distance (ft):	6.8
Structural Grade:	0
O&M Grade:	2
Clock Start/From:	4
Clock To:	8
1st Value:	
2nd Value:	
Value Percent:	10.000
Continuous Index:	S02
Within 8" of Joint:	NO
Remarks:

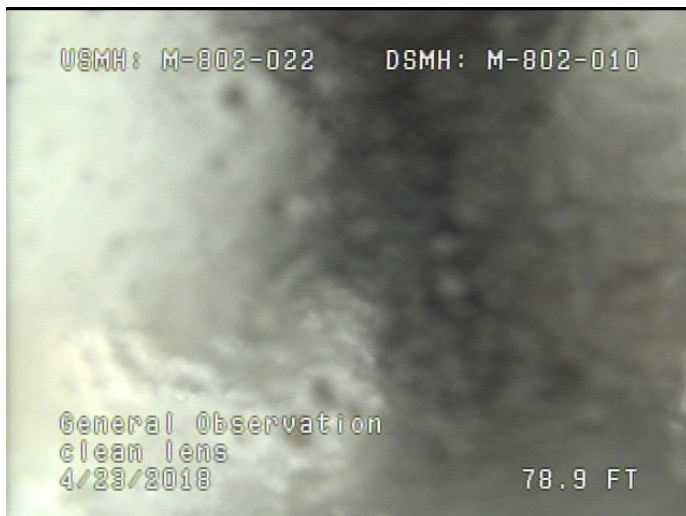
Code:	MGO
Description:	General Observation
Distance (ft):	78.9
Structural Grade:	0
O&M Grade:	0
Clock Start/From:	
Clock To:	
1st Value:	
2nd Value:	
Value Percent:	
Continuous Index:	
Within 8" of Joint:	NO
Remarks:	clean lens

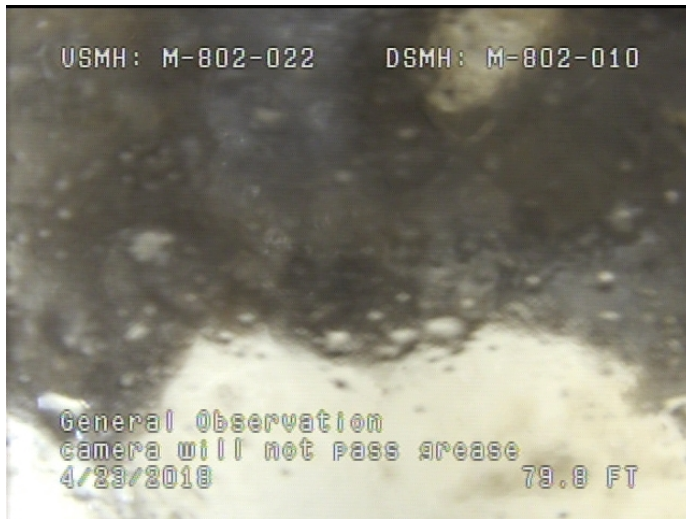
Code:	MGO
Description:	General Observation
Distance (ft):	79.8
Structural Grade:	0
O&M Grade:	0
Clock Start/From:	
Clock To:	
1st Value:	
2nd Value:	
Value Percent:	
Continuous Index:	
Within 8" of Joint:	NO
Remarks:	camera will not pass grease

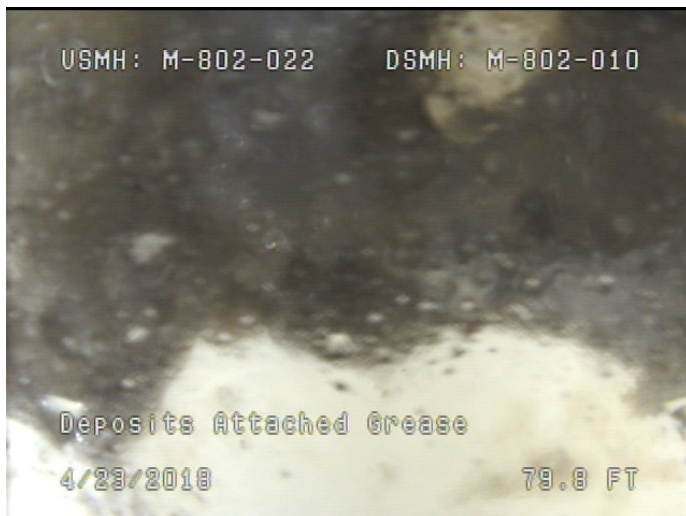
Code:	DAGS
Description:	Deposits Attached Grease
Distance (ft):	79.8
Structural Grade:	0
O&M Grade:	2
Clock Start/From:	4
Clock To:	8
1st Value:	
2nd Value:	
Value Percent:	10.000
Continuous Index:	F02
Within 8" of Joint:	NO
Remarks:

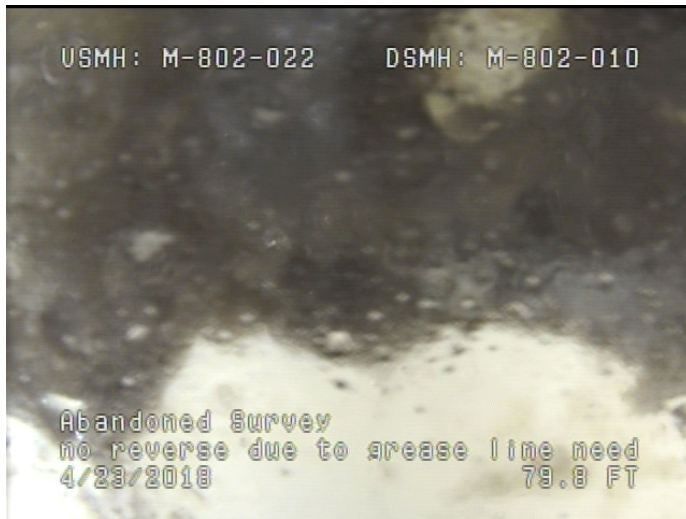
Code:	MSA
Description:	Abandoned Survey
Distance (ft):	79.8
Structural Grade:	0
O&M Grade:	0
Clock Start/From:	
Clock To:	
1st Value:	
2nd Value:	
Value Percent:	
Continuous Index:	
Within 8" of Joint:	NO
Remarks:	no reverse due to grease line needs cleaned
