Profile/Photo Observation Report

Street:	OFF N HOBART RD	Flow Control:	Not Controlled
City:	Hobart, IN	Year Renewed:	
Location:	Main Highway - Suburban/Rural	Tape/Media #:	
Purpose:	Resurvey	Dia/Height:	8"
Use:	Sanitary	Material:	PVC
Drain Area:	NA	Lining:	
Category:	NA		
Comment:

Location Details:		Direction of Survey:	Downstream
US MH:	M-802-014	DS MH:	M-802-013
		Total Length Surveyed (ft):	94.8

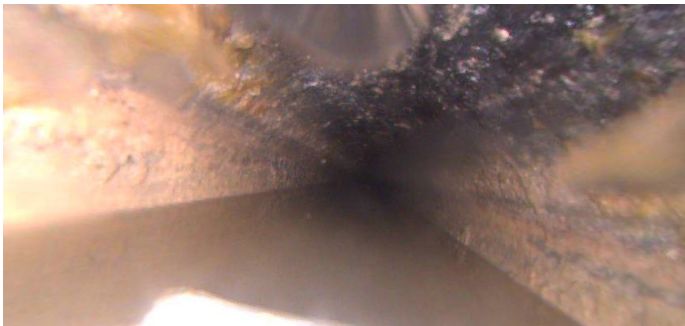
Code: **AMH**
Description: **Manhole**

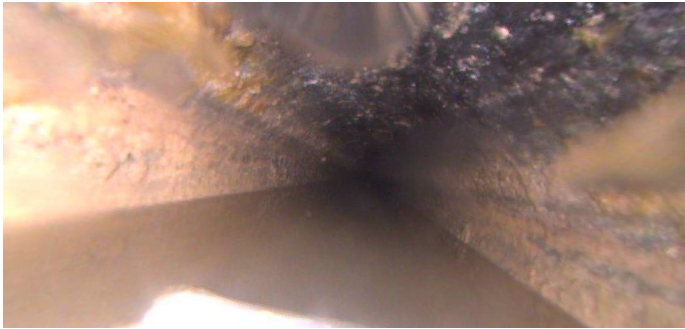
Code:	MWL
Description:	Water Level

Distance (ft):	.0
Structural Grade:	0
O&M Grade:	0
Clock Start/From:	
Clock To:	
1st Value:	
2nd Value:	
Value Percent:	30.000
Continuous Index:	
Within 8" of Joint:	NO
Remarks:

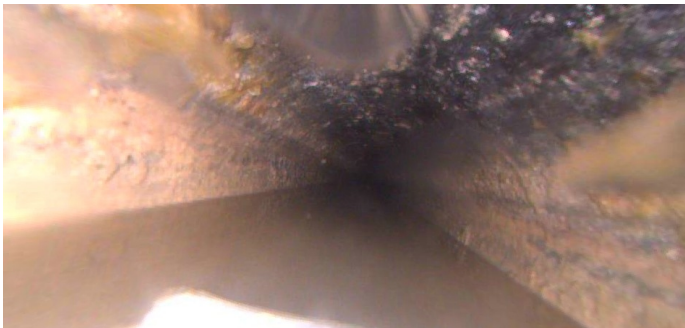
Code:	DAZ
Description:	Deposits Attached Other

Distance (ft):	.0
Structural Grade:	0
O&M Grade:	2
Clock Start/From:	9
Clock To:	3
1st Value:	
2nd Value:	
Value Percent:	5.000
Continuous Index:	S01
Within 8" of Joint:	NO
Remarks:	Mixed materials

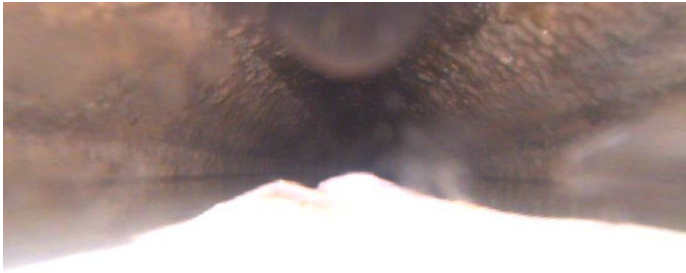
Code: **MWL**
Description: **Water Level**

Distance (ft): **4.5**
Structural Grade: **0**
O&M Grade: **0**
Clock Start/From:
Clock To:
1st Value:
2nd Value:
Value Percent: **40.000**
Continuous Index:
Within 8" of Joint: **NO**
Remarks:

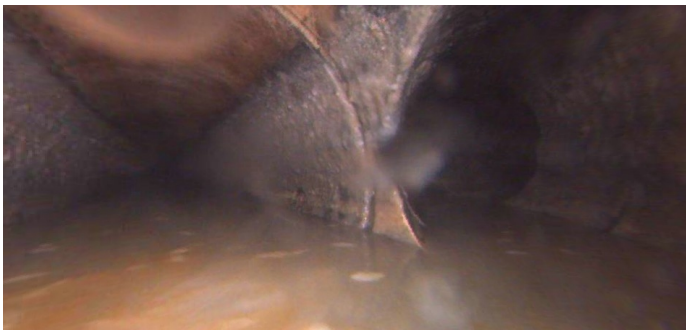
Code: **TF**
Description: **Tap Factory**

Distance (ft): **21.7**
Structural Grade: **0**
O&M Grade: **0**
Clock Start/From: **3**
Clock To:
1st Value: **4.000**
2nd Value:
Value Percent:
Continuous Index:
Within 8" of Joint:
Remarks:

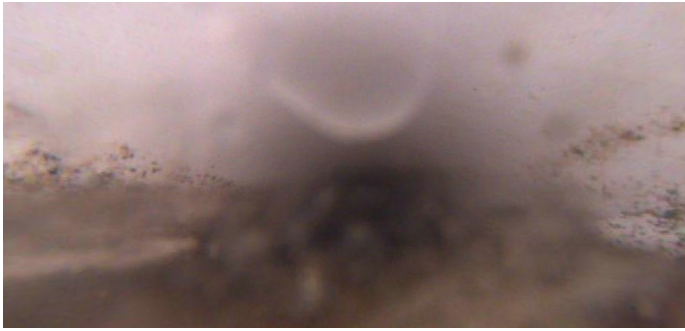
Code: **DAZ**
Description: **Deposits Attached Other**

Distance (ft): **74.8**
Structural Grade: **0**
O&M Grade: **2**
Clock Start/From: **9**
Clock To: **3**
1st Value:
2nd Value:
Value Percent: **5.000**
Continuous Index: **F01**
Within 8" of Joint: **NO**
Remarks: **Mixed materials / Clock positions vary**

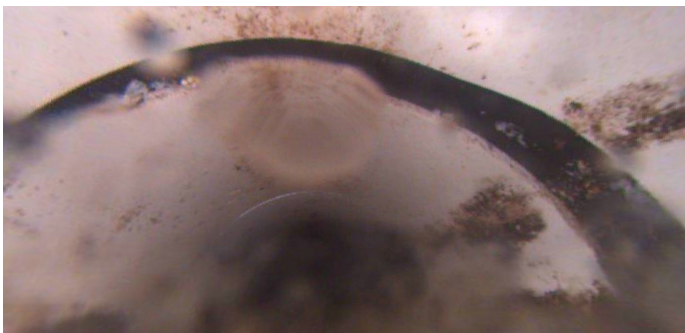
Code: **JSM**
Description: **Joint Separated Medium**

Distance (ft): **79.9**
Structural Grade: **1**
O&M Grade: **0**
Clock Start/From:
Clock To:
1st Value:
2nd Value:
Value Percent:
Continuous Index:
Within 8" of Joint: **NO**
Remarks:

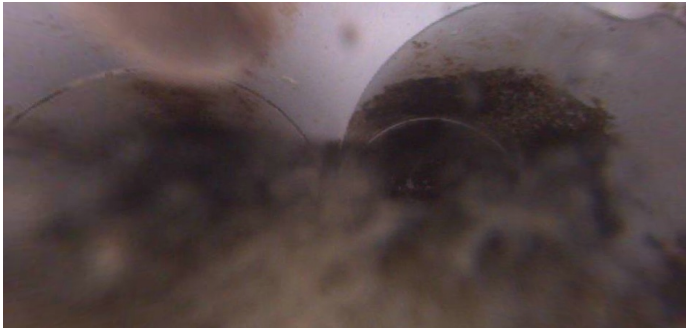
Code: **TF**
Description: **Tap Factory**

Distance (ft): **80.8**
Structural Grade: **0**
O&M Grade: **0**
Clock Start/From: **2**
Clock To:
1st Value: **4.000**
2nd Value:
Value Percent:
Continuous Index:
Within 8" of Joint:
Remarks:

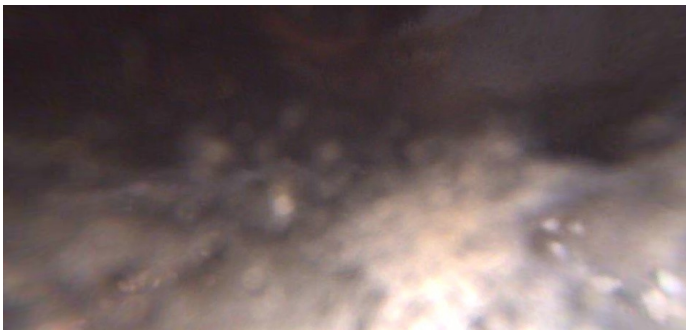
Code: **AMH**
Description: **Manhole**

Distance (ft): **94.8**
Structural Grade: **0**
O&M Grade: **0**
Clock Start/From:
Clock To:
1st Value:
2nd Value:
Value Percent:
Continuous Index:
Within 8" of Joint: **NO**
Remarks: **M-802-013**
