## Profile/Photo Observation Report

Street:	<b>N Hobart Rd</b>	Flow Control:	<b>Not Controlled</b>
City:	<b>Hobart, IN</b>	Year Renewed:	
Location:	<b>Main Highway - Suburban/Rural</b>	Tape/Media #:	
Purpose:	<b>Resurvey</b>	Dia/Height:	<b>8"</b>
Use:	<b>Sanitary</b>	Material:	<b>PVC</b>
Drain Area:	<b>NA</b>	Lining:	
Category:	<b>NA</b>		
Comment:

Location Details:		Direction of Survey:	<b>Downstream</b>
US MH:	<b>M-802-014</b>	DS MH:	<b>M-802-013</b>
		Total Length Surveyed (ft):	<b>94.8</b>

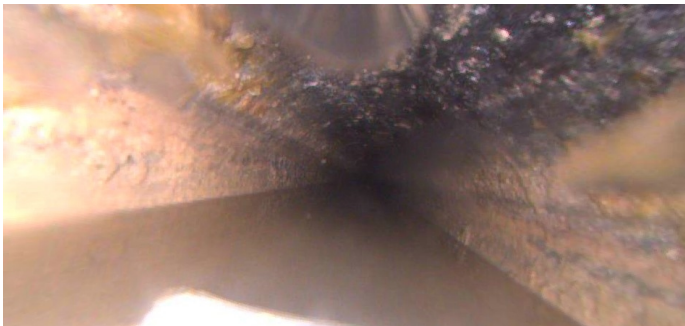
Code: **AMH**  
Description: **Manhole**

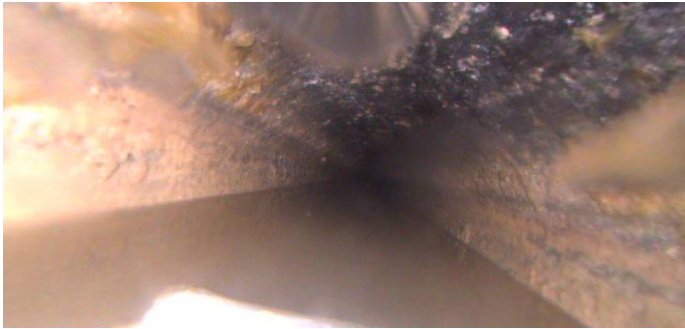
Code:	<b>MWL</b>
Description:	<b>Water Level</b>

Distance (ft):	<b>.0</b>
Structural Grade:	<b>0</b>
O&M Grade:	<b>0</b>
Clock Start/From:	
Clock To:	
1st Value:	
2nd Value:	
Value Percent:	<b>30.000</b>
Continuous Index:	
Within 8" of Joint:	<b>NO</b>
Remarks:

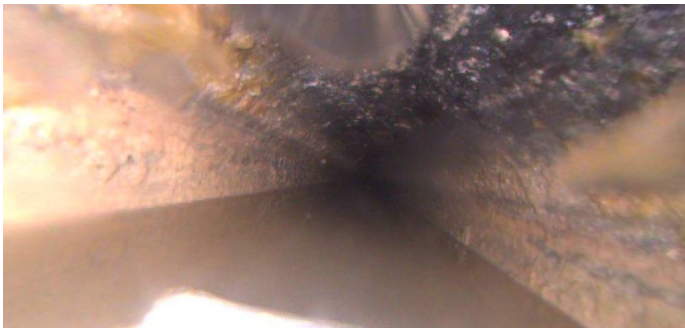
Code:	<b>DAZ</b>
Description:	<b>Deposits Attached Other</b>

Distance (ft):	<b>.0</b>
Structural Grade:	<b>0</b>
O&M Grade:	<b>2</b>
Clock Start/From:	<b>9</b>
Clock To:	<b>3</b>
1st Value:	
2nd Value:	
Value Percent:	<b>5.000</b>
Continuous Index:	<b>S01</b>
Within 8" of Joint:	<b>NO</b>
Remarks:	<b>Mixed materials</b>

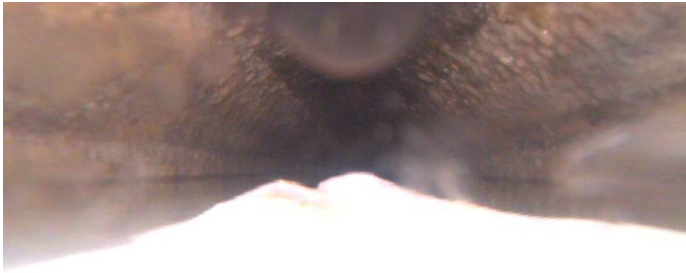
Code: **MWL**  
Description: **Water Level**

Distance (ft): **4.5**  
Structural Grade: **0**  
O&M Grade: **0**  
Clock Start/From:  
Clock To:  
1st Value:  
2nd Value:  
Value Percent: **40.000**  
Continuous Index:  
Within 8" of Joint: **NO**  
Remarks:

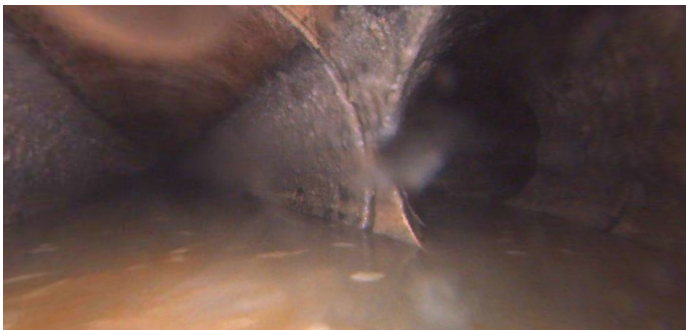
Code: **TF**  
Description: **Tap Factory**

Distance (ft): **21.7**  
Structural Grade: **0**  
O&M Grade: **0**  
Clock Start/From: **3**  
Clock To:  
1st Value: **4.000**  
2nd Value:  
Value Percent:  
Continuous Index:  
Within 8" of Joint:  
Remarks:

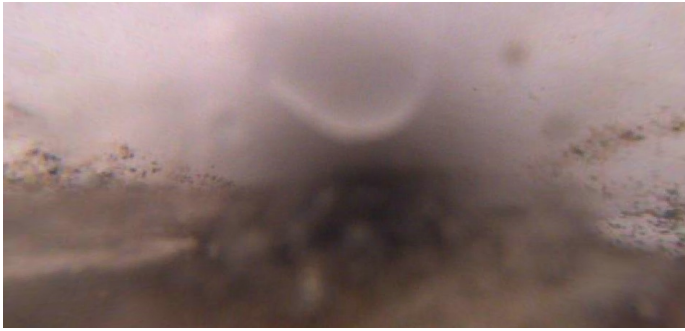
Code: **DAZ**  
Description: **Deposits Attached Other**

Distance (ft): **74.8**  
Structural Grade: **0**  
O&M Grade: **2**  
Clock Start/From: **9**  
Clock To: **3**  
1st Value:  
2nd Value:  
Value Percent: **5.000**  
Continuous Index: **F01**  
Within 8" of Joint: **NO**  
Remarks: **Mixed materials / Clock positions vary**

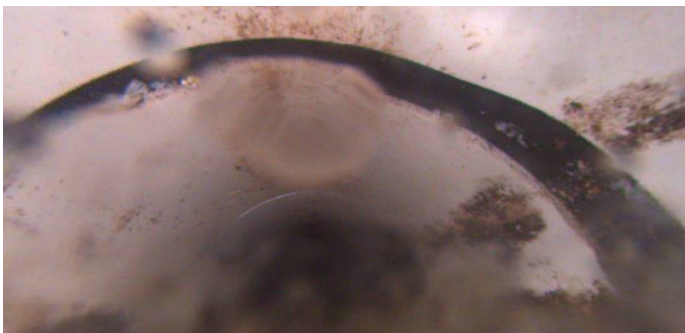
Code: **JSM**  
Description: **Joint Separated Medium**

Distance (ft): **79.9**  
Structural Grade: **1**  
O&M Grade: **0**  
Clock Start/From:  
Clock To:  
1st Value:  
2nd Value:  
Value Percent:  
Continuous Index:  
Within 8" of Joint: **NO**  
Remarks:

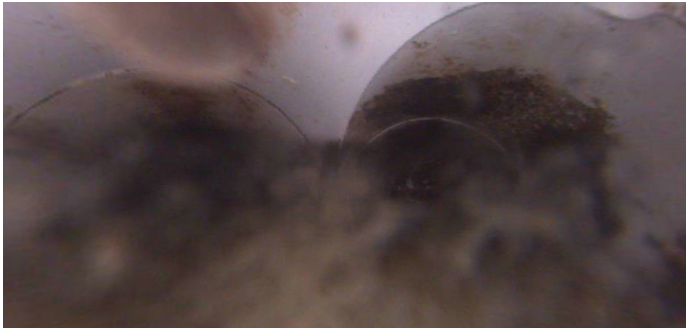
Code: **TF**  
Description: **Tap Factory**

Distance (ft): **80.8**  
Structural Grade: **0**  
O&M Grade: **0**  
Clock Start/From: **2**  
Clock To:  
1st Value: **4.000**  
2nd Value:  
Value Percent:  
Continuous Index:  
Within 8" of Joint:  
Remarks:

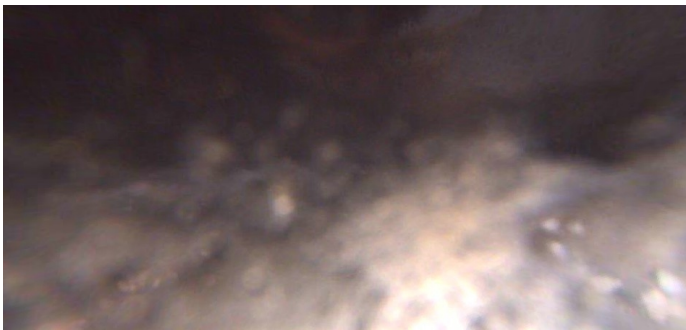
Code: **AMH**  
Description: **Manhole**

Distance (ft): **94.8**  
Structural Grade: **0**  
O&M Grade: **0**  
Clock Start/From:  
Clock To:  
1st Value:  
2nd Value:  
Value Percent:  
Continuous Index:  
Within 8" of Joint: **NO**  
Remarks: **M-802-013**
