Profile/Photo Observation Report

Street:	Randolph Pl	Flow Control:	Not Controlled
City:	Hobart, IN	Year Renewed:	
Location:	Main Highway - Suburban/Rural	Tape/Media #:	
Purpose:	Resurvey	Dia/Height:	8"
Use:	Sanitary	Material:	PVC
Drain Area:	NA	Lining:	
Category:	NA		
Comment:

Location Details:		Direction of Survey:	Downstream
US MH:	M-802-015	DS MH:	M-802-012
		Total Length Surveyed (ft):	344.0

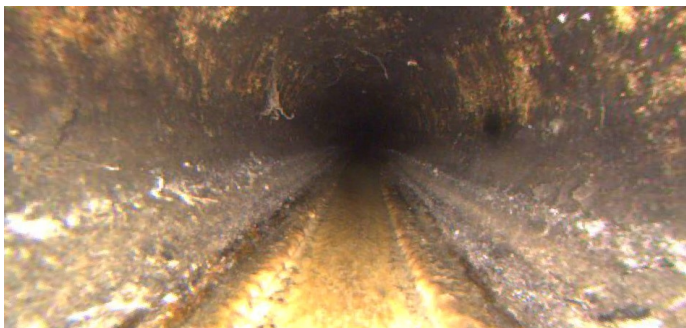
Code: **AMH**
Description: **Manhole**

Distance (ft): **.0**
Structural Grade: **0**
O&M Grade: **0**
Clock Start/From:
Clock To:
1st Value:
2nd Value:
Value Percent:
Continuous Index:
Within 8" of Joint: **NO**
Remarks: **M-802-015**

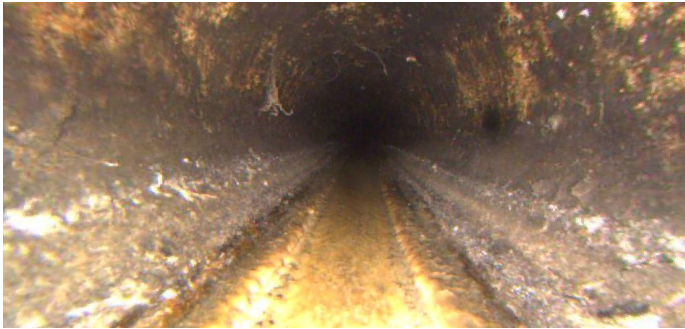
Code:	MWL
Description:	Water Level

Distance (ft):	.0
Structural Grade:	0
O&M Grade:	0
Clock Start/From:	
Clock To:	
1st Value:	
2nd Value:	
Value Percent:	5.000
Continuous Index:	
Within 8" of Joint:	NO
Remarks:

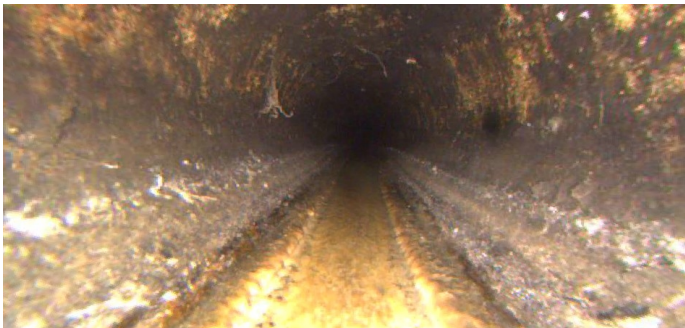
Code:	DAZ
Description:	Deposits Attached Other

Distance (ft):	.0
Structural Grade:	0
O&M Grade:	3
Clock Start/From:	7
Clock To:	5
1st Value:	
2nd Value:	
Value Percent:	15.000
Continuous Index:	S01
Within 8" of Joint:	NO
Remarks:	Mixed materials

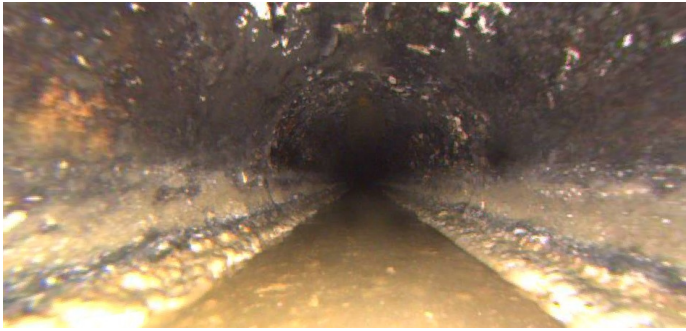
Code: **MWL**
Description: **Water Level**

Distance (ft): **24.3**
Structural Grade: **0**
O&M Grade: **0**
Clock Start/From:
Clock To:
1st Value:
2nd Value:
Value Percent: **15.000**
Continuous Index:
Within 8" of Joint: **NO**
Remarks:

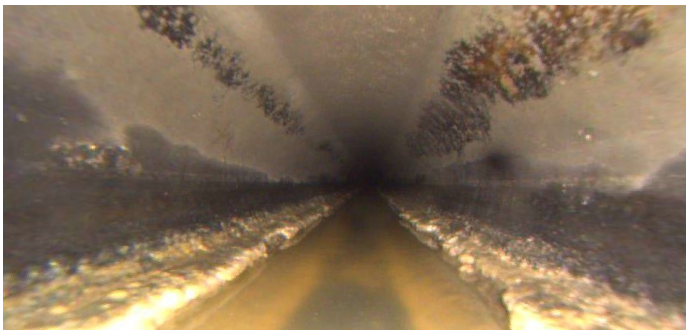
Code: **DAZ**
Description: **Deposits Attached Other**

Distance (ft): **90.4**
Structural Grade: **0**
O&M Grade: **3**
Clock Start/From: **7**
Clock To: **5**
1st Value:
2nd Value:
Value Percent: **15.000**
Continuous Index: **F01**
Within 8" of Joint: **NO**
Remarks: **Mixed materials / Clock positions vary**

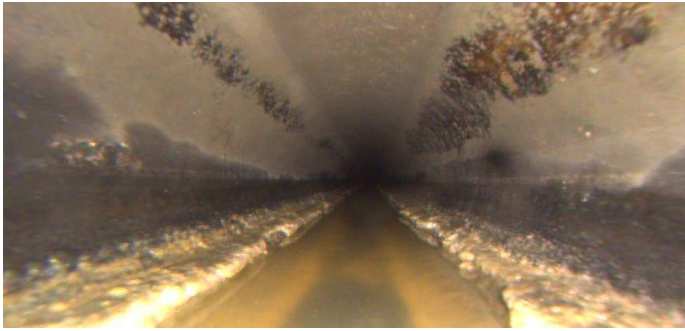
Code: **DAGS**
Description: **Deposits Attached Grease**

Distance (ft): **90.4**
Structural Grade: **0**
O&M Grade: **3**
Clock Start/From: **4**
Clock To: **8**
1st Value:
2nd Value:
Value Percent: **15.000**
Continuous Index: **S02**
Within 8" of Joint: **NO**
Remarks:

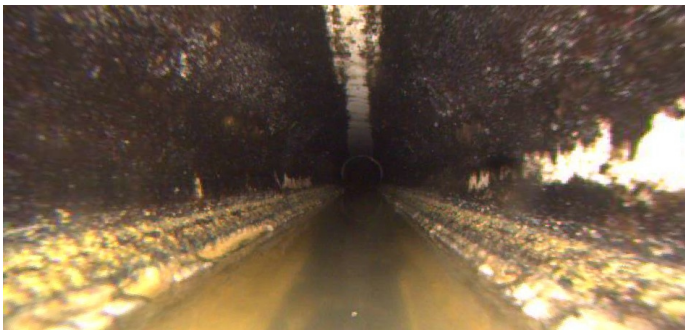
Code: **MWL**
Description: **Water Level**

Distance (ft): **234.4**
Structural Grade: **0**
O&M Grade: **0**
Clock Start/From:
Clock To:
1st Value:
2nd Value:
Value Percent: **25.000**
Continuous Index:
Within 8" of Joint: **NO**
Remarks:

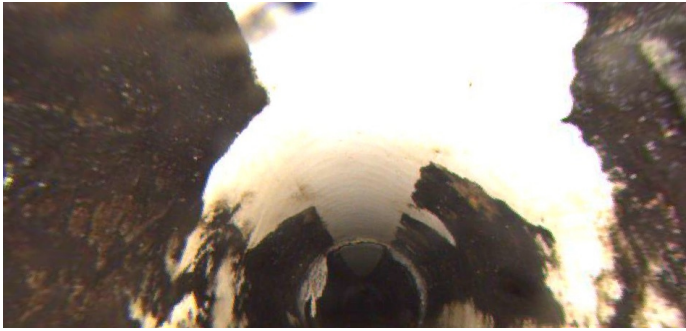
Code: **DAGS**
Description: **Deposits Attached Grease**

Distance (ft): **263.8**
Structural Grade: **0**
O&M Grade: **2**
Clock Start/From: **10**
Clock To: **2**
1st Value:
2nd Value:
Value Percent: **5.000**
Continuous Index:
Within 8" of Joint: **NO**
Remarks:

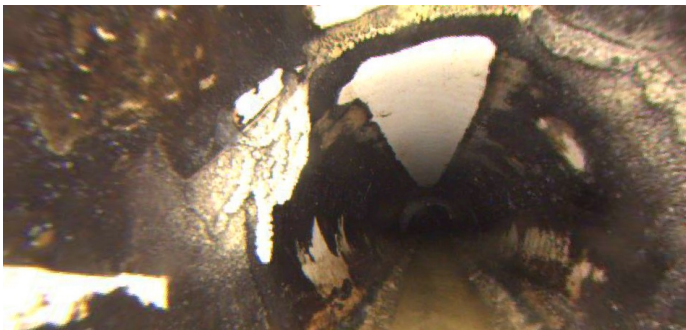
Code: **DAE**
Description: **Deposits Attached Encrustation**

Distance (ft): **265.3**
Structural Grade: **0**
O&M Grade: **2**
Clock Start/From: **9**
Clock To: **10**
1st Value:
2nd Value:
Value Percent: **5.000**
Continuous Index:
Within 8" of Joint: **YES**
Remarks:

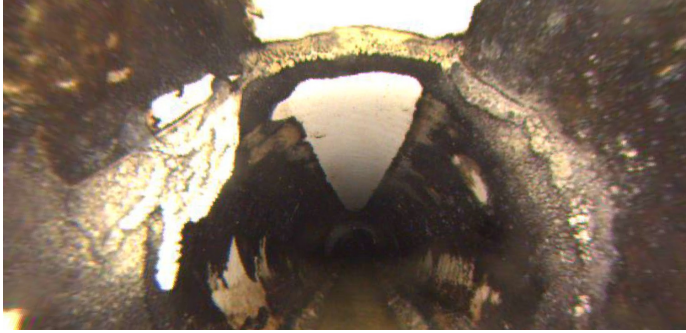
Code: ID
Description: Infil Dripper

Distance (ft): 265.3
Structural Grade: 0
O&M Grade: 3
Clock Start/From: 11
Clock To:
1st Value:
2nd Value:
Value Percent:
Continuous Index:
Within 8" of Joint: YES
Remarks:

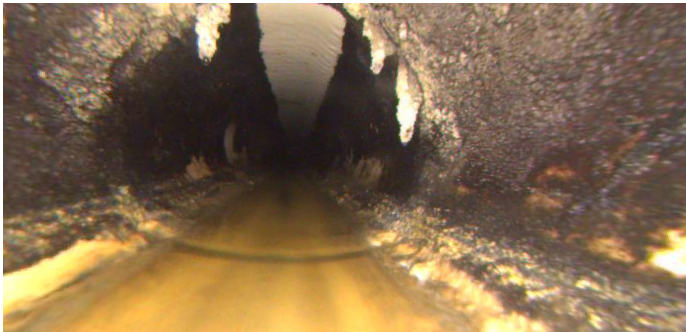
Code: ID
Description: Infil Dripper

Distance (ft): 303.3
Structural Grade: 0
O&M Grade: 3
Clock Start/From: 11
Clock To: 2
1st Value:
2nd Value:
Value Percent:
Continuous Index:
Within 8" of Joint: YES
Remarks:

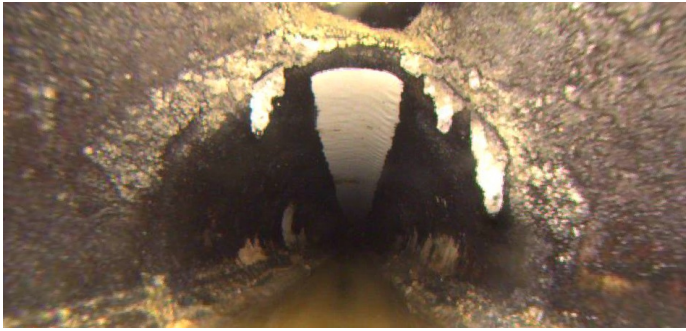
Code: **DAE**
Description: **Deposits Attached Encrustation**

Distance (ft): **303.5**
Structural Grade: **0**
O&M Grade: **2**
Clock Start/From: **11**
Clock To: **2**
1st Value:
2nd Value:
Value Percent: **5.000**
Continuous Index:
Within 8" of Joint: **YES**
Remarks:

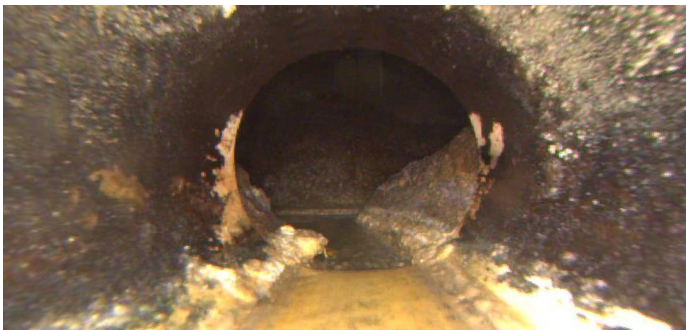
Code: **DAGS**
Description: **Deposits Attached Grease**

Distance (ft): **341.3**
Structural Grade: **0**
O&M Grade: **3**
Clock Start/From: **4**
Clock To: **8**
1st Value:
2nd Value:
Value Percent: **15.000**
Continuous Index: **F02**
Within 8" of Joint: **NO**
Remarks: **Clock positions vary**

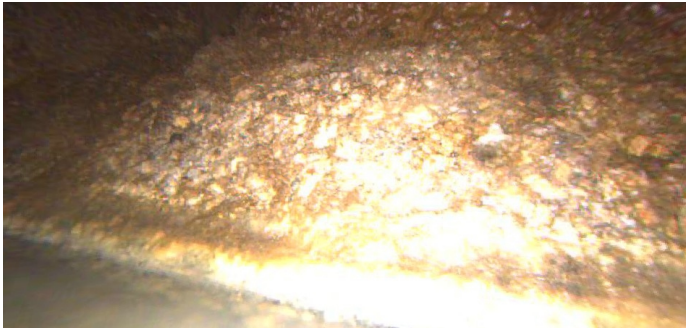
Code:	AMH
Description:	Manhole
Distance (ft):	344.0
Structural Grade:	0
O&M Grade:	0
Clock Start/From:	
Clock To:	
1st Value:	
2nd Value:	
Value Percent:	
Continuous Index:	
Within 8" of Joint:	NO
Remarks:	M-802-012
