## Profile/Photo Observation Report

Street:	<b>OFF N HOBART RD</b>	Flow Control:	<b>Not Controlled</b>
City:	<b>Hobart, IN</b>	Year Renewed:	
Location:	<b>Main Highway - Suburban/Rural</b>	Tape/Media #:	
Purpose:	<b>Resurvey</b>	Dia/Height:	<b>8"</b>
Use:	<b>Sanitary</b>	Material:	<b>PVC</b>
Drain Area:	<b>NA</b>	Lining:	<b>Cured in Place</b>
Category:	<b>NA</b>		
Comment:

Location Details:		Direction of Survey:	<b>Upstream</b>
US MH:	<b>M-802-015</b>	DS MH:	<b>M-802-014</b>
		Total Length Surveyed (ft):	<b>71.5</b>

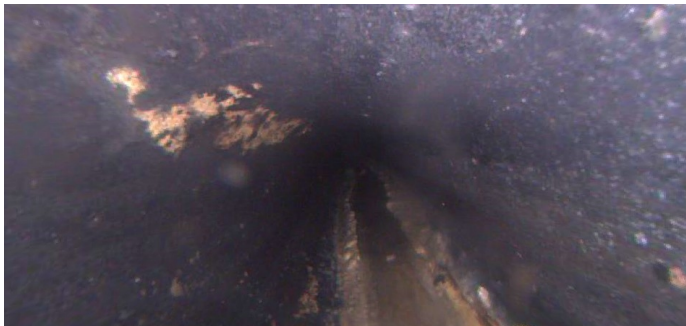
Code: **AMH**  
Description: **Manhole**

Distance (ft): **.0**  
Structural Grade: **0**  
O&M Grade: **0**  
Clock Start/From:  
Clock To:  
1st Value:  
2nd Value:  
Value Percent:  
Continuous Index:  
Within 8" of Joint: **NO**  
Remarks: **M-802-014**

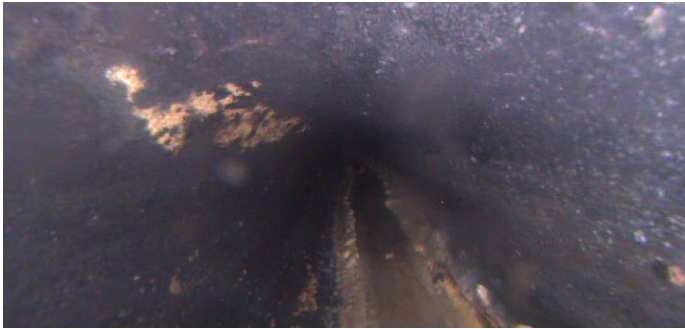
Code:	<b>MWL</b>
Description:	<b>Water Level</b>

Distance (ft):	<b>.0</b>
Structural Grade:	<b>0</b>
O&M Grade:	<b>0</b>
Clock Start/From:	
Clock To:	
1st Value:	
2nd Value:	
Value Percent:	<b>5.000</b>
Continuous Index:	
Within 8" of Joint:	<b>NO</b>
Remarks:

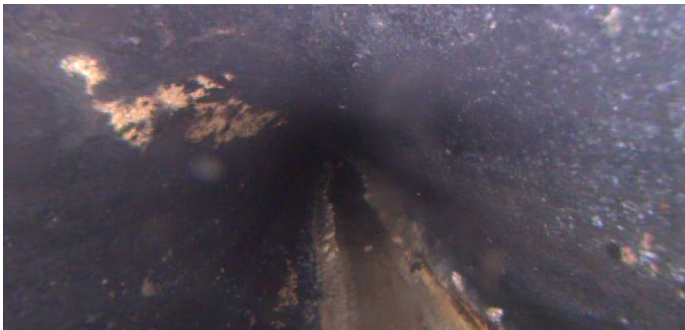
Code:	<b>DAGS</b>
Description:	<b>Deposits Attached Grease</b>

Distance (ft):	<b>.0</b>
Structural Grade:	<b>0</b>
O&M Grade:	<b>2</b>
Clock Start/From:	<b>5</b>
Clock To:	<b>7</b>
1st Value:	
2nd Value:	
Value Percent:	<b>5.000</b>
Continuous Index:	<b>S01</b>
Within 8" of Joint:	<b>NO</b>
Remarks:

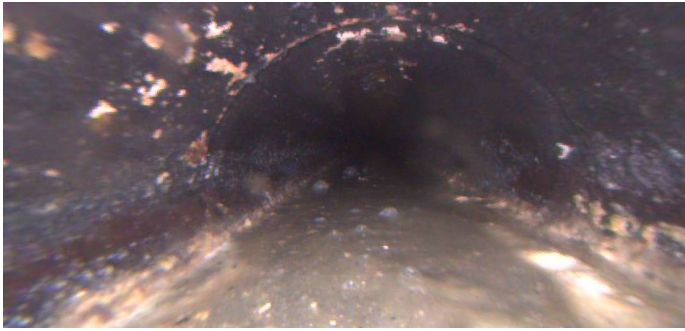
Code: **MWL**  
Description: **Water Level**

Distance (ft): **28.7**  
Structural Grade: **0**  
O&M Grade: **0**  
Clock Start/From:  
Clock To:  
1st Value:  
2nd Value:  
Value Percent: **30.000**  
Continuous Index:  
Within 8" of Joint: **NO**  
Remarks:

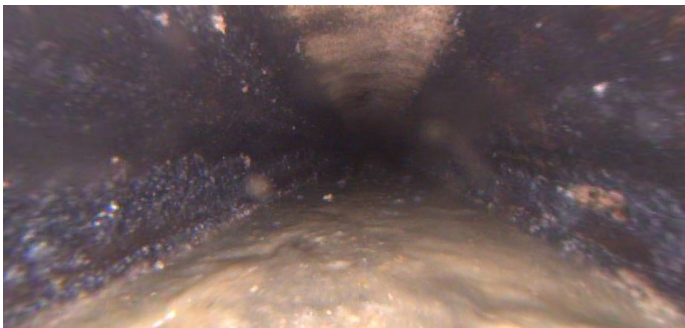
Code: **DAGS**  
Description: **Deposits Attached Grease**

Distance (ft): **29.9**  
Structural Grade: **0**  
O&M Grade: **2**  
Clock Start/From: **5**  
Clock To: **7**  
1st Value:  
2nd Value:  
Value Percent: **5.000**  
Continuous Index: **F01**  
Within 8" of Joint: **NO**  
Remarks: **Clock positions vary**

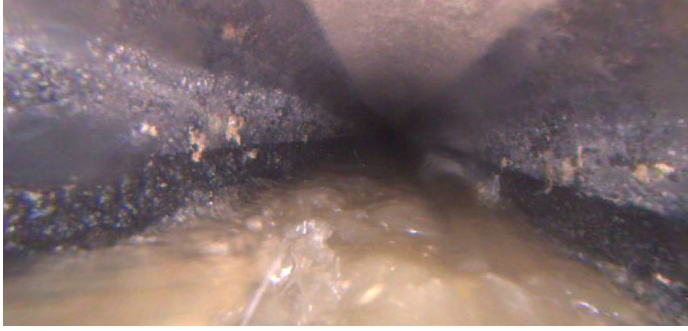
Code:	<b>MSA</b>
Description:	<b>Abandoned Survey</b>
Distance (ft):	<b>71.5</b>
Structural Grade:	<b>0</b>
O&M Grade:	<b>0</b>
Clock Start/From:	
Clock To:	
1st Value:	
2nd Value:	
Value Percent:	
Continuous Index:	
Within 8" of Joint:	<b>NO</b>
Remarks:	<b>Unknown</b>
