Profile/Photo Observation Report

Street:	OFF N HOBART RD	Flow Control:	Not Controlled
City:	Hobart, IN	Year Renewed:	
Location:	Main Highway - Suburban/Rural	Tape/Media #:	
Purpose:	Resurvey	Dia/Height:	8"
Use:	Sanitary	Material:	PVC
Drain Area:	NA	Lining:	
Category:	NA		
Comment:

Location Details:		Direction of Survey:	Upstream
US MH:	M-802-016	DS MH:	M-802-014
		Total Length Surveyed (ft):	152.7

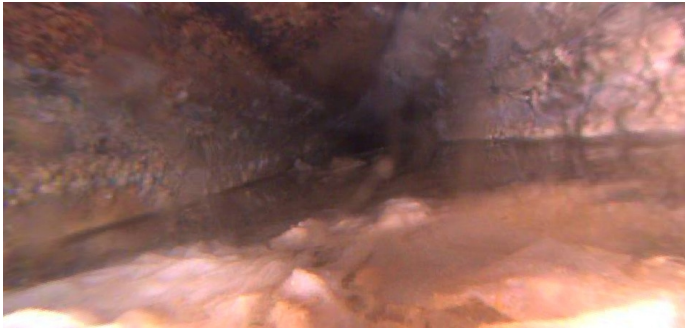
Code:	MWL
Description:	Water Level

Distance (ft):	.0
Structural Grade:	0
O&M Grade:	0
Clock Start/From:	
Clock To:	
1st Value:	
2nd Value:	
Value Percent:	40.000
Continuous Index:	
Within 8" of Joint:	NO
Remarks:

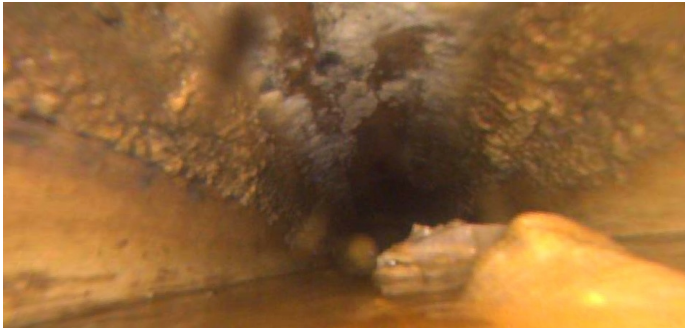
Code:	DAZ
Description:	Deposits Attached Other

Distance (ft):	3.5
Structural Grade:	0
O&M Grade:	2
Clock Start/From:	10
Clock To:	2
1st Value:	
2nd Value:	
Value Percent:	10.000
Continuous Index:	S01
Within 8" of Joint:	NO
Remarks:	Mixed materials

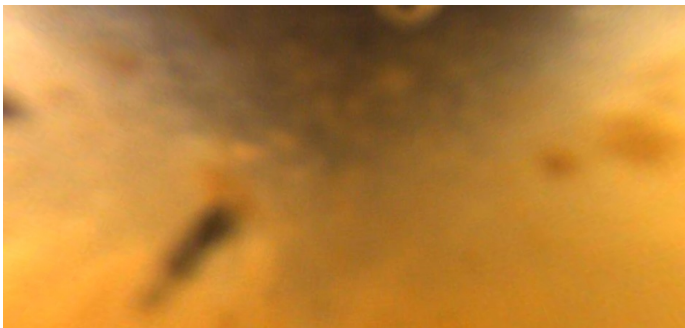
Code:	MCU
Description:	Camera Underwater

Distance (ft):	7.1
Structural Grade:	0
O&M Grade:	4
Clock Start/From:	
Clock To:	
1st Value:	
2nd Value:	
Value Percent:	
Continuous Index:	
Within 8" of Joint:	NO
Remarks:

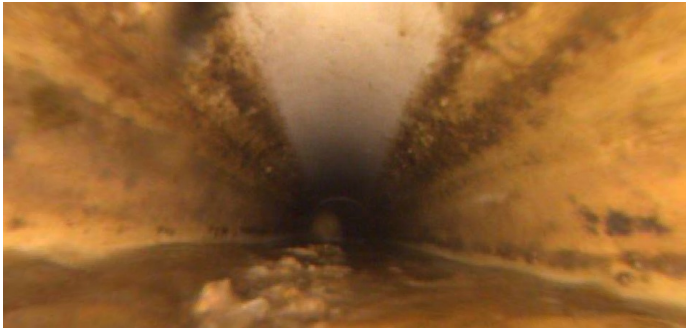
Code: **DAZ**
Description: **Deposits Attached Other**

Distance (ft): **20.8**
Structural Grade: **0**
O&M Grade: **2**
Clock Start/From: **10**
Clock To: **2**
1st Value:
2nd Value:
Value Percent: **10.000**
Continuous Index: **F01**
Within 8" of Joint: **NO**
Remarks: **Mixed materials / Clock positions vary**
