Profile/Photo Observation Report

Date:	03/20/2018	Weather:		Coding:	PACP 6.0
Pipe Length (ft):	149.0	Owner:	NA	Pre Clean:	Not Known
P.O.#:		Surveyor:	John Kuglmaier	PSR:	P-802-016-014
Customer:		Clean Date:	01/01/1900	Shape:	C

Street:	N Hobart Rd	Flow Control:	Not Controlled
City:	Hobart, IN	Year Renewed:	
Location:	Main Highway - Suburban/Rural	Tape/Media #:	
Purpose:	Resurvey	Dia/Height:	8"
Use:	Sanitary	Material:	PVC
Drain Area:	NA	Lining:	
Category:	NA		
Comment:

Location Details:		Direction of Survey:	Upstream
US MH:	M-802-016	DS MH:	M-802-014
		Total Length Surveyed (ft):	152.7

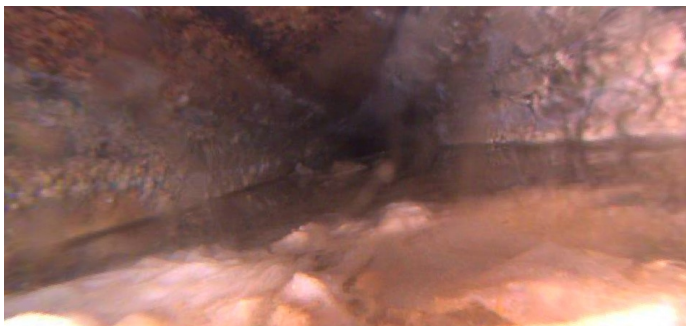
Code: **AMH**
Description: **Manhole**

Distance (ft): **.0**
Structural Grade: **0**
O&M Grade: **0**
Clock Start/From:
Clock To:
1st Value:
2nd Value:
Value Percent:
Continuous Index:
Within 8" of Joint: **NO**
Remarks: **M-802-014**

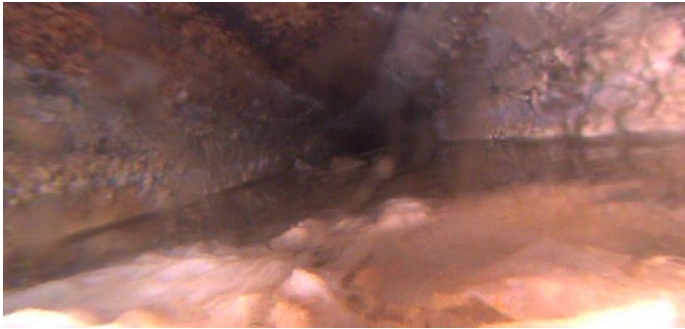
Code:	MWL
Description:	Water Level

Distance (ft):	.0
Structural Grade:	0
O&M Grade:	0
Clock Start/From:	
Clock To:	
1st Value:	
2nd Value:	
Value Percent:	40.000
Continuous Index:	
Within 8" of Joint:	NO
Remarks:

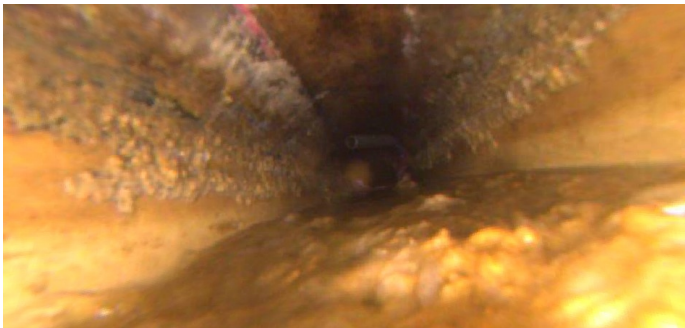
Code:	MGO
Description:	General Observation

Distance (ft):	2.8
Structural Grade:	0
O&M Grade:	0
Clock Start/From:	
Clock To:	
1st Value:	
2nd Value:	
Value Percent:	
Continuous Index:	
Within 8" of Joint:	NO
Remarks:	Switching to rear camera

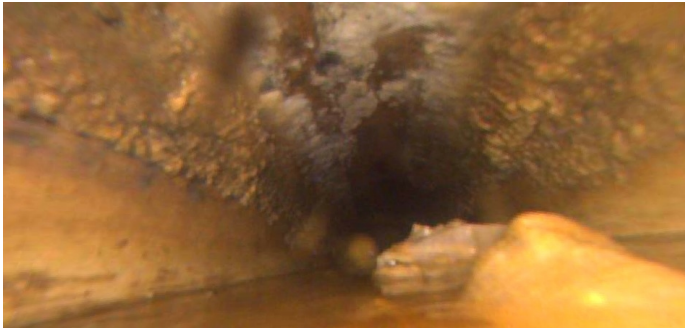
Code: **DAZ**
Description: **Deposits Attached Other**

Distance (ft): **3.5**
Structural Grade: **0**
O&M Grade: **2**
Clock Start/From: **10**
Clock To: **2**
1st Value:
2nd Value:
Value Percent: **10.000**
Continuous Index: **S01**
Within 8" of Joint: **NO**
Remarks: **Mixed materials**

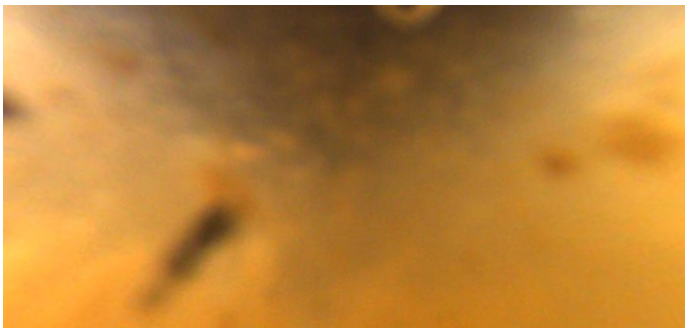
Code: **MCU**
Description: **Camera Underwater**

Distance (ft): **7.1**
Structural Grade: **0**
O&M Grade: **4**
Clock Start/From:
Clock To:
1st Value:
2nd Value:
Value Percent:
Continuous Index:
Within 8" of Joint: **NO**
Remarks:

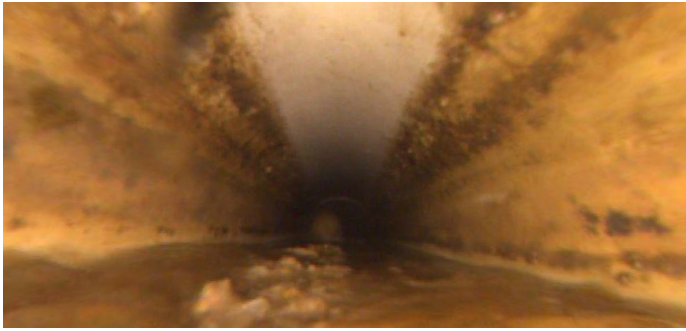
Code: **DAZ**
Description: **Deposits Attached Other**

Distance (ft): **20.8**
Structural Grade: **0**
O&M Grade: **2**
Clock Start/From: **10**
Clock To: **2**
1st Value:
2nd Value:
Value Percent: **10.000**
Continuous Index: **F01**
Within 8" of Joint: **NO**
Remarks: **Mixed materials / Clock positions vary**

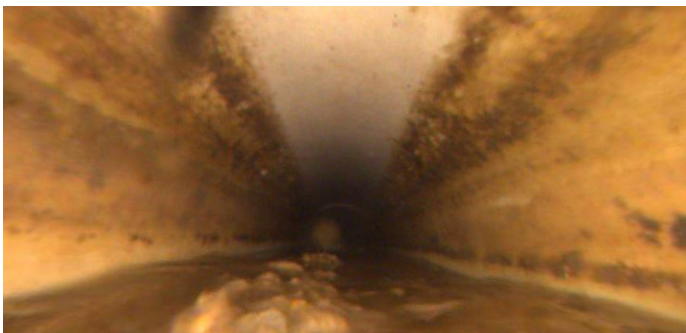
Code: **MGO**
Description: **General Observation**

Distance (ft): **20.8**
Structural Grade: **0**
O&M Grade: **0**
Clock Start/From:
Clock To:
1st Value:
2nd Value:
Value Percent:
Continuous Index:
Within 8" of Joint: **NO**
Remarks: **rear camera**

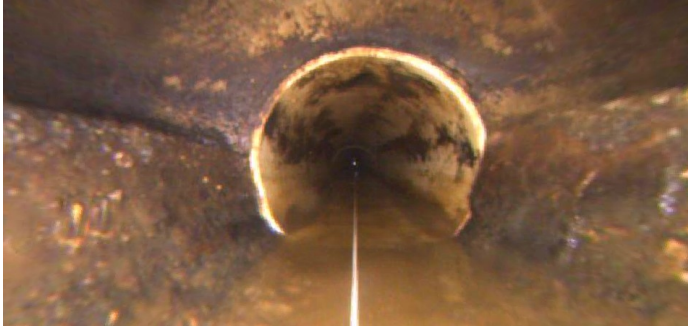
Code:	AMH
Description:	Manhole
Distance (ft):	151.0
Structural Grade:	0
O&M Grade:	0
Clock Start/From:	
Clock To:	
1st Value:	
2nd Value:	
Value Percent:	
Continuous Index:	
Within 8" of Joint:	NO
Remarks:	M-802-016
