## Profile/Photo Observation Report

Date:	<b>04/24/2018</b>	Weather:		Coding:	<b>PACP 4.2</b>
Pipe Length (ft):	<b>288.0</b>	Owner:	<b>City of Hobart</b>	Pre Clean:	<b>No Pre-Cleaning</b>
P.O.#:	<b>2004</b>	Surveyor:	<b>SAN</b>	PSR:	<b>P-802-019-LS015</b>
Customer:	<b>Red Zone</b>	Clean Date:		Shape:	<b>C</b>

Street:	<b>7770 E Ridge Rd</b>	Flow Control:	<b>Not Controlled</b>
City:	<b>Hobart In</b>	Year Renewed:	
Location:	<b>Parking Lot</b>	Tape/Media #:	<b>Deliverable 1</b>
Purpose:	<b>Routine Assessment</b>	Dia/Height:	<b>8"</b>
Use:	<b>Sanitary</b>	Material:	<b>PVC</b>
Drain Area:	<b>Northeast</b>	Lining:	
Category:	<b>NA</b>		
Comment:	<b>429-1/Incomplete due to debris. No reverse due to camera being underwater.</b>		
Location Details:	<b>KFC parking lot</b>	Direction of Survey:	<b>Downstream</b>
US MH:	<b>M-802-19</b>	DS MH:	<b>M-802-LS015</b>
		Total Length Surveyed (ft):	<b>282.3</b>

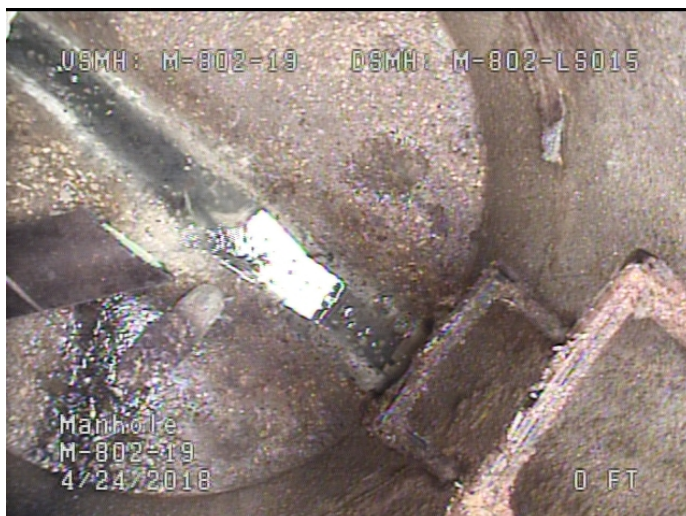
Code: **AMH**  
Description: **Manhole**

Distance (ft): **.0**  
Structural Grade: **0**  
O&M Grade: **0**  
Clock Start/From:  
Clock To:  
1st Value:  
2nd Value:  
Value Percent:  
Continuous Index:  
Within 8" of Joint: **NO**  
Remarks: **M-802-19**

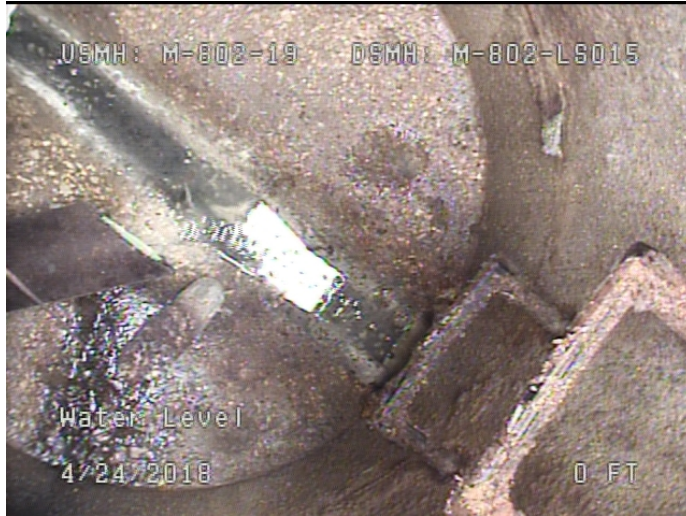
Code:	<b>MWL</b>
Description:	<b>Water Level</b>
Distance (ft):	<b>.0</b>
Structural Grade:	<b>0</b>
O&M Grade:	<b>0</b>
Clock Start/From:	
Clock To:	
1st Value:	
2nd Value:	
Value Percent:	<b>5.000</b>
Continuous Index:	
Within 8" of Joint:	<b>NO</b>
Remarks:

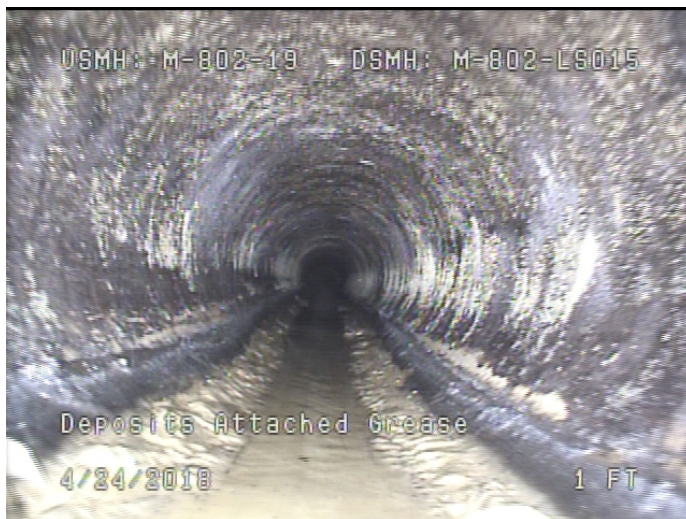
Code:	<b>DAGS</b>
Description:	<b>Deposits Attached Grease</b>
Distance (ft):	<b>1.0</b>
Structural Grade:	<b>0</b>
O&M Grade:	<b>2</b>
Clock Start/From:	<b>12</b>
Clock To:	<b>12</b>
1st Value:	
2nd Value:	
Value Percent:	<b>5.000</b>
Continuous Index:	<b>S01</b>
Within 8" of Joint:	<b>NO</b>
Remarks:

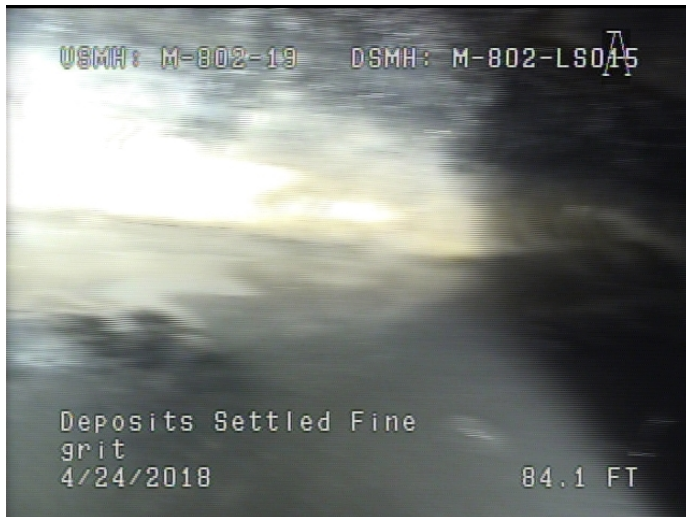
Code:	<b>DSF</b>
Description:	<b>Deposits Settled Fine</b>
Distance (ft):	<b>84.1</b>
Structural Grade:	<b>0</b>
O&M Grade:	<b>2</b>
Clock Start/From:	<b>5</b>
Clock To:	<b>7</b>
1st Value:	
2nd Value:	
Value Percent:	<b>10.000</b>
Continuous Index:	<b>S02</b>
Within 8" of Joint:	<b>NO</b>
Remarks:	<b>grit</b>

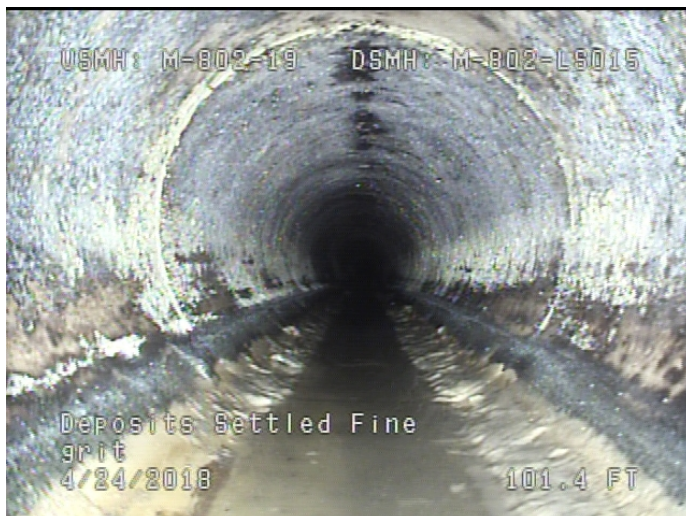
Code:	<b>DSF</b>
Description:	<b>Deposits Settled Fine</b>
Distance (ft):	<b>101.4</b>
Structural Grade:	<b>0</b>
O&M Grade:	<b>2</b>
Clock Start/From:	<b>5</b>
Clock To:	<b>7</b>
1st Value:	
2nd Value:	
Value Percent:	<b>10.000</b>
Continuous Index:	<b>F02</b>
Within 8" of Joint:	<b>NO</b>
Remarks:	<b>grit</b>

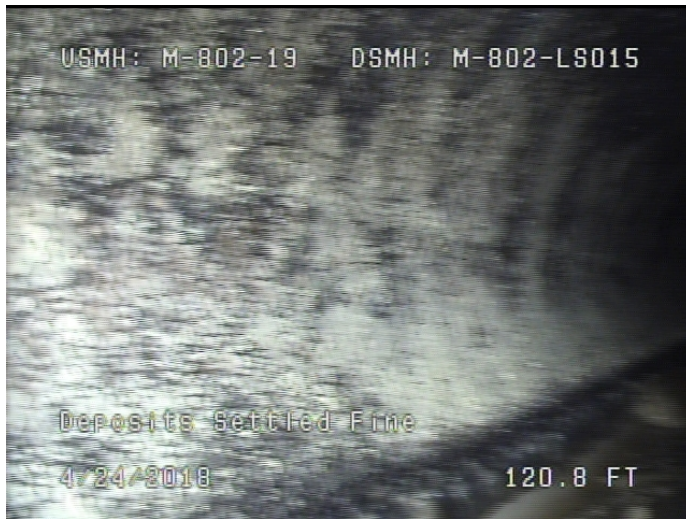
Code: **DSF**  
 Description: **Deposits Settled Fine**

Distance (ft): **120.8**  
 Structural Grade: **0**  
 O&M Grade: **2**  
 Clock Start/From: **5**  
 Clock To: **7**  
 1st Value:  
 2nd Value:  
 Value Percent: **10.000**  
 Continuous Index: **S03**  
 Within 8" of Joint: **NO**  
 Remarks:

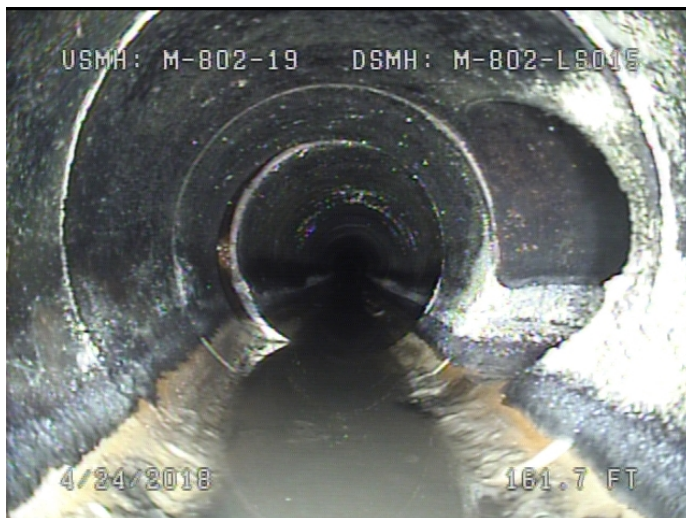
Code: **TF**  
 Description: **Tap Factory**

Distance (ft): **161.8**  
 Structural Grade: **0**  
 O&M Grade: **0**  
 Clock Start/From: **3**  
 Clock To:  
 1st Value: **6.000**  
 2nd Value:  
 Value Percent:  
 Continuous Index:  
 Within 8" of Joint: **NO**  
 Remarks:

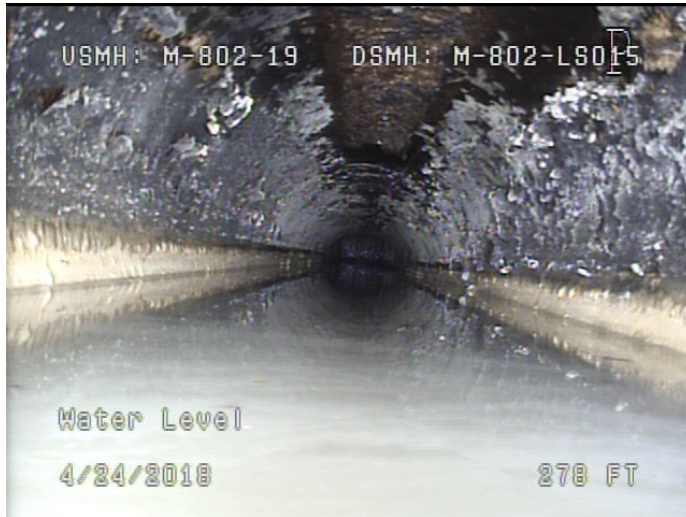
Code: **MWL**  
 Description: **Water Level**

Distance (ft): **278.0**  
 Structural Grade: **0**  
 O&M Grade: **0**  
 Clock Start/From:  
 Clock To:  
 1st Value:  
 2nd Value:  
 Value Percent: **40.000**  
 Continuous Index:  
 Within 8" of Joint: **NO**  
 Remarks:

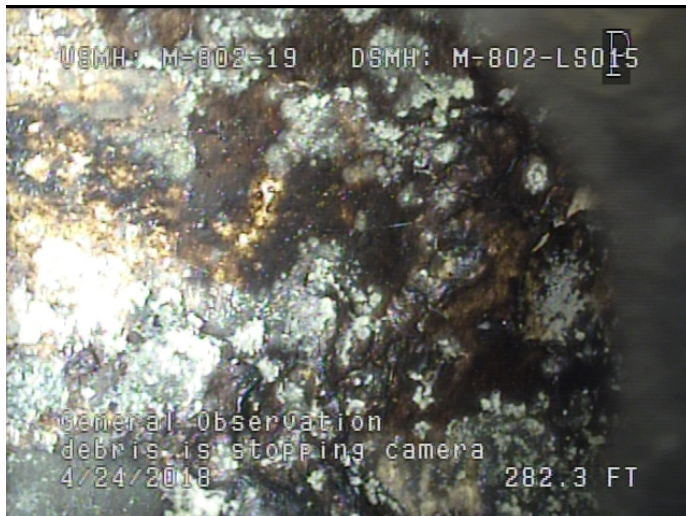
Code: **MGO**  
 Description: **General Observation**

Distance (ft): **282.3**  
 Structural Grade: **0**  
 O&M Grade: **0**  
 Clock Start/From:  
 Clock To:  
 1st Value:  
 2nd Value:  
 Value Percent:  
 Continuous Index:  
 Within 8" of Joint: **NO**  
 Remarks: **debris is stopping camera**

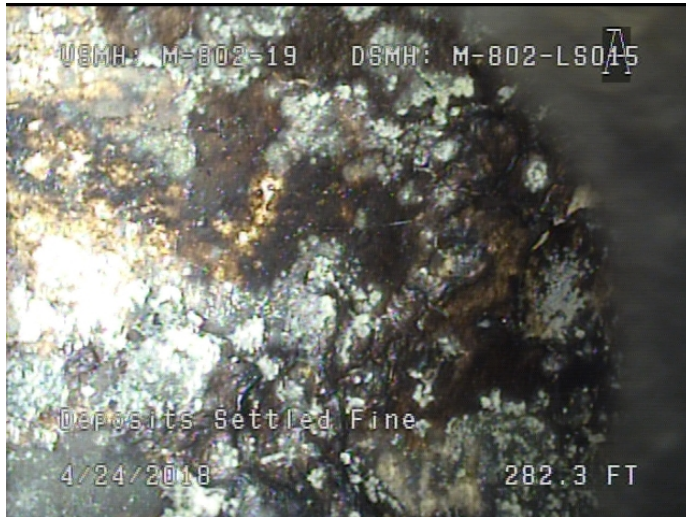
Code: **DSF**  
 Description: **Deposits Settled Fine**

Distance (ft): **282.3**  
 Structural Grade: **0**  
 O&M Grade: **2**  
 Clock Start/From: **5**  
 Clock To: **7**  
 1st Value:  
 2nd Value:  
 Value Percent: **10.000**  
 Continuous Index: **F03**  
 Within 8" of Joint: **NO**  
 Remarks:

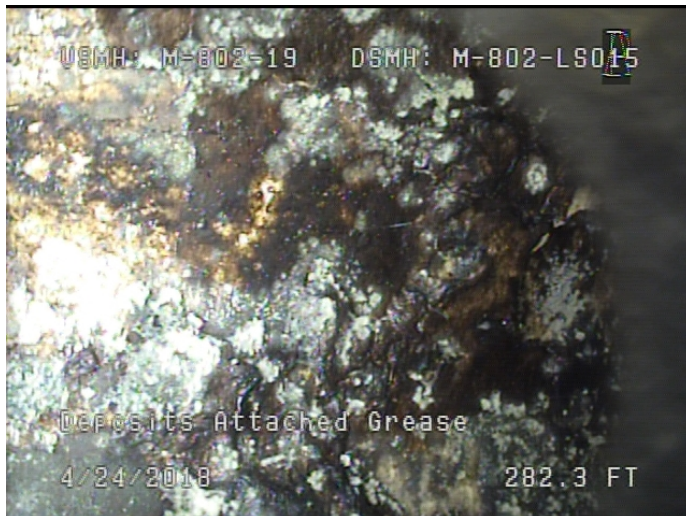
Code: **DAGS**  
 Description: **Deposits Attached Grease**

Distance (ft): **282.3**  
 Structural Grade: **0**  
 O&M Grade: **2**  
 Clock Start/From: **12**  
 Clock To: **12**  
 1st Value:  
 2nd Value:  
 Value Percent: **5.000**  
 Continuous Index: **F01**  
 Within 8" of Joint: **NO**  
 Remarks:

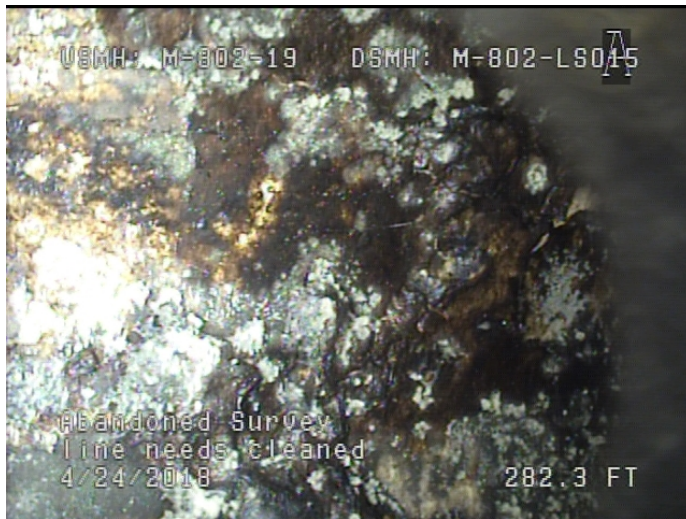
Code:	<b>MSA</b>
Description:	<b>Abandoned Survey</b>
Distance (ft):	<b>282.3</b>
Structural Grade:	<b>0</b>
O&M Grade:	<b>0</b>
Clock Start/From:	
Clock To:	
1st Value:	
2nd Value:	
Value Percent:	
Continuous Index:	
Within 8" of Joint:	<b>NO</b>
Remarks:	<b>line needs cleaned</b>
