Profile/Photo Observation Report

Street:	N HOBART RD	Flow Control:	Not Controlled
City:	Hobart, IN	Year Renewed:	
Location:	Main Highway - Suburban/Rural	Tape/Media #:	
Purpose:	Resurvey	Dia/Height:	12"
Use:	Sanitary	Material:	PVC
Drain Area:	NA	Lining:	
Category:	NA		
Comment:

Location Details:		Direction of Survey:	Upstream
US MH:	M-802-020	DS MH:	M-802-008
		Total Length Surveyed (ft):	238.0

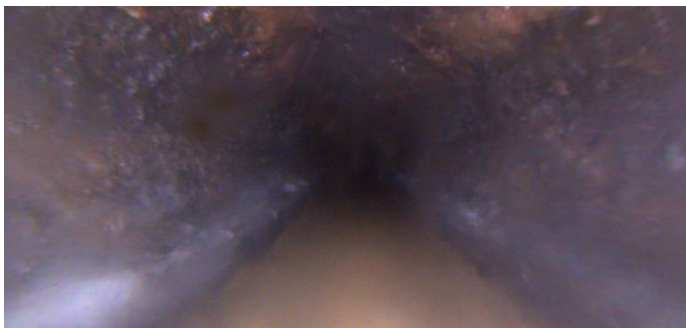
Code: **AMH**
Description: **Manhole**

Distance (ft): **.0**
Structural Grade: **0**
O&M Grade: **0**
Clock Start/From:
Clock To:
1st Value:
2nd Value:
Value Percent:
Continuous Index:
Within 8" of Joint: **NO**
Remarks: **M-802-008**

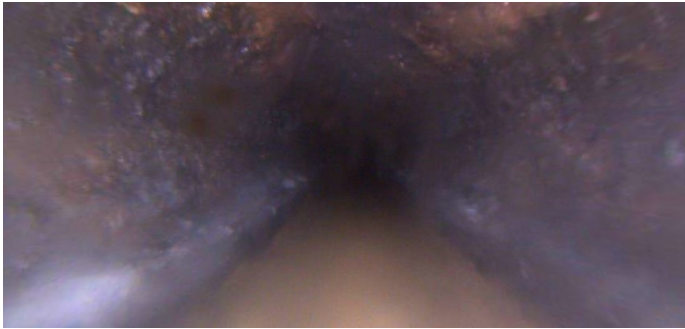
Code:	MWL
Description:	Water Level

Distance (ft):	.0
Structural Grade:	0
O&M Grade:	0
Clock Start/From:	
Clock To:	
1st Value:	
2nd Value:	
Value Percent:	15.000
Continuous Index:	
Within 8" of Joint:	NO
Remarks:

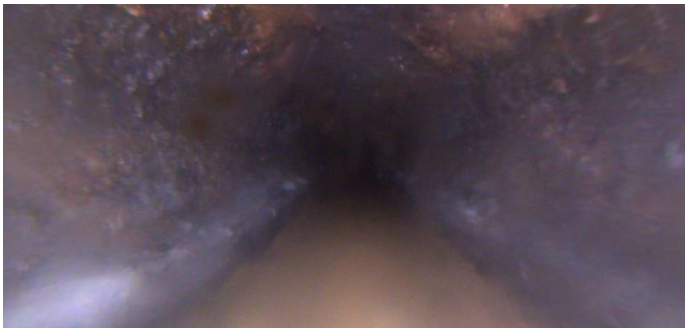
Code:	DAZ
Description:	Deposits Attached Other

Distance (ft):	.0
Structural Grade:	0
O&M Grade:	4
Clock Start/From:	7
Clock To:	5
1st Value:	
2nd Value:	
Value Percent:	30.000
Continuous Index:	S01
Within 8" of Joint:	NO
Remarks:	Mixed materials

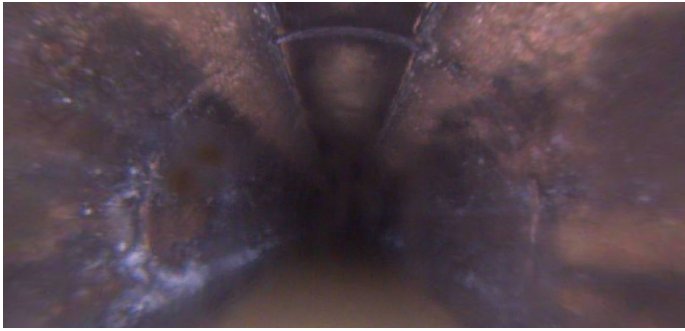
Code: **DAZ**
Description: **Deposits Attached Other**

Distance (ft): **24.2**
Structural Grade: **0**
O&M Grade: **4**
Clock Start/From: **7**
Clock To: **5**
1st Value:
2nd Value:
Value Percent: **30.000**
Continuous Index: **F01**
Within 8" of Joint: **NO**
Remarks: **Mixed materials / Clock positions vary**

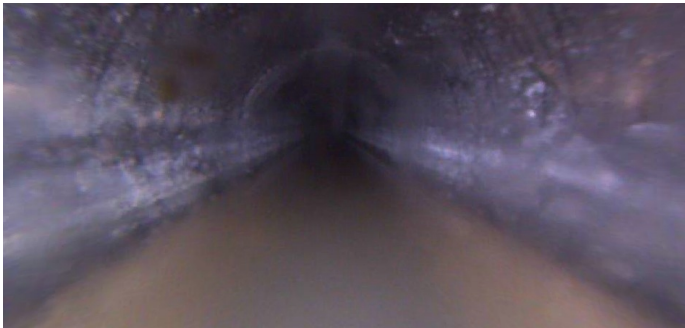
Code: **MWL**
Description: **Water Level**

Distance (ft): **126.1**
Structural Grade: **0**
O&M Grade: **0**
Clock Start/From:
Clock To:
1st Value:
2nd Value:
Value Percent: **25.000**
Continuous Index:
Within 8" of Joint: **NO**
Remarks:

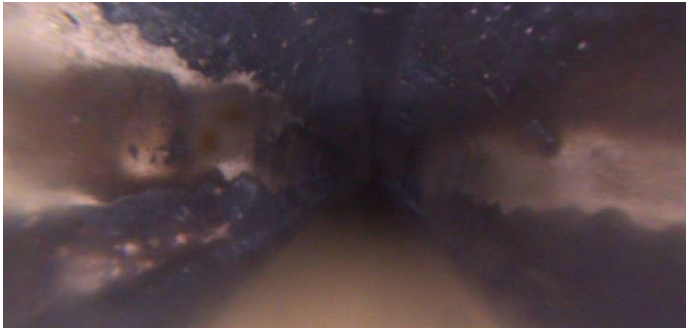
Code: **DAGS**
Description: **Deposits Attached Grease**

Distance (ft): **160.9**
Structural Grade: **0**
O&M Grade: **2**
Clock Start/From: **9**
Clock To: **3**
1st Value:
2nd Value:
Value Percent: **5.000**
Continuous Index: **S02**
Within 8" of Joint: **NO**
Remarks:

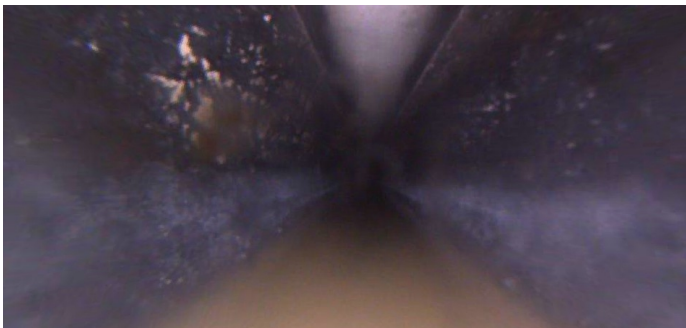
Code: **DAGS**
Description: **Deposits Attached Grease**

Distance (ft): **179.1**
Structural Grade: **0**
O&M Grade: **2**
Clock Start/From: **9**
Clock To: **3**
1st Value:
2nd Value:
Value Percent: **5.000**
Continuous Index: **F02**
Within 8" of Joint: **NO**
Remarks: **Clock positions vary**

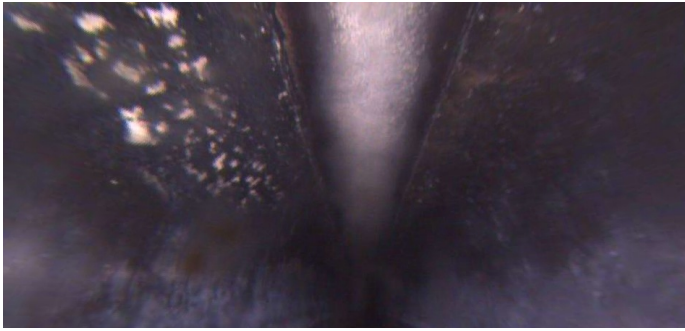
Code: **DAGS**
Description: **Deposits Attached Grease**

Distance (ft): **183.7**
Structural Grade: **0**
O&M Grade: **2**
Clock Start/From: **11**
Clock To: **1**
1st Value:
2nd Value:
Value Percent: **5.000**
Continuous Index: **S03**
Within 8" of Joint: **NO**
Remarks:

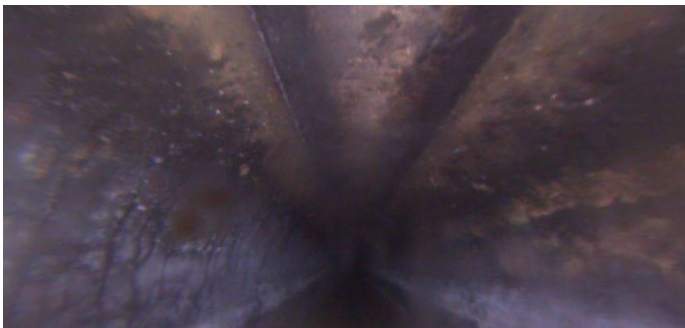
Code: **DAGS**
Description: **Deposits Attached Grease**

Distance (ft): **199.6**
Structural Grade: **0**
O&M Grade: **2**
Clock Start/From: **11**
Clock To: **1**
1st Value:
2nd Value:
Value Percent: **5.000**
Continuous Index: **F03**
Within 8" of Joint: **NO**
Remarks: **Clock positions vary**

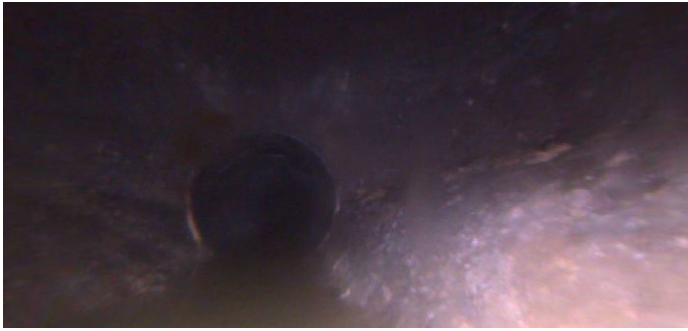
Code:	AMH
Description:	Manhole
Distance (ft):	238.0
Structural Grade:	0
O&M Grade:	0
Clock Start/From:	
Clock To:	
1st Value:	
2nd Value:	
Value Percent:	
Continuous Index:	
Within 8" of Joint:	NO
Remarks:	M-802-020
