## Profile/Photo Observation Report

Date:	<b>04/23/2018</b>	Weather:		Coding:	<b>PACP 4.2</b>
Pipe Length (ft):	<b>225.0</b>	Owner:	<b>City of Hobart</b>	Pre Clean:	<b>No Pre-Cleaning</b>
P.O.#:	<b>2004</b>	Surveyor:	<b>SAN</b>	PSR:	<b>P-802-021-022</b>
Customer:	<b>Red Zone</b>	Clean Date:		Shape:	<b>C</b>

Street:	<b>E Randolph St</b>	Flow Control:	<b>Not Controlled</b>
City:	<b>Hobart In</b>	Year Renewed:	
Location:	<b>Parking Lot</b>	Tape/Media #:	<b>Deliverable 1</b>
Purpose:	<b>Routine Assessment</b>	Dia/Height:	<b>6"</b>
Use:	<b>Sanitary</b>	Material:	<b>PVC</b>
Drain Area:	<b>Northeast</b>	Lining:	
Category:	<b>NA</b>		
Comment:	<b>427-1/No reverse due to grease/ Line needs cleaning.</b>		
Location Details:	<b>Lot behind strip mall</b>	Direction of Survey:	<b>Downstream</b>
US MH:	<b>M-802-021</b>	DS MH:	<b>M-802-022</b>
		Total Length Surveyed (ft):	<b>25.6</b>

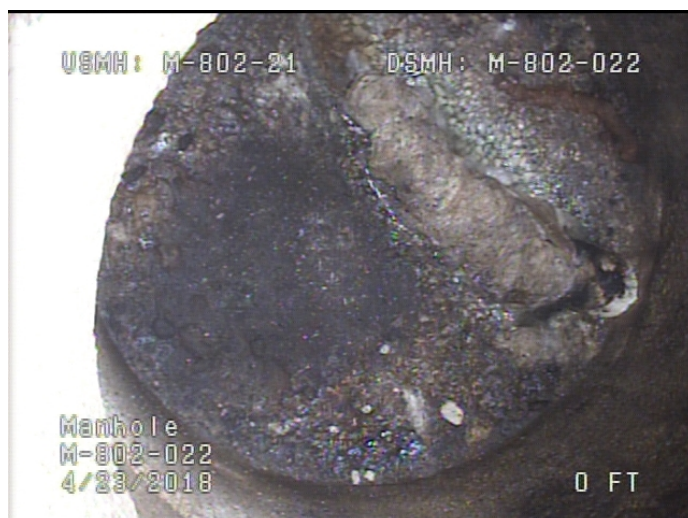
Code: **AMH**  
Description: **Manhole**

Distance (ft): **.0**  
Structural Grade: **0**  
O&M Grade: **0**  
Clock Start/From:  
Clock To:  
1st Value:  
2nd Value:  
Value Percent:  
Continuous Index:  
Within 8" of Joint: **NO**  
Remarks: **M-802-021**

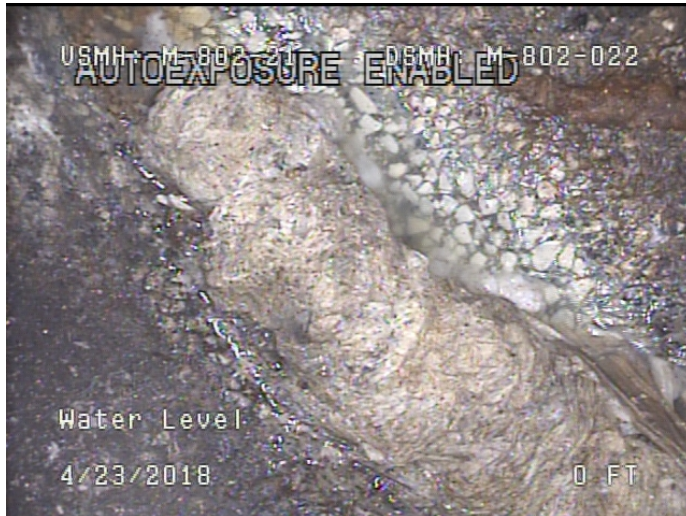
Code:	<b>MWL</b>
Description:	<b>Water Level</b>
Distance (ft):	<b>.0</b>
Structural Grade:	<b>0</b>
O&M Grade:	<b>0</b>
Clock Start/From:	
Clock To:	
1st Value:	
2nd Value:	
Value Percent:	<b>5.000</b>
Continuous Index:	
Within 8" of Joint:	<b>NO</b>
Remarks:

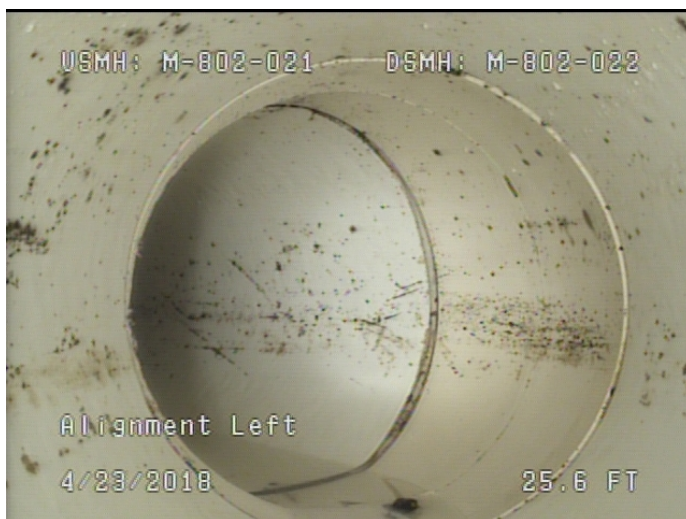
Code:	<b>LL</b>
Description:	<b>Alignment Left</b>
Distance (ft):	<b>25.6</b>
Structural Grade:	<b>0</b>
O&M Grade:	<b>4</b>
Clock Start/From:	
Clock To:	
1st Value:	
2nd Value:	
Value Percent:	<b>45.000</b>
Continuous Index:	
Within 8" of Joint:	<b>NO</b>
Remarks:

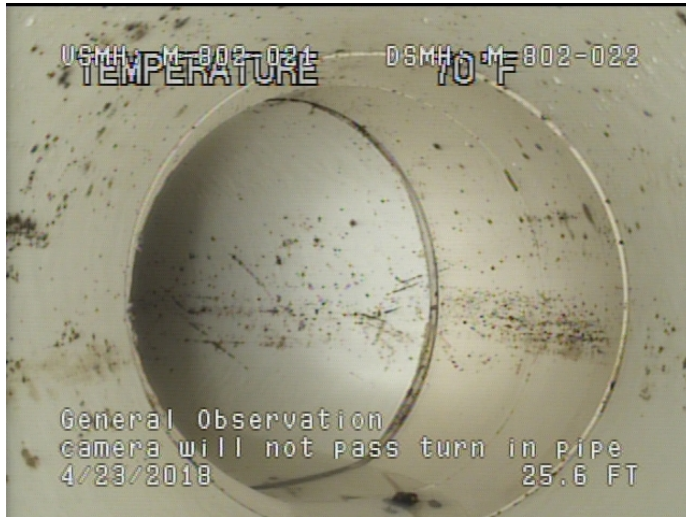
Code:	<b>MGO</b>
Description:	<b>General Observation</b>
Distance (ft):	<b>25.6</b>
Structural Grade:	<b>0</b>
O&M Grade:	<b>0</b>
Clock Start/From:	
Clock To:	
1st Value:	
2nd Value:	
Value Percent:	
Continuous Index:	
Within 8" of Joint:	<b>NO</b>
Remarks:	<b>camera will not pass turn in pipe</b>

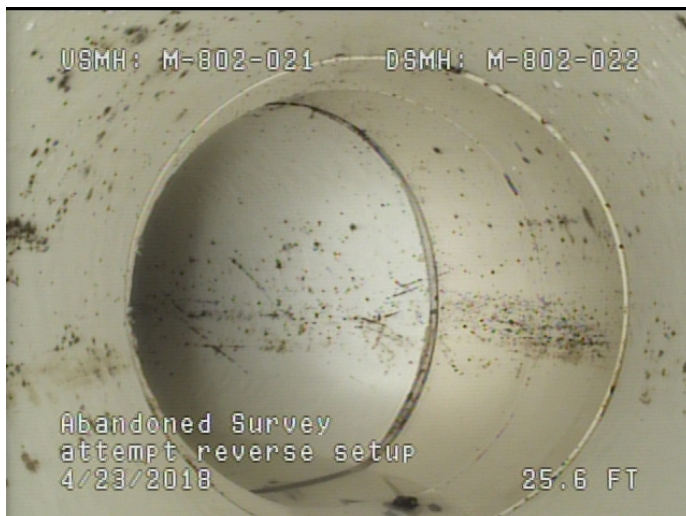
Code:	<b>MSA</b>
Description:	<b>Abandoned Survey</b>
Distance (ft):	<b>25.6</b>
Structural Grade:	<b>0</b>
O&M Grade:	<b>0</b>
Clock Start/From:	
Clock To:	
1st Value:	
2nd Value:	
Value Percent:	
Continuous Index:	
Within 8" of Joint:	<b>NO</b>
Remarks:	<b>attempt reverse setup</b>
