Profile/Photo Observation Report

Date:	10/15/2021	Weather:		Coding:	PACP 6.0
Pipe Length (ft):		Owner:	Hobart, IN	Pre Clean:	Not Known
P.O.#:	813_1	Surveyor:	M. Pielacha	PSR:	P-802-024-025
Customer:	Hobart, IN	Clean Date:		Shape:	C

Location Details:		Direction of Survey:	Upstream
US MH:	M-802-24	DS MH:	M-802-25
		Total Length Surveyed (ft):	6.3

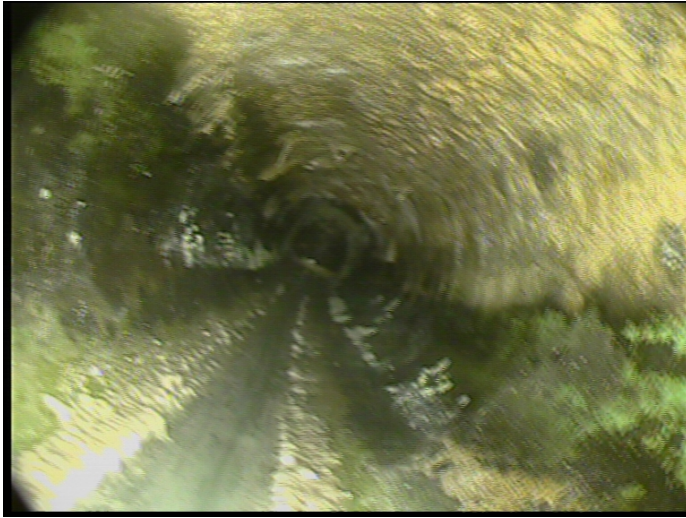
Code: **MWL**
Description: **Water Level**

Distance (ft): **.0**
Structural Grade: **0**
O&M Grade: **0**
Clock Start/From:
Clock To:
1st Value:
2nd Value:
Value Percent: **5.000**
Continuous Index:
Within 8" of Joint: **NO**
Remarks:

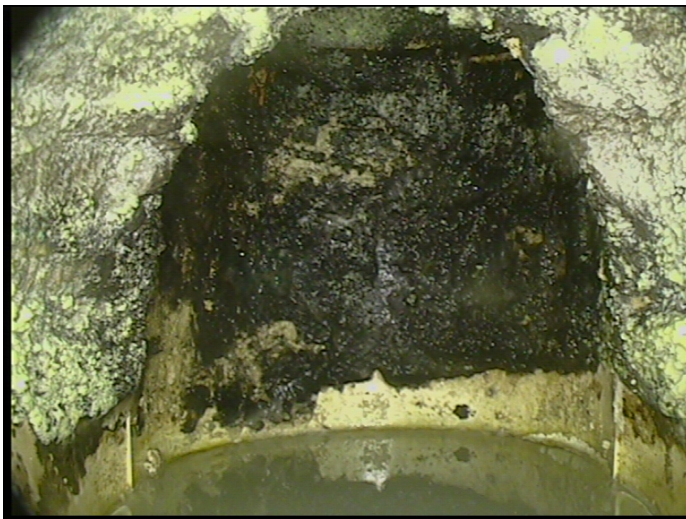
Code: **ACOM**
Description: **Cleanout Mainline**

Distance (ft): **6.3**
Structural Grade: **0**
O&M Grade: **0**
Clock Start/From:
Clock To:
1st Value:
2nd Value:
Value Percent:
Continuous Index:
Within 8" of Joint: **NO**
Remarks: **M-802-24**
