Profile/Photo Observation Report

Date:	03/29/2018	Weather:		Coding:	PACP 6.0
Pipe Length (ft):	164.0	Owner:	NA	Pre Clean:	Not Known
P.O.#:		Surveyor:	Jen Costello	PSR:	P-803-001-041
Customer:		Clean Date:	01/01/1900	Shape:	C

Street:	HIGH ST	Flow Control:	Not Controlled
City:	Hobart, IN	Year Renewed:	
Location:	Other	Tape/Media #:	
Purpose:	Not Known	Dia/Height:	10"
Use:	Sanitary	Material:	VCP
Drain Area:	NA	Lining:	
Category:	NA		
Comment:

Location Details:		Direction of Survey:	Downstream
US MH:	M-803-001	DS MH:	M-804-041
		Total Length Surveyed (ft):	10.1

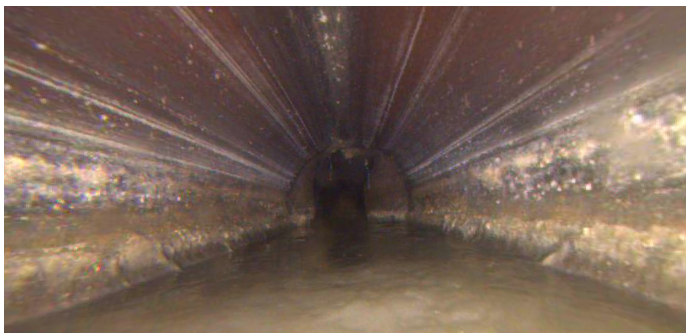
Code: **AMH**
Description: **Manhole**

Distance (ft): **.0**
Structural Grade: **0**
O&M Grade: **0**
Clock Start/From:
Clock To:
1st Value:
2nd Value:
Value Percent:
Continuous Index:
Within 8" of Joint: **NO**
Remarks: **M-803-001**

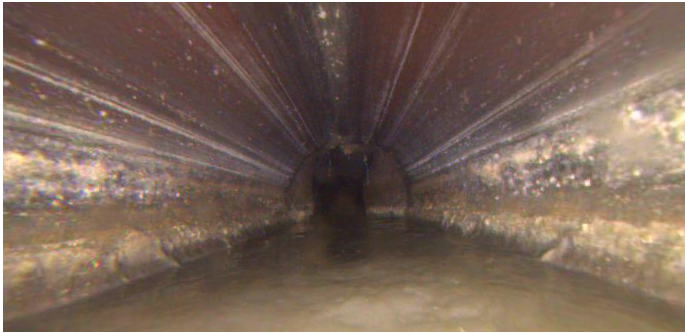
Code:	MWL
Description:	Water Level

Distance (ft):	.0
Structural Grade:	0
O&M Grade:	0
Clock Start/From:	
Clock To:	
1st Value:	
2nd Value:	
Value Percent:	30.000
Continuous Index:	
Within 8" of Joint:	NO
Remarks:

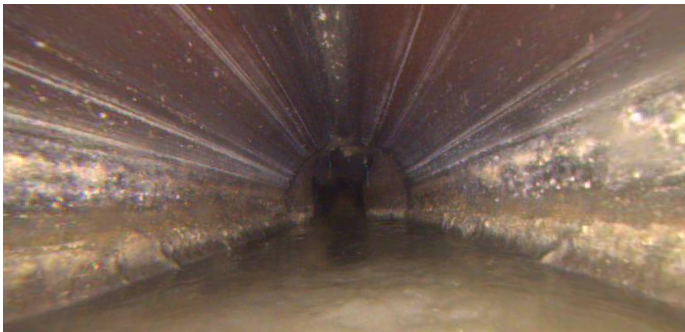
Code:	DAGS
Description:	Deposits Attached Grease

Distance (ft):	.0
Structural Grade:	0
O&M Grade:	2
Clock Start/From:	8
Clock To:	4
1st Value:	
2nd Value:	
Value Percent:	5.000
Continuous Index:	S01
Within 8" of Joint:	NO
Remarks:

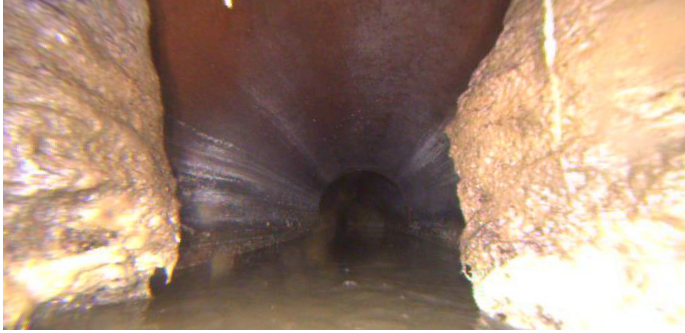
Code: **DAE**
Description: **Deposits Attached Encrustation**

Distance (ft): **3.6**
Structural Grade: **0**
O&M Grade: **5**
Clock Start/From: **8**
Clock To: **4**
1st Value:
2nd Value:
Value Percent: **40.000**
Continuous Index:
Within 8" of Joint: **YES**
Remarks:

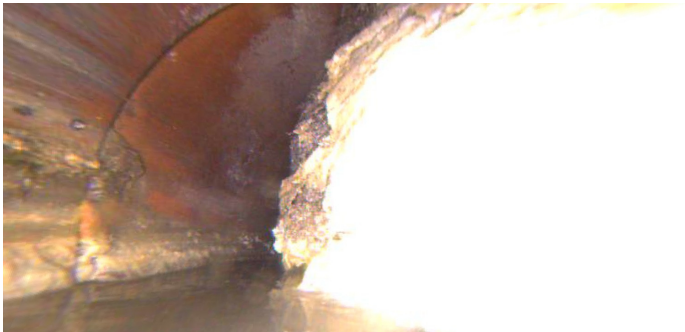
Code: **RBJ**
Description: **Roots Ball Joint**

Distance (ft): **9.0**
Structural Grade: **0**
O&M Grade: **4**
Clock Start/From: **12**
Clock To: **6**
1st Value:
2nd Value:
Value Percent: **70.000**
Continuous Index:
Within 8" of Joint: **YES**
Remarks:

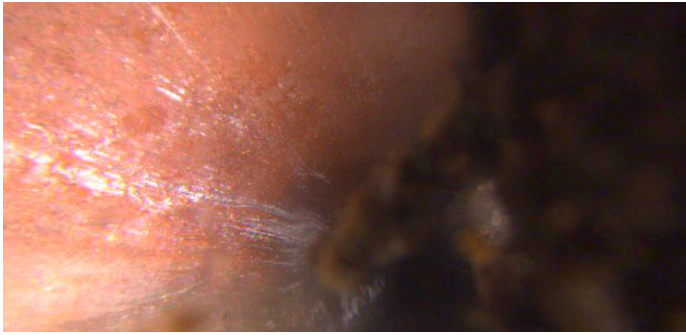
Code: **MSA**
Description: **Abandoned Survey**

Distance (ft): **10.1**
Structural Grade: **0**
O&M Grade: **0**
Clock Start/From:
Clock To:
1st Value:
2nd Value:
Value Percent:
Continuous Index:
Within 8" of Joint: **NO**
Remarks: **RBJ**

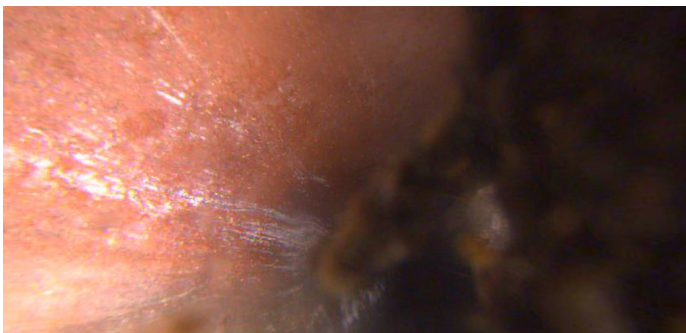
Code: **DAGS**
Description: **Deposits Attached Grease**

Distance (ft): **10.1**
Structural Grade: **0**
O&M Grade: **2**
Clock Start/From: **8**
Clock To: **4**
1st Value:
2nd Value:
Value Percent: **5.000**
Continuous Index: **F01**
Within 8" of Joint: **NO**
Remarks:
