Profile/Photo Observation Report

Street:	HIGH ST	Flow Control:	Not Controlled
City:	Hobart, IN	Year Renewed:	
Location:	Other	Tape/Media #:	
Purpose:	Not Known	Dia/Height:	10"
Use:	Sanitary	Material:	VCP
Drain Area:	NA	Lining:	
Category:	NA		
Comment:

Location Details:		Direction of Survey:	Downstream
US MH:	M-803-001	DS MH:	M-804-041
		Total Length Surveyed (ft):	10.1

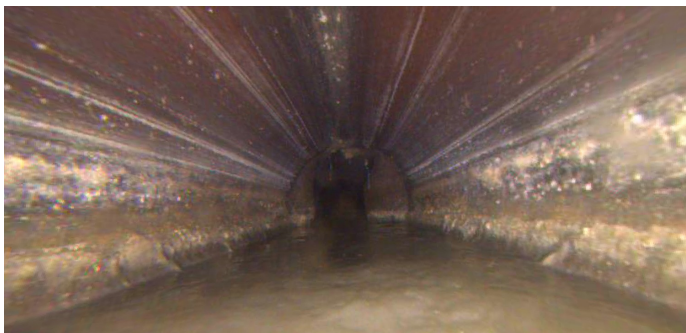
Code: **AMH**
Description: **Manhole**

Distance (ft): **.0**
Structural Grade: **0**
O&M Grade: **0**
Clock Start/From:
Clock To:
1st Value:
2nd Value:
Value Percent:
Continuous Index:
Within 8" of Joint: **NO**
Remarks: **M-803-001**

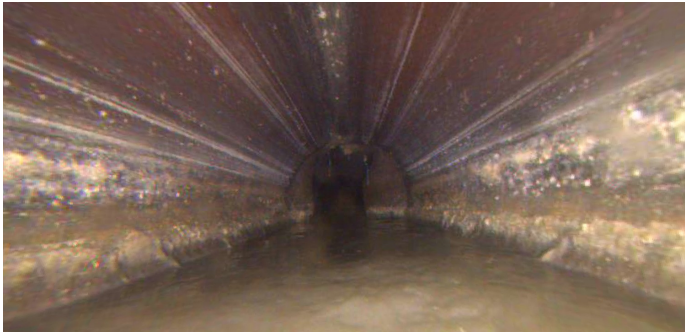
Code:	MWL
Description:	Water Level

Distance (ft):	.0
Structural Grade:	0
O&M Grade:	0
Clock Start/From:	
Clock To:	
1st Value:	
2nd Value:	
Value Percent:	30.000
Continuous Index:	
Within 8" of Joint:	NO
Remarks:

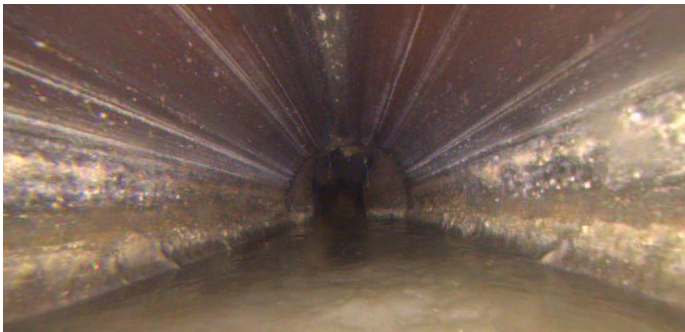
Code:	DAGS
Description:	Deposits Attached Grease

Distance (ft):	.0
Structural Grade:	0
O&M Grade:	2
Clock Start/From:	8
Clock To:	4
1st Value:	
2nd Value:	
Value Percent:	5.000
Continuous Index:	S01
Within 8" of Joint:	NO
Remarks:

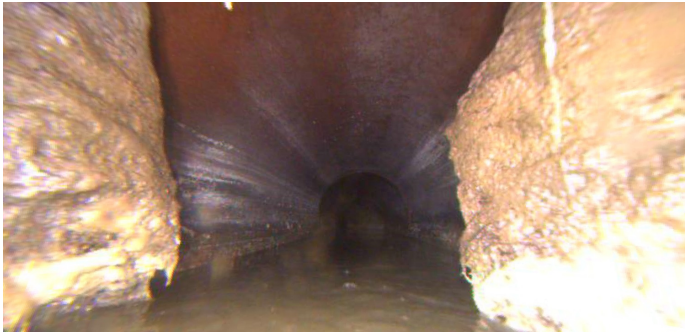
Code: **DAE**
Description: **Deposits Attached Encrustation**

Distance (ft): **3.6**
Structural Grade: **0**
O&M Grade: **5**
Clock Start/From: **8**
Clock To: **4**
1st Value:
2nd Value:
Value Percent: **40.000**
Continuous Index:
Within 8" of Joint: **YES**
Remarks:

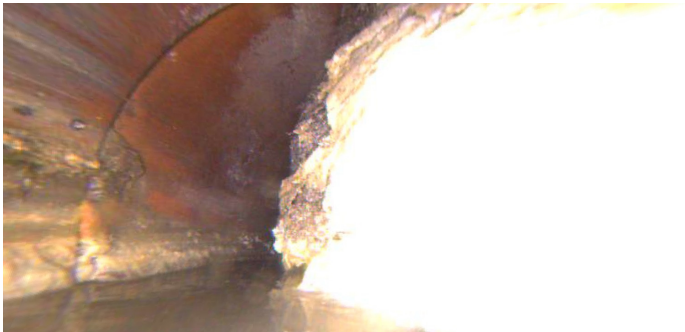
Code: **RBJ**
Description: **Roots Ball Joint**

Distance (ft): **9.0**
Structural Grade: **0**
O&M Grade: **4**
Clock Start/From: **12**
Clock To: **6**
1st Value:
2nd Value:
Value Percent: **70.000**
Continuous Index:
Within 8" of Joint: **YES**
Remarks:

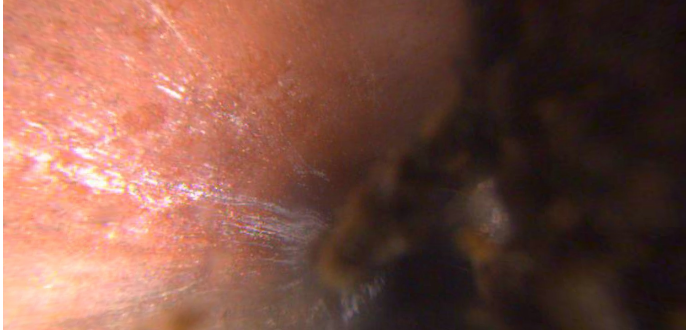
Code: **MSA**
Description: **Abandoned Survey**

Distance (ft): **10.1**
Structural Grade: **0**
O&M Grade: **0**
Clock Start/From:
Clock To:
1st Value:
2nd Value:
Value Percent:
Continuous Index:
Within 8" of Joint: **NO**
Remarks: **RBJ**

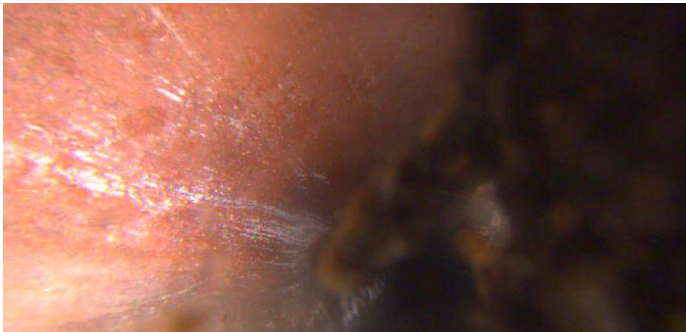
Code: **DAGS**
Description: **Deposits Attached Grease**

Distance (ft): **10.1**
Structural Grade: **0**
O&M Grade: **2**
Clock Start/From: **8**
Clock To: **4**
1st Value:
2nd Value:
Value Percent: **5.000**
Continuous Index: **F01**
Within 8" of Joint: **NO**
Remarks:
