## Profile/Photo Observation Report

Street:	<b>HIGH ST</b>	Flow Control:	<b>Not Controlled</b>
City:	<b>Hobart, IN</b>	Year Renewed:	
Location:	<b>Light Highway</b>	Tape/Media #:	
Purpose:	<b>Routine Assessment</b>	Dia/Height:	<b>12"</b>
Use:	<b>Sanitary</b>	Material:	<b>VCP</b>
Drain Area:	<b>NA</b>	Lining:	
Category:	<b>NA</b>		
Comment:

Location Details:		Direction of Survey:	<b>Downstream</b>
US MH:	<b>M-803-001</b>	DS MH:	<b>M-804-041</b>
		Total Length Surveyed (ft):	<b>24.1</b>

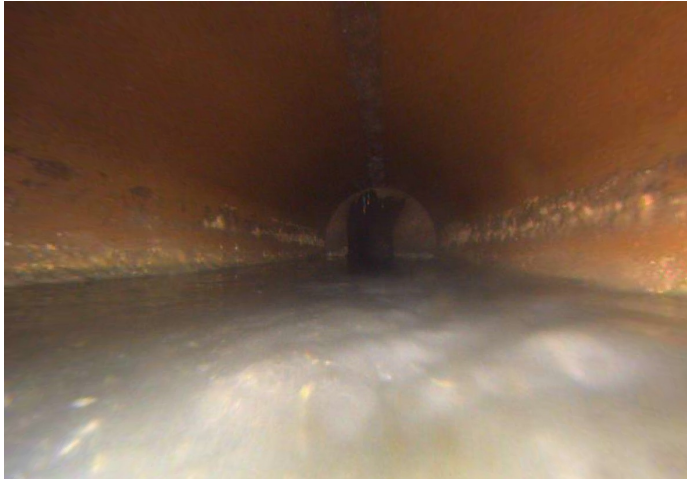
Code: **MWL**  
Description: **Water Level**

Distance (ft): **.0**  
Structural Grade: **0**  
O&M Grade: **0**  
Clock Start/From:  
Clock To:  
1st Value:  
2nd Value:  
Value Percent: **25.000**  
Continuous Index:  
Within 8" of Joint: **NO**  
Remarks:

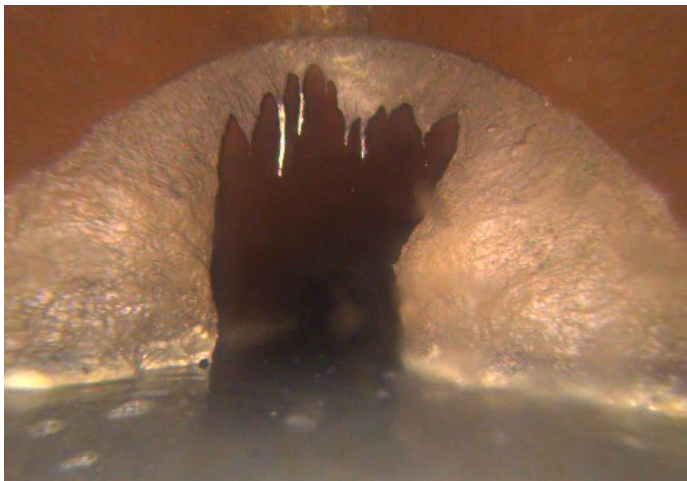
Code: **RMJ**  
Description: **Roots Medium Joint**

Distance (ft): **3.4**  
Structural Grade: **0**  
O&M Grade: **3**  
Clock Start/From: **9**  
Clock To: **3**  
1st Value:  
2nd Value:  
Value Percent: **30.000**  
Continuous Index:  
Within 8" of Joint: **YES**  
Remarks:

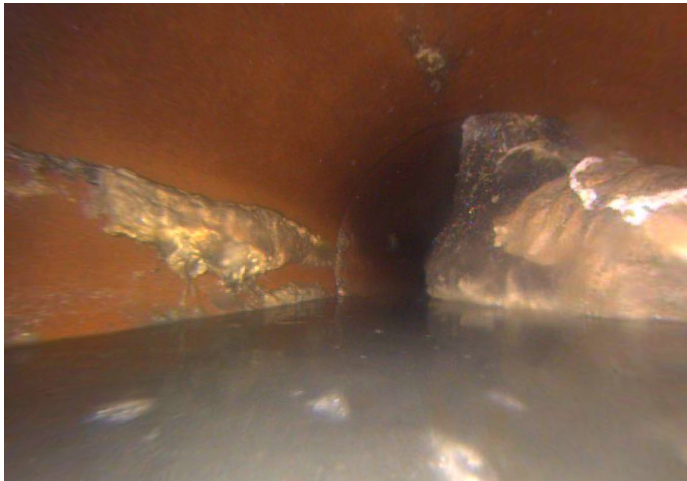
Code: **DAGS**  
Description: **Deposits Attached Grease**

Distance (ft): **8.6**  
Structural Grade: **0**  
O&M Grade: **2**  
Clock Start/From: **9**  
Clock To:  
1st Value:  
2nd Value:  
Value Percent: **5.000**  
Continuous Index:  
Within 8" of Joint: **NO**  
Remarks:

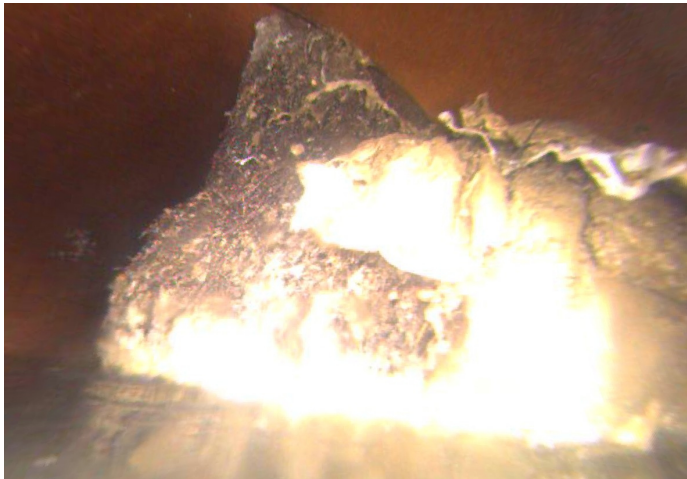
Code: **RMJ**  
Description: **Roots Medium Joint**

Distance (ft): **9.2**  
Structural Grade: **0**  
O&M Grade: **3**  
Clock Start/From: **1**  
Clock To: **6**  
1st Value:  
2nd Value:  
Value Percent: **30.000**  
Continuous Index:  
Within 8" of Joint: **YES**  
Remarks:

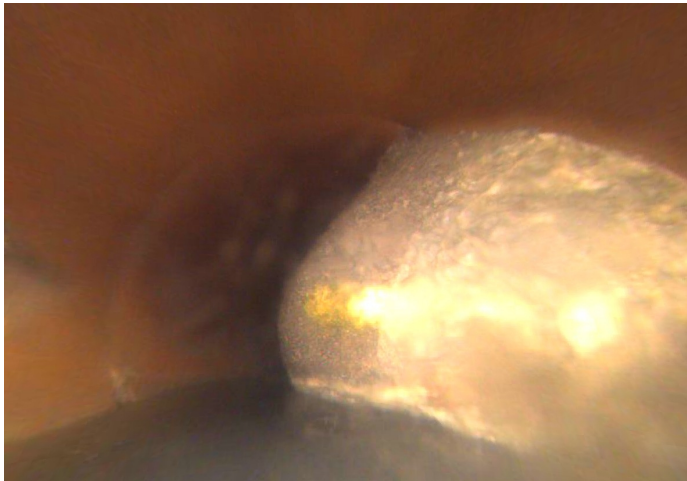
Code:	<b>RMJ</b>
Description:	<b>Roots Medium Joint</b>
Distance (ft):	<b>23.3</b>
Structural Grade:	<b>0</b>
O&M Grade:	<b>3</b>
Clock Start/From:	<b>1</b>
Clock To:	<b>6</b>
1st Value:	
2nd Value:	
Value Percent:	<b>45.000</b>
Continuous Index:	
Within 8" of Joint:	<b>YES</b>
Remarks:

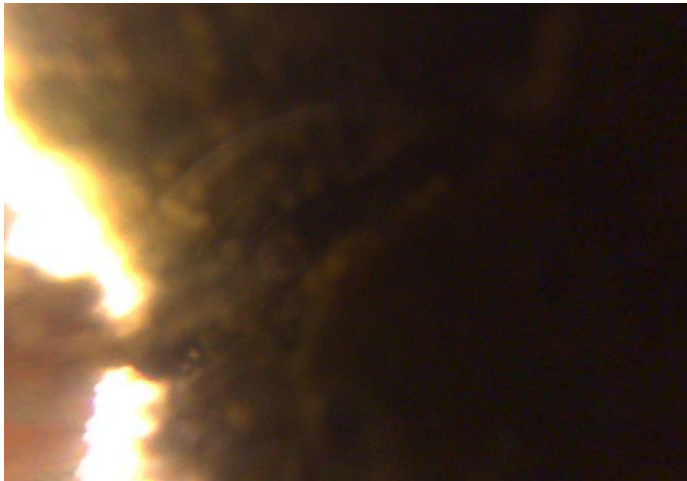
Code:	<b>MSA</b>
Description:	<b>Abandoned Survey</b>
Distance (ft):	<b>24.1</b>
Structural Grade:	<b>0</b>
O&M Grade:	<b>0</b>
Clock Start/From:	
Clock To:	
1st Value:	
2nd Value:	
Value Percent:	
Continuous Index:	
Within 8" of Joint:	<b>NO</b>
Remarks:	<b>RMJ</b>
