## Profile/Photo Observation Report

Street:	<b>High St.</b>	Flow Control:	<b>Not Controlled</b>
City:	<b>Hobart, IN</b>	Year Renewed:	
Location:	<b>Light Highway</b>	Tape/Media #:	
Purpose:	<b>Routine Assessment</b>	Dia/Height:	<b>12"</b>
Use:	<b>Sanitary</b>	Material:	<b>VCP</b>
Drain Area:	<b>NA</b>	Lining:	
Category:	<b>NA</b>		
Comment:

Location Details:		Direction of Survey:	<b>Downstream</b>
US MH:	<b>M-803-001</b>	DS MH:	<b>M-804-041</b>
		Total Length Surveyed (ft):	<b>24.1</b>

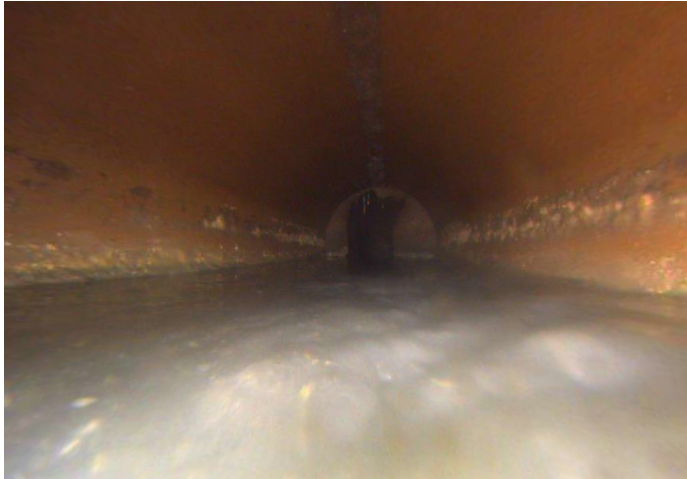
Code: **MWL**  
Description: **Water Level**

Distance (ft): **.0**  
Structural Grade: **0**  
O&M Grade: **0**  
Clock Start/From:  
Clock To:  
1st Value:  
2nd Value:  
Value Percent: **25.000**  
Continuous Index:  
Within 8" of Joint: **NO**  
Remarks:

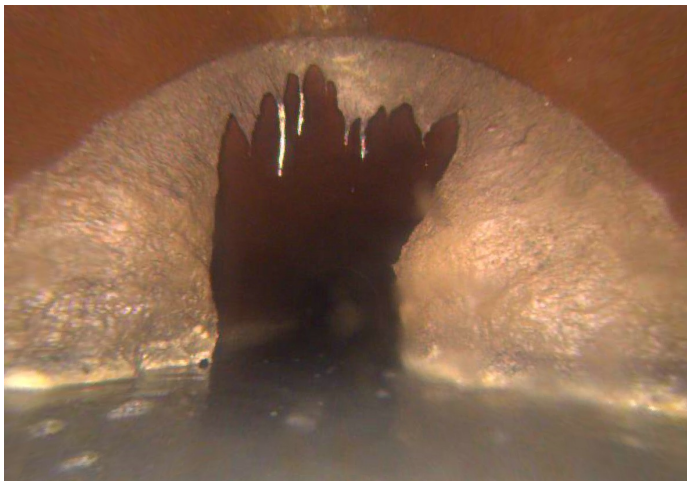
Code: **RMJ**  
Description: **Roots Medium Joint**

Distance (ft): **3.4**  
Structural Grade: **0**  
O&M Grade: **3**  
Clock Start/From: **9**  
Clock To: **3**  
1st Value:  
2nd Value:  
Value Percent: **30.000**  
Continuous Index:  
Within 8" of Joint: **YES**  
Remarks:

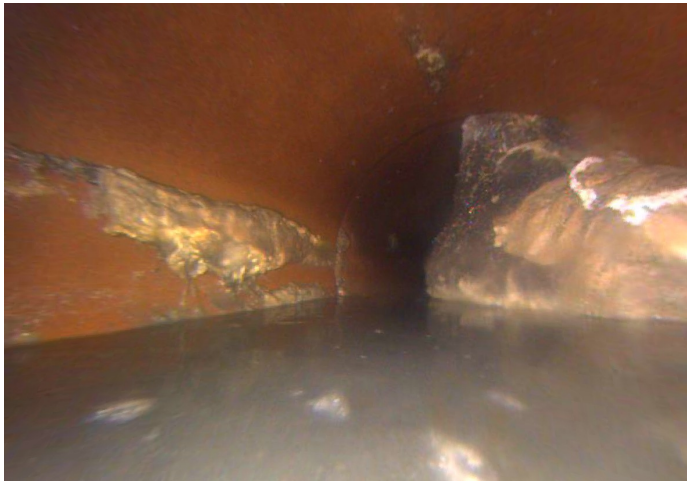
Code:	<b>DAGS</b>
Description:	<b>Deposits Attached Grease</b>
Distance (ft):	<b>8.6</b>
Structural Grade:	<b>0</b>
O&M Grade:	<b>2</b>
Clock Start/From:	<b>9</b>
Clock To:	
1st Value:	
2nd Value:	
Value Percent:	<b>5.000</b>
Continuous Index:	
Within 8" of Joint:	<b>NO</b>
Remarks:

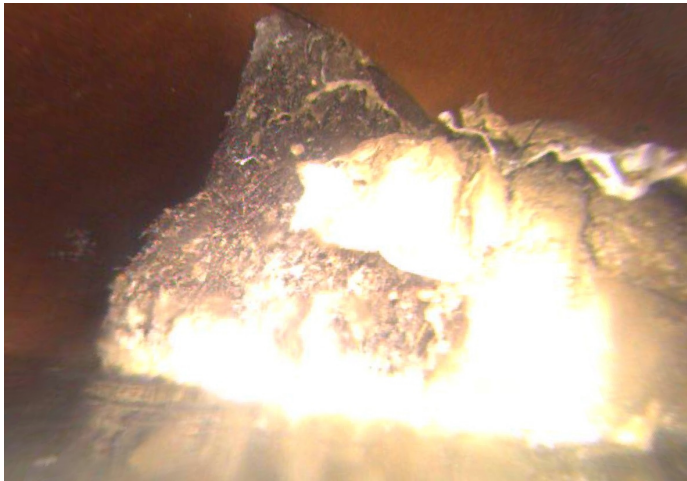
Code:	<b>RMJ</b>
Description:	<b>Roots Medium Joint</b>
Distance (ft):	<b>9.2</b>
Structural Grade:	<b>0</b>
O&M Grade:	<b>3</b>
Clock Start/From:	<b>1</b>
Clock To:	<b>6</b>
1st Value:	
2nd Value:	
Value Percent:	<b>30.000</b>
Continuous Index:	
Within 8" of Joint:	<b>YES</b>
Remarks:

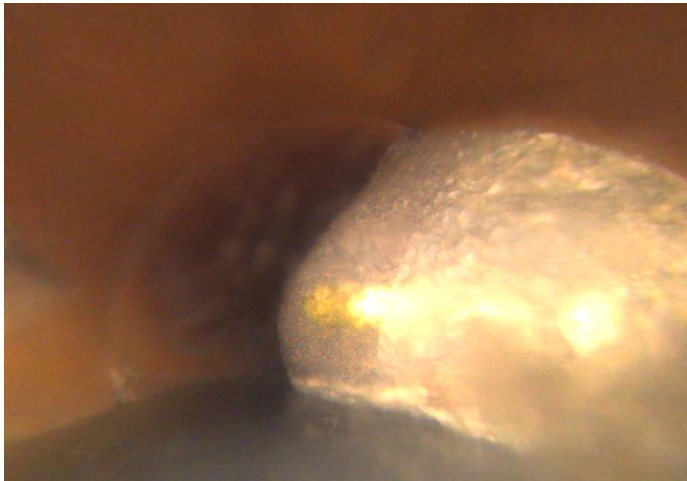
Code:	<b>RMJ</b>
Description:	<b>Roots Medium Joint</b>
Distance (ft):	<b>23.3</b>
Structural Grade:	<b>0</b>
O&M Grade:	<b>3</b>
Clock Start/From:	<b>1</b>
Clock To:	<b>6</b>
1st Value:	
2nd Value:	
Value Percent:	<b>45.000</b>
Continuous Index:	
Within 8" of Joint:	<b>YES</b>
Remarks:

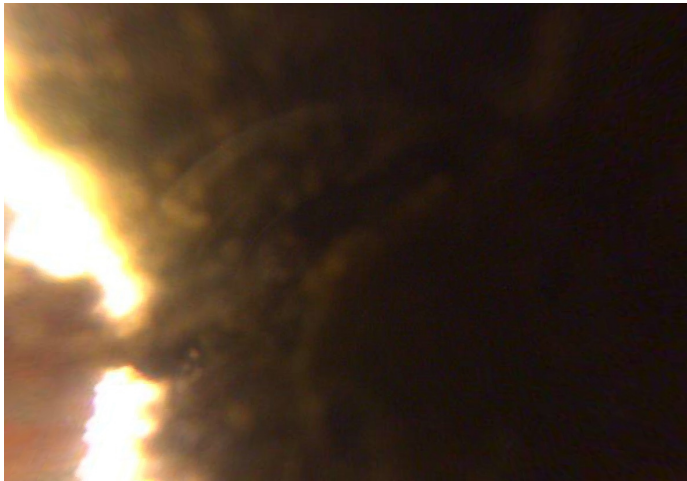
Code:	<b>MSA</b>
Description:	<b>Abandoned Survey</b>
Distance (ft):	<b>24.1</b>
Structural Grade:	<b>0</b>
O&M Grade:	<b>0</b>
Clock Start/From:	
Clock To:	
1st Value:	
2nd Value:	
Value Percent:	
Continuous Index:	
Within 8" of Joint:	<b>NO</b>
Remarks:	<b>RMJ</b>
