## Profile/Photo Observation Report

Date:	<b>10/02/2018</b>	Weather:		Coding:	<b>PACP 6.0</b>
Pipe Length (ft):	<b>164.0</b>	Owner:	<b>NA</b>	Pre Clean:	<b>Not Known</b>
P.O.#:		Surveyor:	<b>Michael Carlino</b>	PSR:	<b>P-803-001-041</b>
Customer:		Clean Date:	<b>01/01/1900</b>	Shape:	<b>C</b>

Location Details:		Direction of Survey:	<b>Upstream</b>
US MH:	<b>M-803-001</b>	DS MH:	<b>M-804-041</b>
		Total Length Surveyed (ft):	<b>7.7</b>

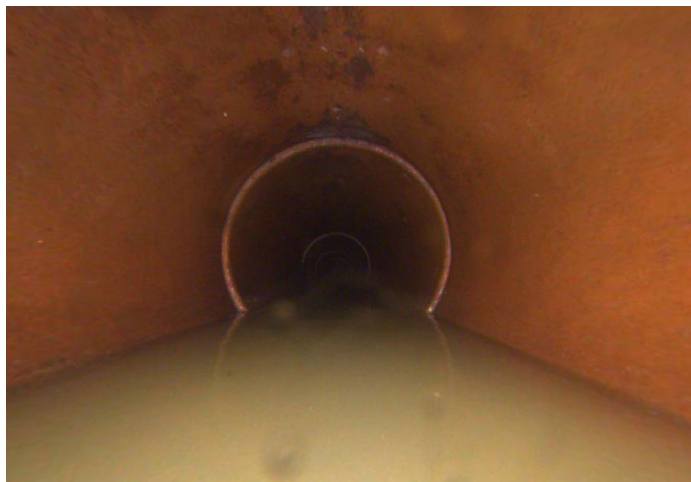
Code: **AMH**  
Description: **Manhole**

Distance (ft): **.0**  
Structural Grade: **0**  
O&M Grade: **0**  
Clock Start/From:  
Clock To:  
1st Value:  
2nd Value:  
Value Percent:  
Continuous Index:  
Within 8" of Joint: **NO**  
Remarks: **M-804-041**

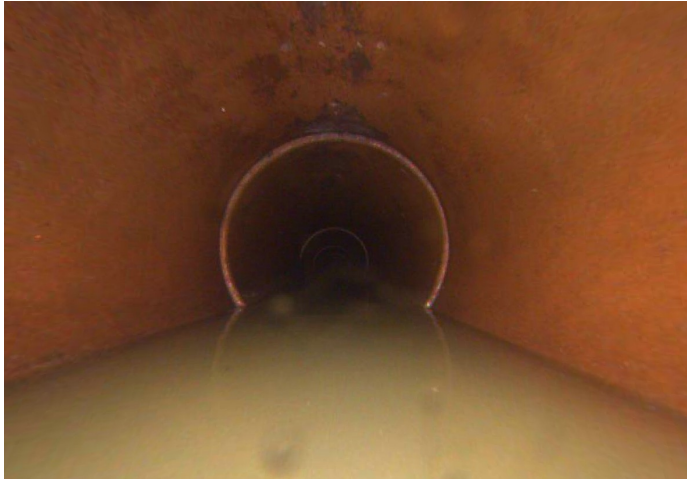
Code: **MWL**  
Description: **Water Level**

Distance (ft): **.0**  
Structural Grade: **0**  
O&M Grade: **0**  
Clock Start/From:  
Clock To:  
1st Value:  
2nd Value:  
Value Percent: **20.000**  
Continuous Index:  
Within 8" of Joint: **NO**  
Remarks:

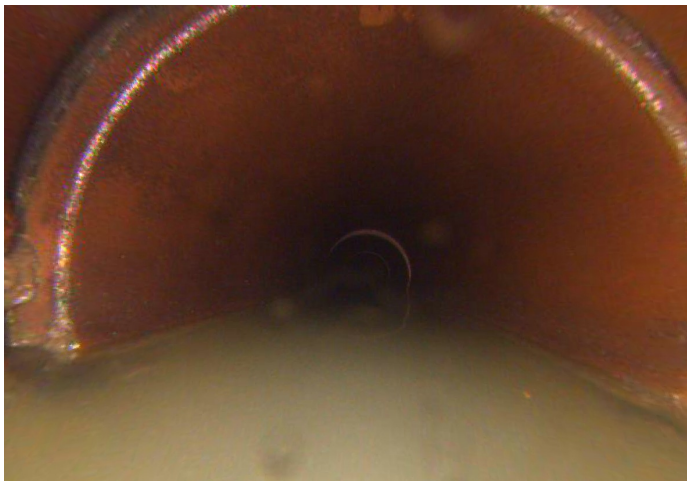
Code: **MSA**  
Description: **Abandoned Survey**

Distance (ft): **7.7**  
Structural Grade: **0**  
O&M Grade: **0**  
Clock Start/From:  
Clock To:  
1st Value:  
2nd Value:  
Value Percent:  
Continuous Index:  
Within 8" of Joint: **NO**  
Remarks: **Unknown**
