Profile/Photo Observation Report

Date:	01/15/2025	Weather:		Coding:	PACP 7.0
Pipe Length (ft):	164.0	Owner:	City of Hobart	Pre Clean:	Heavy Cleaning
P.O.#:	YES502259	Surveyor:	S. Bucklin	PSR:	P-803-001-041
Customer:	City of Hobart	Clean Date:	10/29/2024	Shape:	C

Street:	East High Street	Flow Control:	Not Controlled
City:	Hobart, IN	Year Renewed:	
Location:	Local rural streets with light traffic, t	Tape/Media #:	
Purpose:	Sewer System Evaluation Survey (SS	Dia/Height:	12"
Use:	Sanitary Sewage Pipe	Material:	VCP
Drain Area:		Lining:	None
Category:	NA		
Comment:			
Location Details:		Direction of Survey:	Downstream
US MH:	M-803-001	DS MH:	M-804-041
		Total Length Surveyed (ft):	157.5

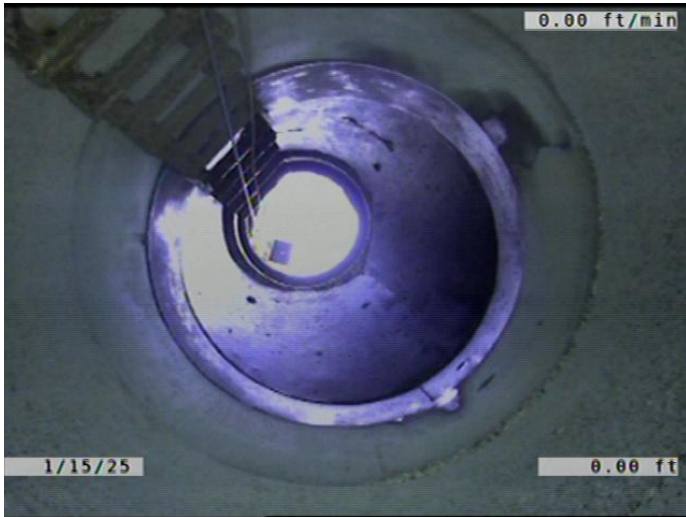
Code: **AMH**
Description: **Manhole**

Distance (ft): **.0**
Structural Grade: **0**
O&M Grade: **0**
Clock Start/From:
Clock To:
1st Value:
2nd Value:
Value Percent:
Continuous Index:
Within 8" of Joint: **NO**
Remarks: **M-803-001**

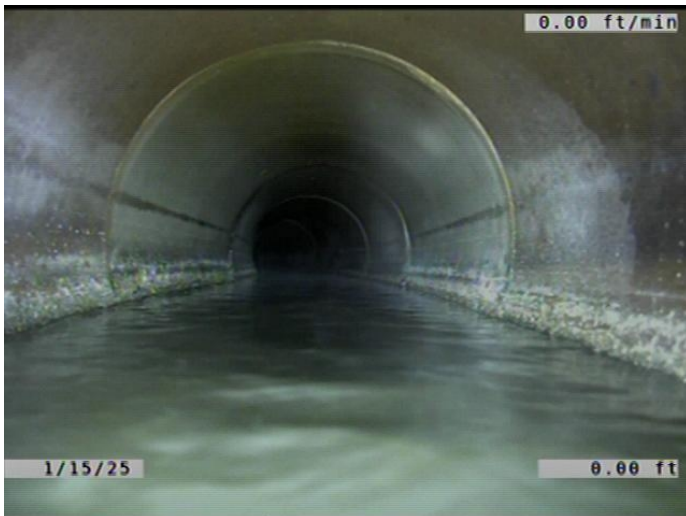
Code: **MWL**
Description: **Miscellaneous Water Level**

Distance (ft): **.0**
Structural Grade: **0**
O&M Grade: **0**
Clock Start/From:
Clock To:
1st Value:
2nd Value:
Value Percent: **20.000**
Continuous Index:
Within 8" of Joint: **NO**
Remarks:

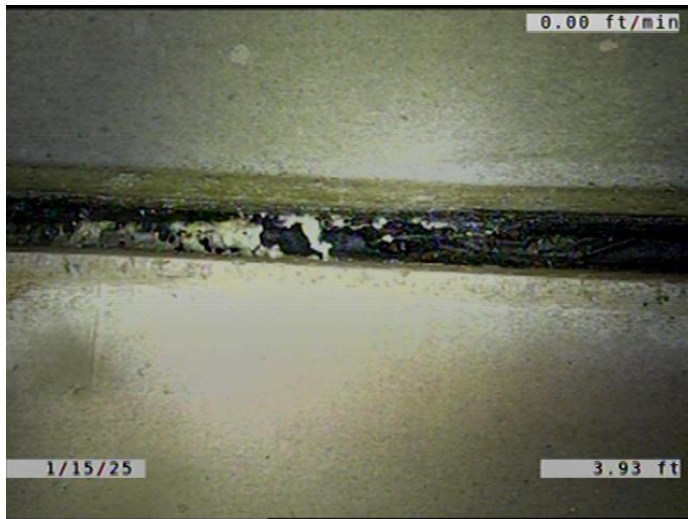
Code: **RFJ**
Description: **Roots Fine Joint**

Distance (ft): **3.9**
Structural Grade: **0**
O&M Grade: **1**
Clock Start/From: **8**
Clock To: **12**
1st Value:
2nd Value:
Value Percent:
Continuous Index:
Within 8" of Joint: **YES**
Remarks:

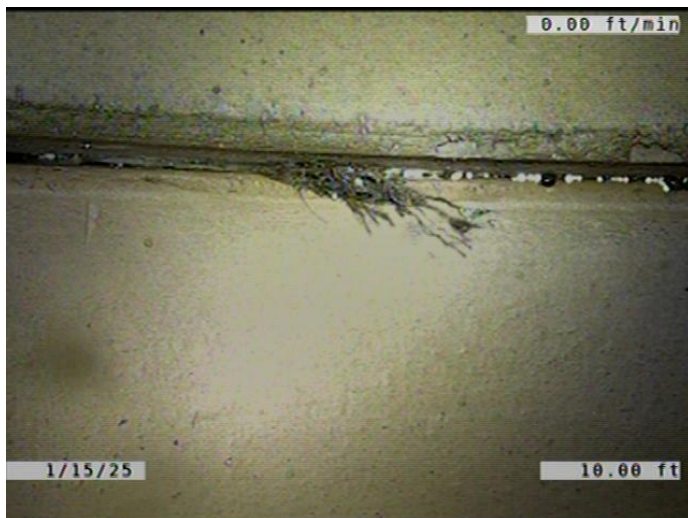
Code: **RFJ**
Description: **Roots Fine Joint**

Distance (ft): **10.0**
Structural Grade: **0**
O&M Grade: **1**
Clock Start/From: **10**
Clock To: **2**
1st Value:
2nd Value:
Value Percent:
Continuous Index:
Within 8" of Joint: **YES**
Remarks:

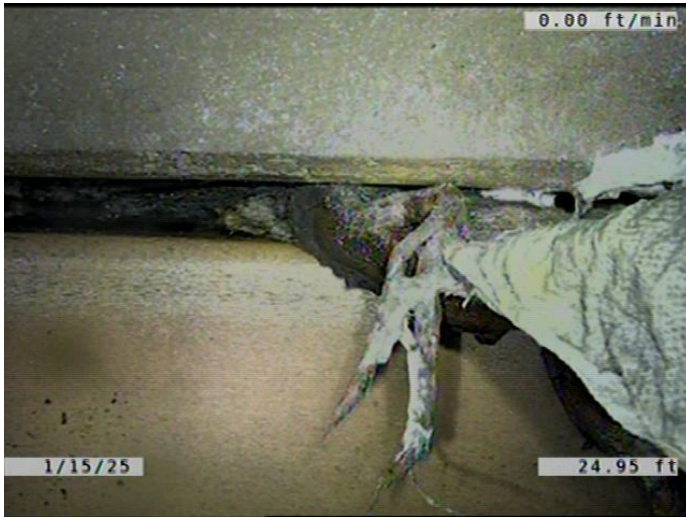
Code: **RTJ**
Description: **Roots Tap Joint**

Distance (ft): **25.0**
Structural Grade: **0**
O&M Grade: **2**
Clock Start/From: **9**
Clock To: **3**
1st Value:
2nd Value:
Value Percent: **5.000**
Continuous Index:
Within 8" of Joint: **YES**
Remarks:

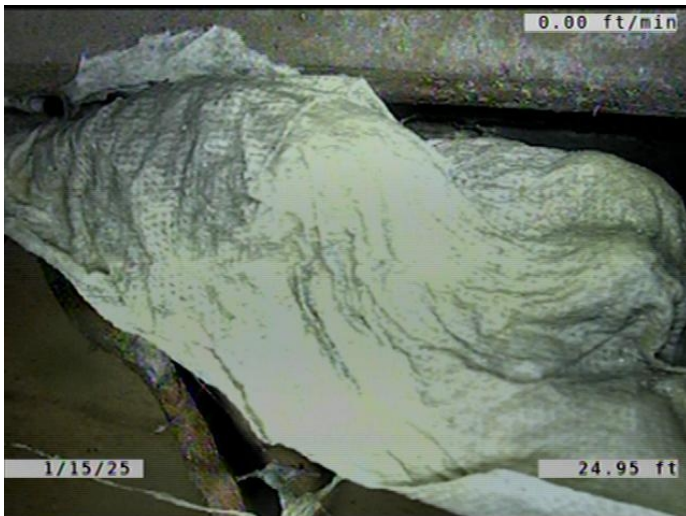
Code: **DAR**
Description: **Deposits Attached Ragging**

Distance (ft): **25.0**
Structural Grade: **0**
O&M Grade: **2**
Clock Start/From: **1**
Clock To: **5**
1st Value:
2nd Value:
Value Percent: **5.000**
Continuous Index:
Within 8" of Joint: **YES**
Remarks:

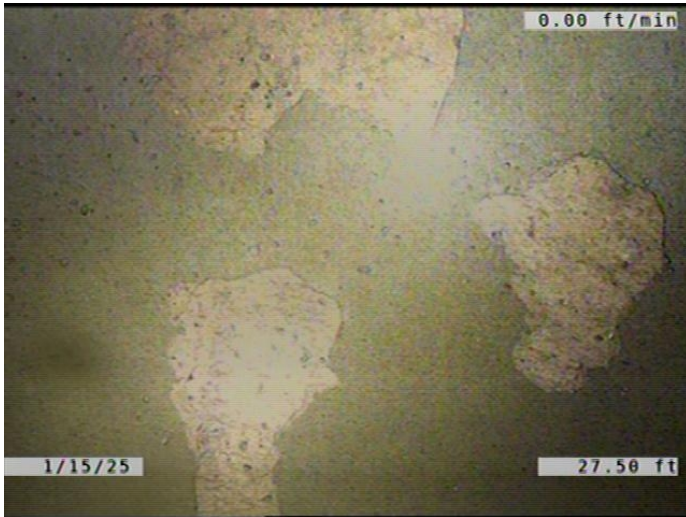
Code: **SSC**
Description: **Surface Spalling of Damage Coating**

Distance (ft): **27.5**
Structural Grade: **1**
O&M Grade: **0**
Clock Start/From: **2**
Clock To: **3**
1st Value:
2nd Value:
Value Percent:
Continuous Index:
Within 8" of Joint: **YES**
Remarks:

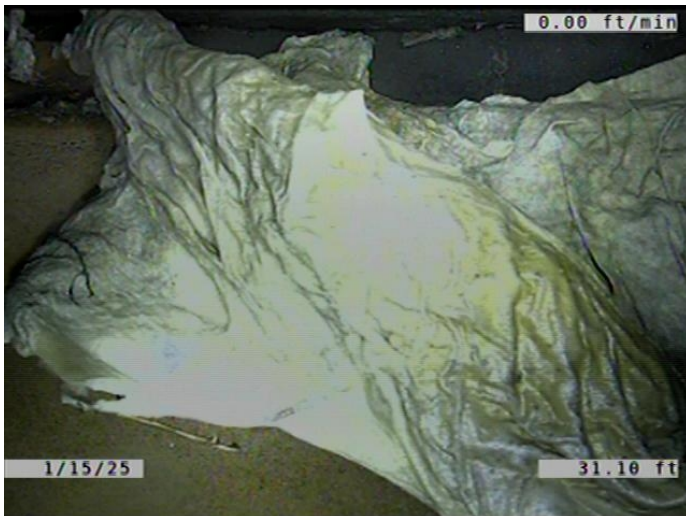
Code: **DAR**
Description: **Deposits Attached Ragging**

Distance (ft): **31.1**
Structural Grade: **0**
O&M Grade: **2**
Clock Start/From: **9**
Clock To: **3**
1st Value:
2nd Value:
Value Percent: **5.000**
Continuous Index:
Within 8" of Joint: **YES**
Remarks:

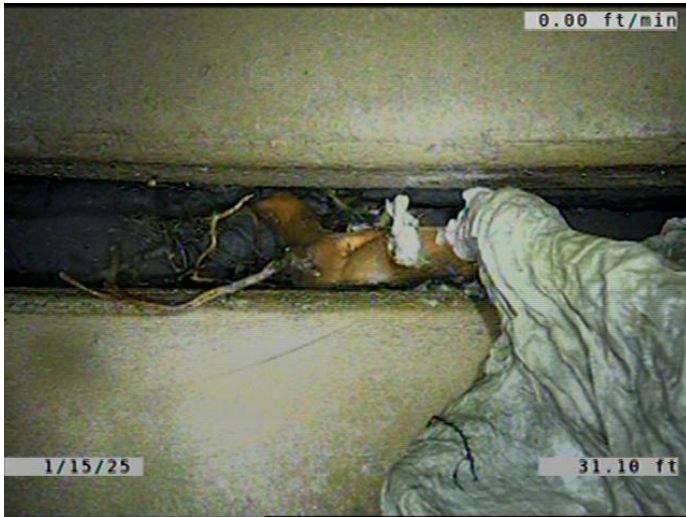
Code: **RTJ**
Description: **Roots Tap Joint**

Distance (ft): **31.1**
Structural Grade: **0**
O&M Grade: **2**
Clock Start/From: **9**
Clock To: **3**
1st Value:
2nd Value:
Value Percent: **5.000**
Continuous Index:
Within 8" of Joint: **YES**
Remarks:

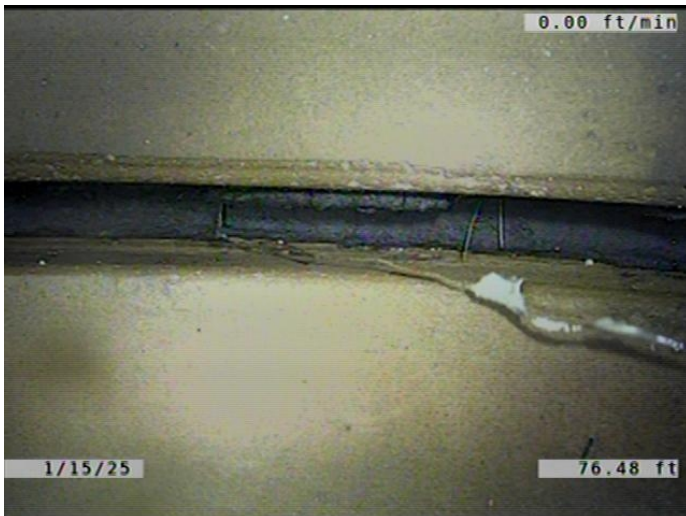
Code: **RFJ**
Description: **Roots Fine Joint**

Distance (ft): **76.5**
Structural Grade: **0**
O&M Grade: **1**
Clock Start/From: **1**
Clock To: **3**
1st Value:
2nd Value:
Value Percent:
Continuous Index:
Within 8" of Joint: **YES**
Remarks:

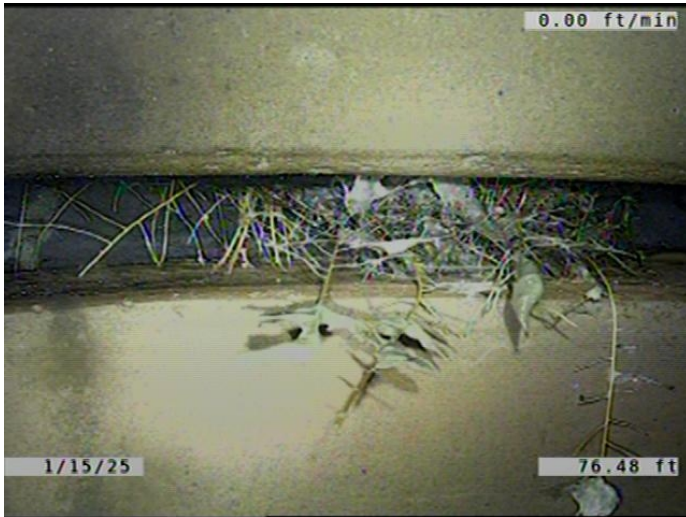
Code: **RFJ**
Description: **Roots Fine Joint**

Distance (ft): **76.5**
Structural Grade: **0**
O&M Grade: **1**
Clock Start/From: **9**
Clock To: **11**
1st Value:
2nd Value:
Value Percent:
Continuous Index:
Within 8" of Joint: **YES**
Remarks:

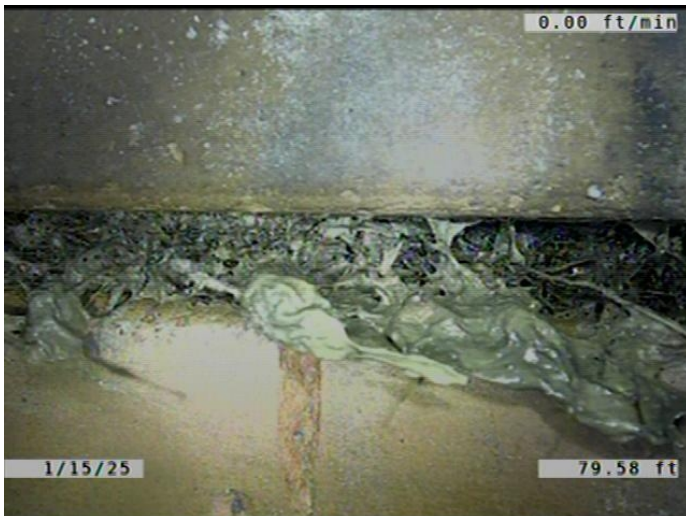
Code: **RFJ**
Description: **Roots Fine Joint**

Distance (ft): **79.6**
Structural Grade: **0**
O&M Grade: **1**
Clock Start/From: **9**
Clock To: **3**
1st Value:
2nd Value:
Value Percent:
Continuous Index:
Within 8" of Joint: **YES**
Remarks:

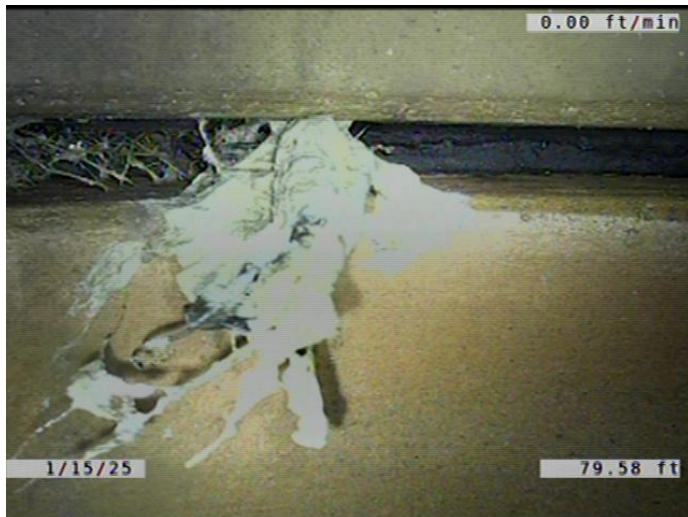
Code:	DAR
Description:	Deposits Attached Ragging
Distance (ft):	79.6
Structural Grade:	0
O&M Grade:	2
Clock Start/From:	10
Clock To:	11
1st Value:	
2nd Value:	
Value Percent:	5.000
Continuous Index:	
Within 8" of Joint:	NO
Remarks:

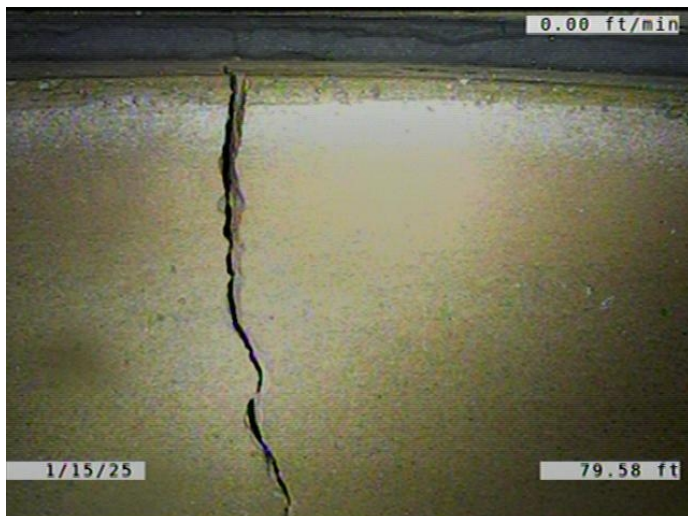
Code:	FM
Description:	Fracture Multiple
Distance (ft):	79.6
Structural Grade:	4
O&M Grade:	0
Clock Start/From:	9
Clock To:	3
1st Value:	
2nd Value:	
Value Percent:	
Continuous Index:	
Within 8" of Joint:	YES
Remarks:

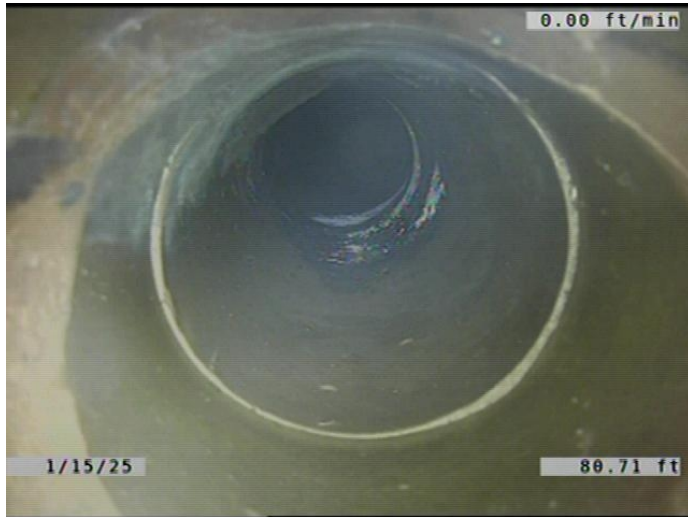
Code: **TFD**
Description: **Tap Factory Defective**

Distance (ft): **80.7**
Structural Grade: **0**
O&M Grade: **3**
Clock Start/From: **11**
Clock To:
1st Value: **6.000**
2nd Value:
Value Percent:
Continuous Index:
Within 8" of Joint: **YES**
Remarks: **TAP CRACKED.**

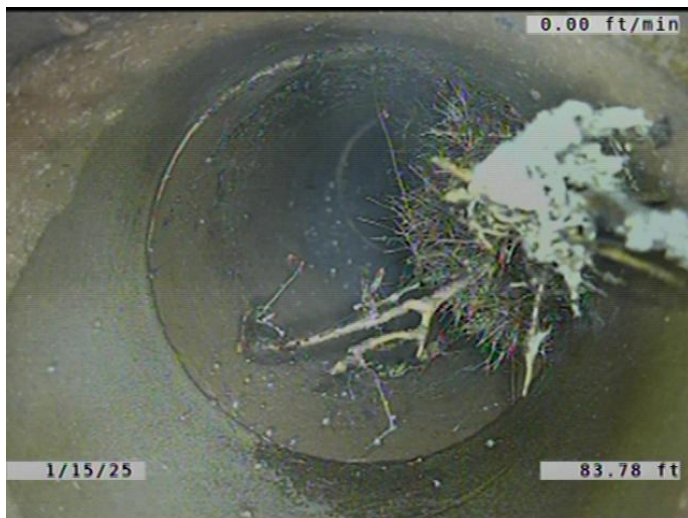
Code: **TFD**
Description: **Tap Factory Defective**

Distance (ft): **83.8**
Structural Grade: **0**
O&M Grade: **3**
Clock Start/From: **1**
Clock To:
1st Value: **6.000**
2nd Value:
Value Percent:
Continuous Index:
Within 8" of Joint: **YES**
Remarks: **ROOTS GROWING DOWN THE SERVICE INTO THE MAIN.**

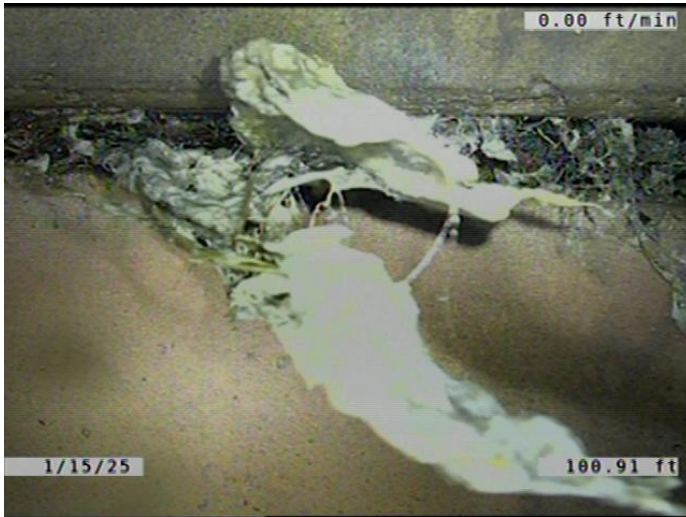
Code: **RFJ**
Description: **Roots Fine Joint**

Distance (ft): **100.9**
Structural Grade: **0**
O&M Grade: **1**
Clock Start/From: **9**
Clock To: **3**
1st Value:
2nd Value:
Value Percent:
Continuous Index: **S01**
Within 8" of Joint: **YES**
Remarks:

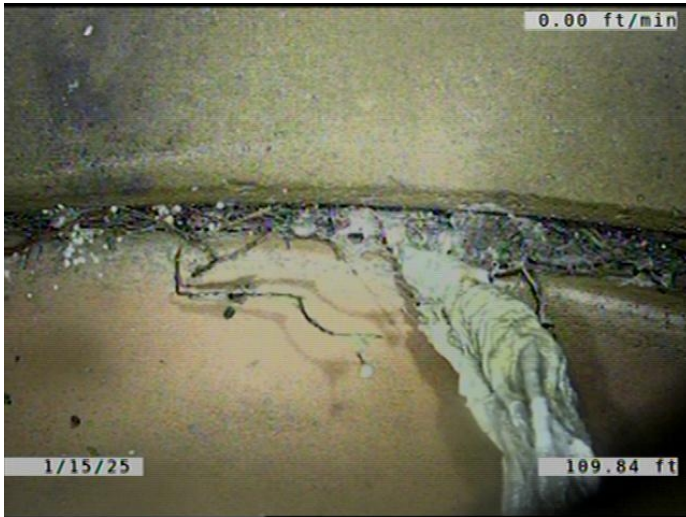
Code: **DAR**
Description: **Deposits Attached Ragging**

Distance (ft): **109.8**
Structural Grade: **0**
O&M Grade: **2**
Clock Start/From: **1**
Clock To:
1st Value:
2nd Value:
Value Percent: **5.000**
Continuous Index:
Within 8" of Joint: **YES**
Remarks:

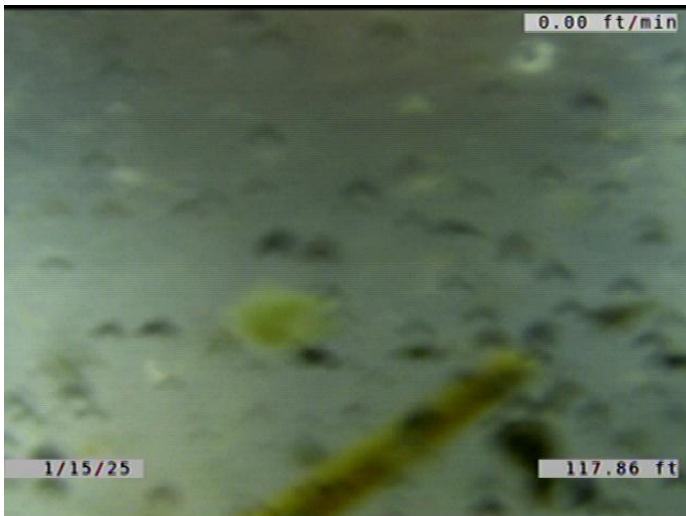
Code: **MCU**
Description: **Miscellaneous Camera Underwater**

Distance (ft): **117.9**
Structural Grade: **0**
O&M Grade: **4**
Clock Start/From:
Clock To:
1st Value:
2nd Value:
Value Percent:
Continuous Index: **S02**
Within 8" of Joint: **NO**
Remarks:

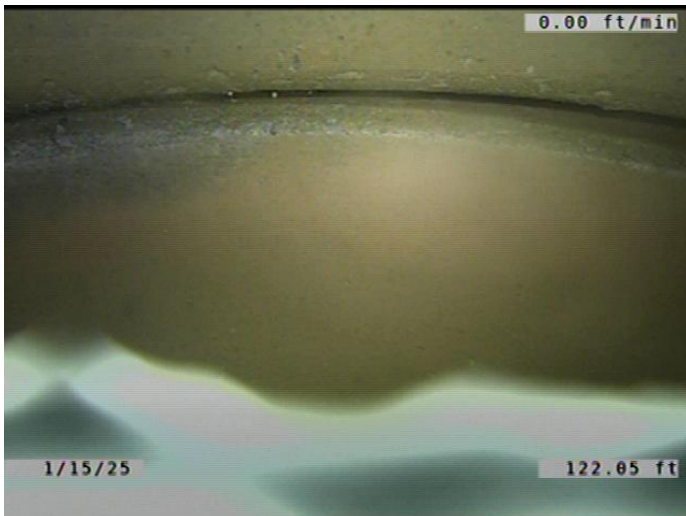
Code: **MCU**
Description: **Miscellaneous Camera Underwater**

Distance (ft): **122.0**
Structural Grade: **0**
O&M Grade: **4**
Clock Start/From:
Clock To:
1st Value:
2nd Value:
Value Percent:
Continuous Index: **F02**
Within 8" of Joint: **NO**
Remarks:

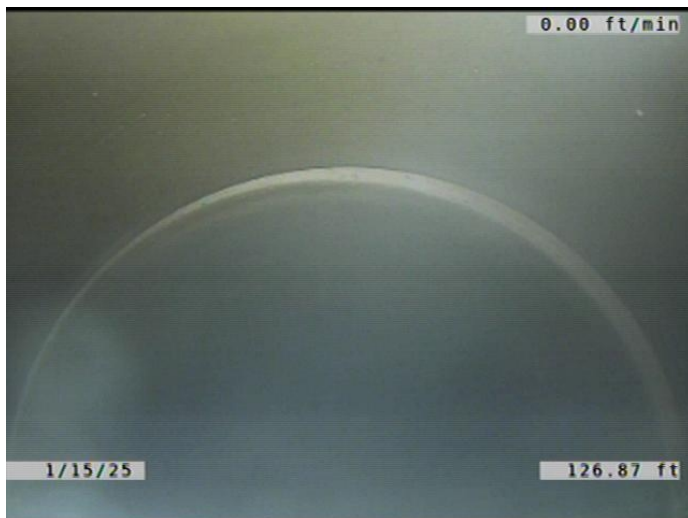
Code: **MWL**
Description: **Miscellaneous Water Level**

Distance (ft): **126.9**
Structural Grade: **0**
O&M Grade: **0**
Clock Start/From:
Clock To:
1st Value:
2nd Value:
Value Percent: **30.000**
Continuous Index:
Within 8" of Joint: **NO**
Remarks:

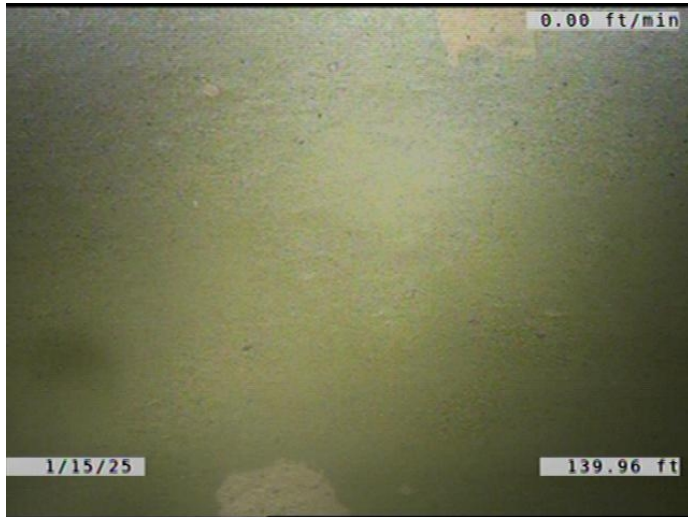
Code: **SSC**
Description: **Surface Spalling of Damage Coating**

Distance (ft): **140.0**
Structural Grade: **1**
O&M Grade: **0**
Clock Start/From: **11**
Clock To: **1**
1st Value:
2nd Value:
Value Percent:
Continuous Index:
Within 8" of Joint: **YES**
Remarks:

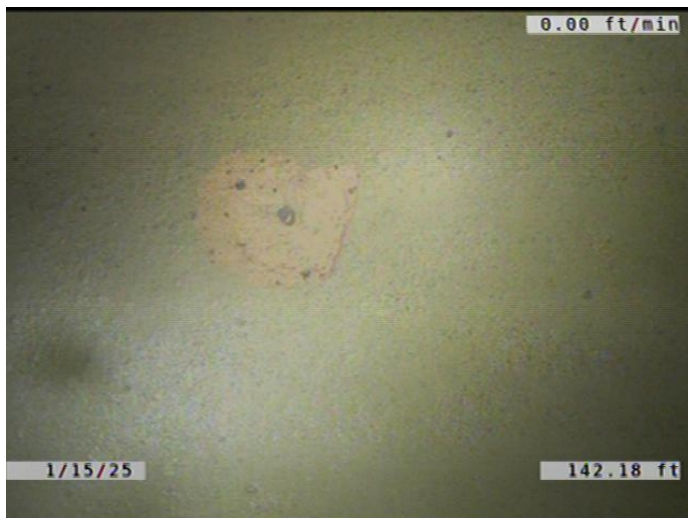
Code: **SSC**
Description: **Surface Spalling of Damage Coating**

Distance (ft): **142.2**
Structural Grade: **1**
O&M Grade: **0**
Clock Start/From: **1**
Clock To:
1st Value:
2nd Value:
Value Percent:
Continuous Index:
Within 8" of Joint: **NO**
Remarks:

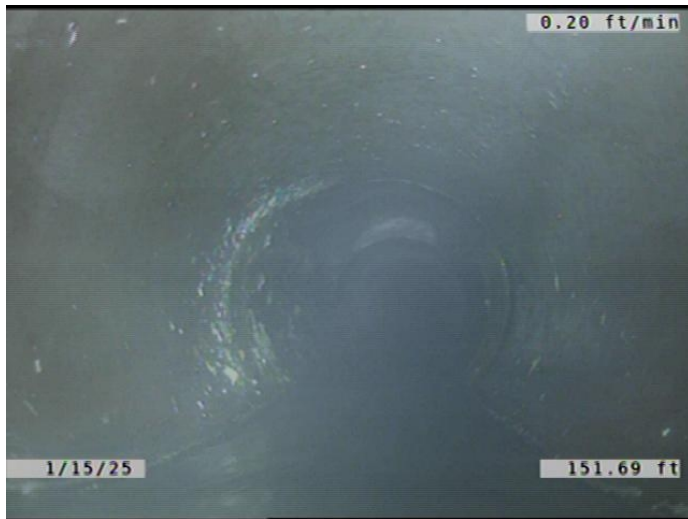
Code: **MWL**
Description: **Miscellaneous Water Level**

Distance (ft): **151.7**
Structural Grade: **0**
O&M Grade: **0**
Clock Start/From:
Clock To:
1st Value:
2nd Value:
Value Percent: **10.000**
Continuous Index:
Within 8" of Joint: **NO**
Remarks:
