Profile/Photo Observation Report

Date:	03/29/2018	Weather:		Coding:	PACP 6.0
Pipe Length (ft):	130.9	Owner:	NA	Pre Clean:	Not Known
P.O.#:		Surveyor:	Jen Costello	PSR:	P-803-003-002
Customer:		Clean Date:	01/01/1900	Shape:	C

Street:	HIGH ST	Flow Control:	Not Controlled
City:	Hobart, IN	Year Renewed:	
Location:	Other	Tape/Media #:	
Purpose:	Not Known	Dia/Height:	10"
Use:	Sanitary	Material:	VCP
Drain Area:	NA	Lining:	
Category:	NA		
Comment:

Location Details:		Direction of Survey:	Upstream
US MH:	M-803-003	DS MH:	M-803-002
		Total Length Surveyed (ft):	28.9

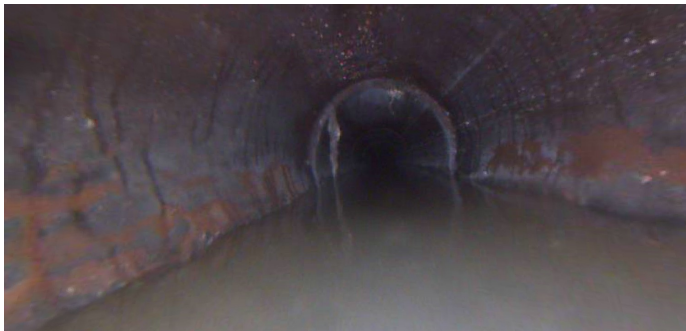
Code: **AMH**
Description: **Manhole**

Distance (ft): **.0**
Structural Grade: **0**
O&M Grade: **0**
Clock Start/From:
Clock To:
1st Value:
2nd Value:
Value Percent:
Continuous Index:
Within 8" of Joint: **NO**
Remarks: **M-803-002**

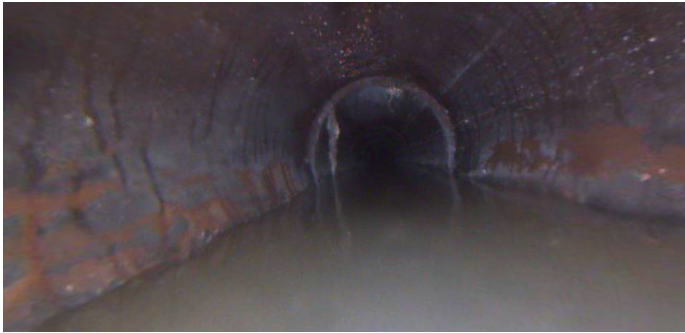
Code:	MWL
Description:	Water Level

Distance (ft):	.0
Structural Grade:	0
O&M Grade:	0
Clock Start/From:	
Clock To:	
1st Value:	
2nd Value:	
Value Percent:	30.000
Continuous Index:	
Within 8" of Joint:	NO
Remarks:

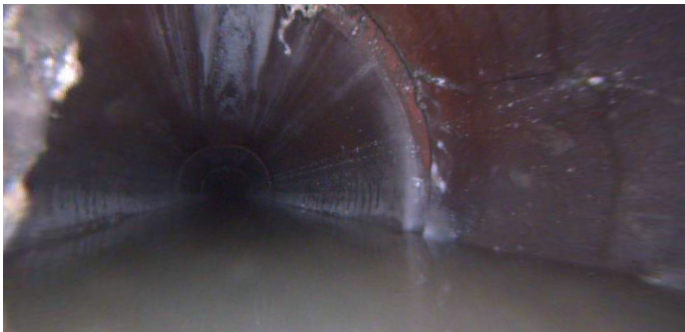
Code:	FL
Description:	Fracture Longitudinal

Distance (ft):	2.0
Structural Grade:	3
O&M Grade:	0
Clock Start/From:	3
Clock To:	
1st Value:	
2nd Value:	
Value Percent:	
Continuous Index:	
Within 8" of Joint:	YES
Remarks:

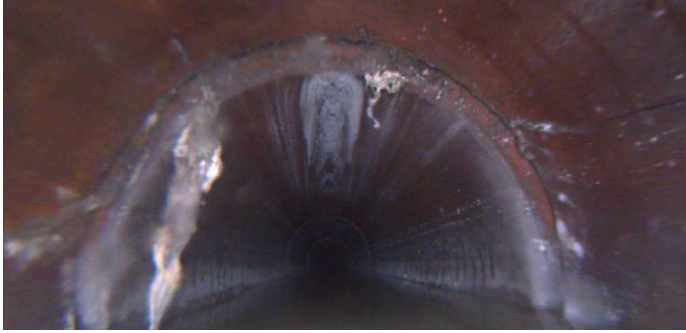
Code: **DAR**
Description: **Deposits Attached Ragging**

Distance (ft): **2.0**
Structural Grade: **0**
O&M Grade: **2**
Clock Start/From: **11**
Clock To:
1st Value:
2nd Value:
Value Percent: **5.000**
Continuous Index:
Within 8" of Joint: **YES**
Remarks:

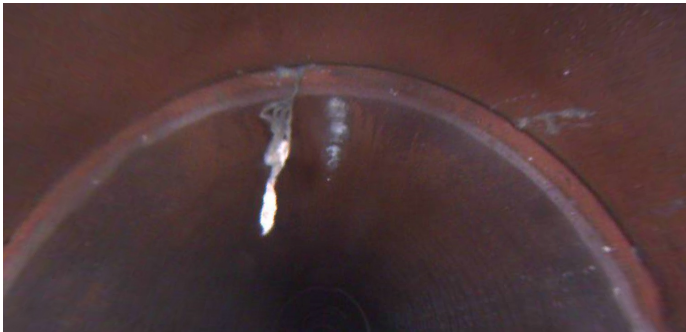
Code: **RFJ**
Description: **Roots Fine Joint**

Distance (ft): **13.9**
Structural Grade: **0**
O&M Grade: **1**
Clock Start/From: **12**
Clock To:
1st Value:
2nd Value:
Value Percent:
Continuous Index:
Within 8" of Joint: **YES**
Remarks:

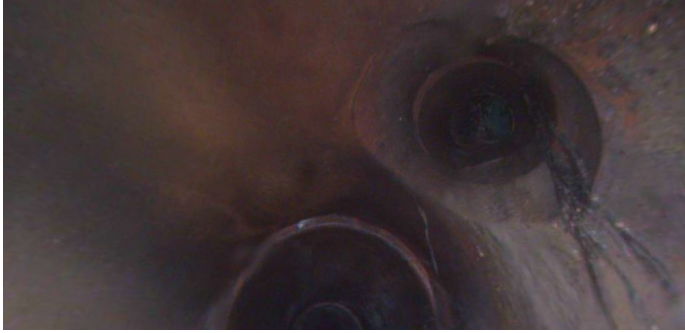
Code: **TFD**
Description: **Tap Factory Defective**

Distance (ft): **18.9**
Structural Grade: **0**
O&M Grade: **2**
Clock Start/From: **2**
Clock To:
1st Value: **4.000**
2nd Value:
Value Percent:
Continuous Index:
Within 8" of Joint:
Remarks: **ROOTS**

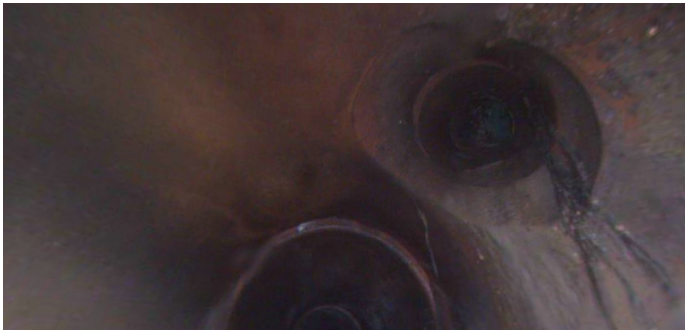
Code: **RFL**
Description: **Roots Fine Lateral**

Distance (ft): **18.9**
Structural Grade: **0**
O&M Grade: **1**
Clock Start/From: **2**
Clock To:
1st Value:
2nd Value:
Value Percent:
Continuous Index:
Within 8" of Joint: **NO**
Remarks:

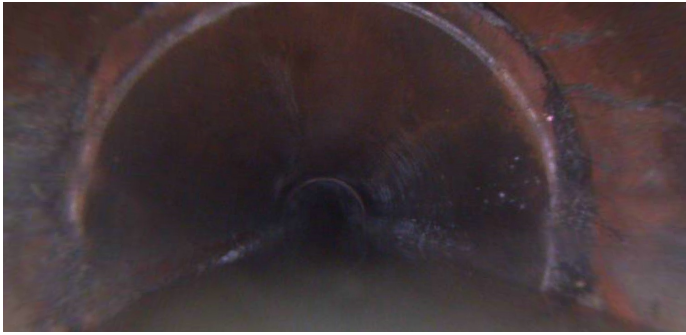
Code: **RFJ**
Description: **Roots Fine Joint**

Distance (ft): **19.9**
Structural Grade: **0**
O&M Grade: **1**
Clock Start/From: **8**
Clock To: **4**
1st Value:
2nd Value:
Value Percent:
Continuous Index:
Within 8" of Joint: **YES**
Remarks:

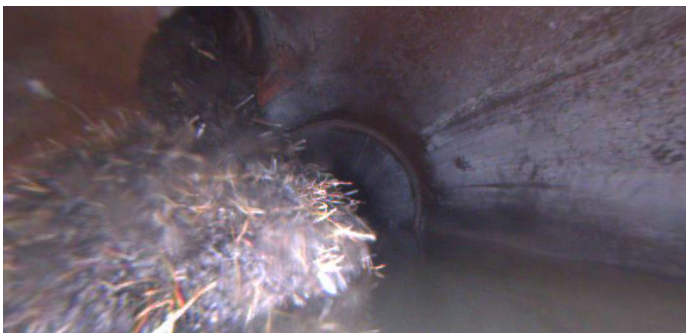
Code: **TFD**
Description: **Tap Factory Defective**

Distance (ft): **27.8**
Structural Grade: **0**
O&M Grade: **2**
Clock Start/From: **10**
Clock To:
1st Value: **4.000**
2nd Value:
Value Percent:
Continuous Index:
Within 8" of Joint:
Remarks: **ROOTS**

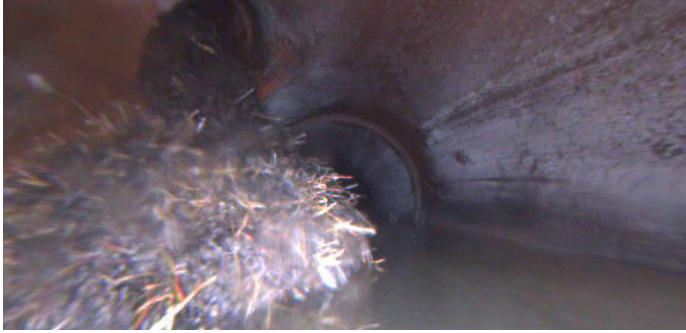
Code: **RML**
Description: **Roots Medium Lateral**

Distance (ft): **27.8**
Structural Grade: **0**
O&M Grade: **3**
Clock Start/From: **6**
Clock To: **10**
1st Value:
2nd Value:
Value Percent: **40.000**
Continuous Index:
Within 8" of Joint: **NO**
Remarks:

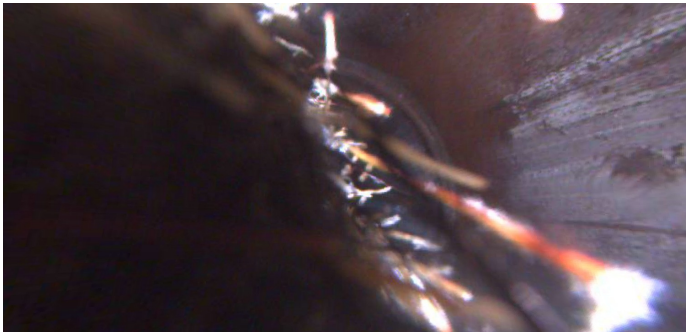
Code: **MSA**
Description: **Abandoned Survey**

Distance (ft): **28.9**
Structural Grade: **0**
O&M Grade: **0**
Clock Start/From:
Clock To:
1st Value:
2nd Value:
Value Percent:
Continuous Index:
Within 8" of Joint: **NO**
Remarks: **ROOTS**
