Profile/Photo Observation Report

Date:	03/29/2018	Weather:		Coding:	PACP 6.0
Pipe Length (ft):	130.9	Owner:	NA	Pre Clean:	Not Known
P.O.#:		Surveyor:	Jen Costello	PSR:	P-803-003-002
Customer:		Clean Date:	01/01/1900	Shape:	C

Street:	HIGH ST	Flow Control:	Not Controlled
City:	Hobart, IN	Year Renewed:	
Location:	Other	Tape/Media #:	
Purpose:	Not Known	Dia/Height:	10"
Use:	Sanitary	Material:	VCP
Drain Area:	NA	Lining:	
Category:	NA		
Comment:

Location Details:		Direction of Survey:	Upstream
US MH:	M-803-003	DS MH:	M-803-002
		Total Length Surveyed (ft):	28.9

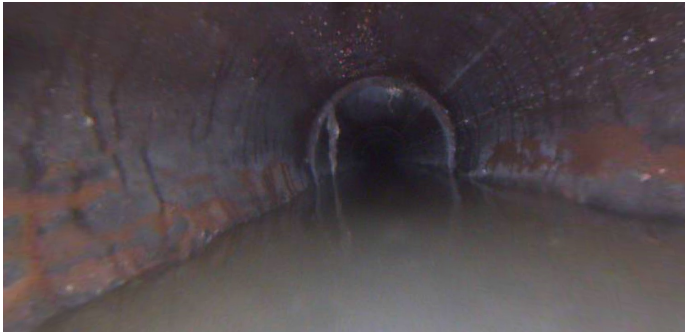
Code:	MWL
Description:	Water Level

Distance (ft):	.0
Structural Grade:	0
O&M Grade:	0
Clock Start/From:	
Clock To:	
1st Value:	
2nd Value:	
Value Percent:	30.000
Continuous Index:	
Within 8" of Joint:	NO
Remarks:

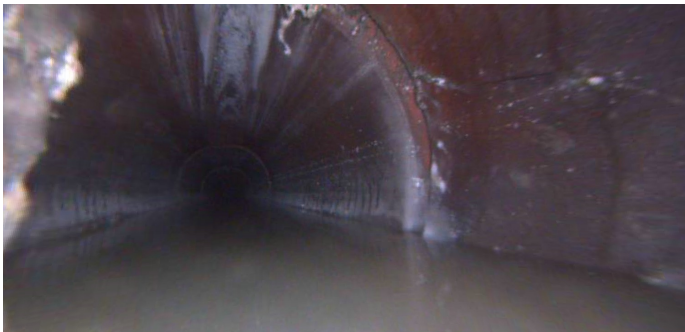
Code:	FL
Description:	Fracture Longitudinal

Distance (ft):	2.0
Structural Grade:	3
O&M Grade:	0
Clock Start/From:	3
Clock To:	
1st Value:	
2nd Value:	
Value Percent:	
Continuous Index:	
Within 8" of Joint:	YES
Remarks:

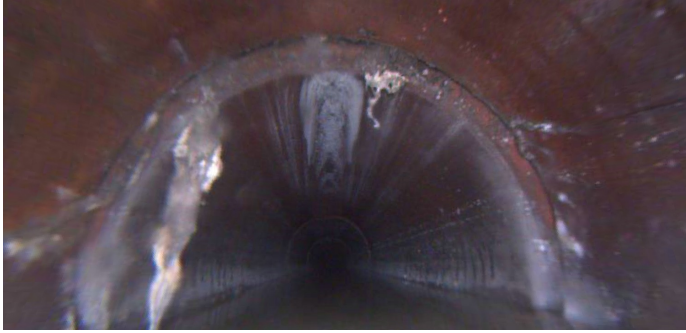
Code: **DAR**
Description: **Deposits Attached Ragging**

Distance (ft): **2.0**
Structural Grade: **0**
O&M Grade: **2**
Clock Start/From: **11**
Clock To:
1st Value:
2nd Value:
Value Percent: **5.000**
Continuous Index:
Within 8" of Joint: **YES**
Remarks:

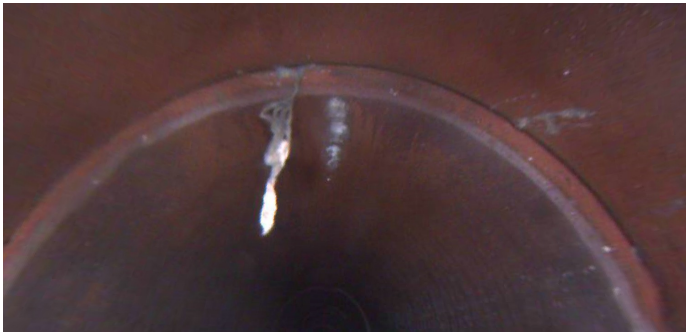
Code: **RFJ**
Description: **Roots Fine Joint**

Distance (ft): **13.9**
Structural Grade: **0**
O&M Grade: **1**
Clock Start/From: **12**
Clock To:
1st Value:
2nd Value:
Value Percent:
Continuous Index:
Within 8" of Joint: **YES**
Remarks:

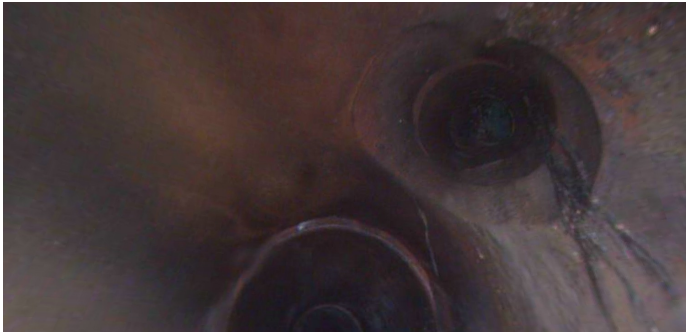
Code: **TFD**
Description: **Tap Factory Defective**

Distance (ft): **18.9**
Structural Grade: **0**
O&M Grade: **2**
Clock Start/From: **2**
Clock To:
1st Value: **4.000**
2nd Value:
Value Percent:
Continuous Index:
Within 8" of Joint:
Remarks: **ROOTS**

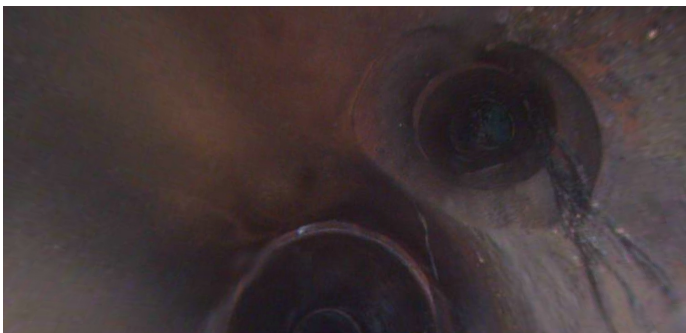
Code: **RFL**
Description: **Roots Fine Lateral**

Distance (ft): **18.9**
Structural Grade: **0**
O&M Grade: **1**
Clock Start/From: **2**
Clock To:
1st Value:
2nd Value:
Value Percent:
Continuous Index:
Within 8" of Joint: **NO**
Remarks:

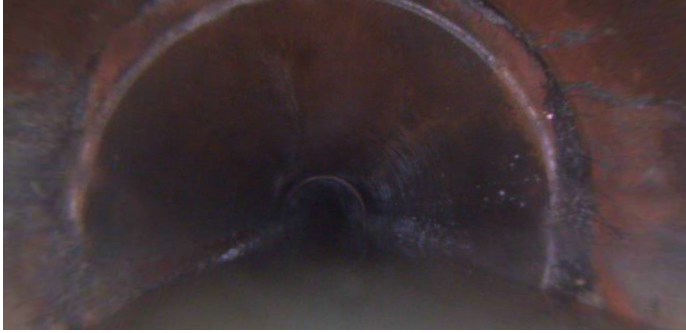
Code: **RFJ**
Description: **Roots Fine Joint**

Distance (ft): **19.9**
Structural Grade: **0**
O&M Grade: **1**
Clock Start/From: **8**
Clock To: **4**
1st Value:
2nd Value:
Value Percent:
Continuous Index:
Within 8" of Joint: **YES**
Remarks:

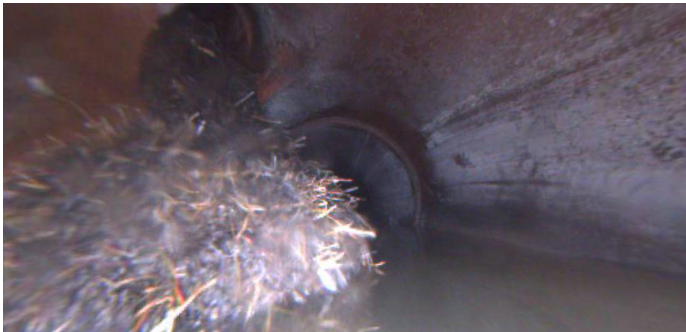
Code: **TFD**
Description: **Tap Factory Defective**

Distance (ft): **27.8**
Structural Grade: **0**
O&M Grade: **2**
Clock Start/From: **10**
Clock To:
1st Value: **4.000**
2nd Value:
Value Percent:
Continuous Index:
Within 8" of Joint:
Remarks: **ROOTS**

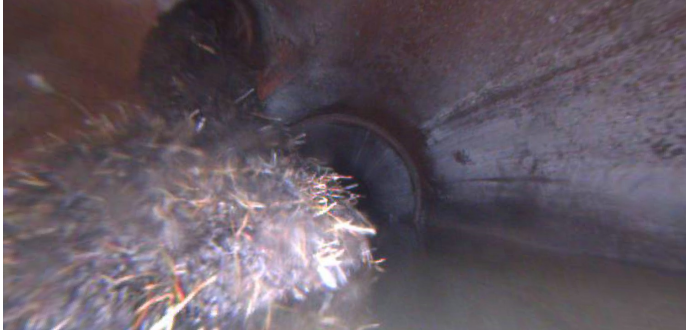
Code: **RML**
Description: **Roots Medium Lateral**

Distance (ft): **27.8**
Structural Grade: **0**
O&M Grade: **3**
Clock Start/From: **6**
Clock To: **10**
1st Value:
2nd Value:
Value Percent: **40.000**
Continuous Index:
Within 8" of Joint: **NO**
Remarks:

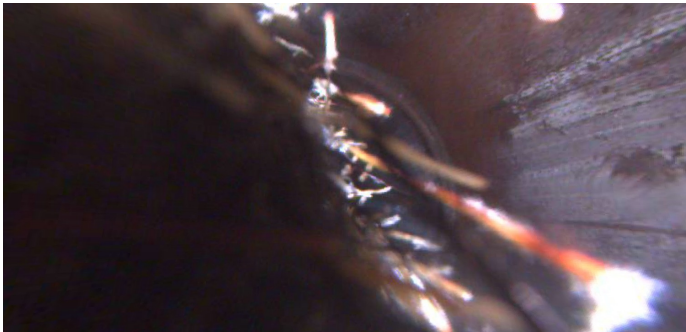
Code: **MSA**
Description: **Abandoned Survey**

Distance (ft): **28.9**
Structural Grade: **0**
O&M Grade: **0**
Clock Start/From:
Clock To:
1st Value:
2nd Value:
Value Percent:
Continuous Index:
Within 8" of Joint: **NO**
Remarks: **ROOTS**
