Profile/Photo Observation Report

Street:	HIGH ST	Flow Control:	Not Controlled
City:	Hobart, IN	Year Renewed:	
Location:	Other	Tape/Media #:	
Purpose:	Not Known	Dia/Height:	10"
Use:	Sanitary	Material:	VCP
Drain Area:	NA	Lining:	
Category:	NA		
Comment:

Location Details:		Direction of Survey:	Downstream
US MH:	M-803-003	DS MH:	M-803-002
		Total Length Surveyed (ft):	94.8

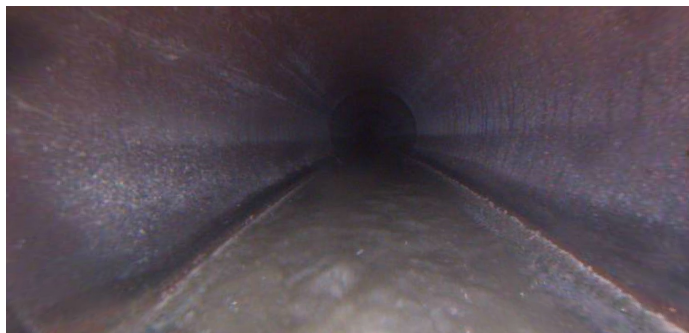
Code: **AMH**
Description: **Manhole**

Distance (ft): **.0**
Structural Grade: **0**
O&M Grade: **0**
Clock Start/From:
Clock To:
1st Value:
2nd Value:
Value Percent:
Continuous Index:
Within 8" of Joint: **NO**
Remarks: **M-803-003**

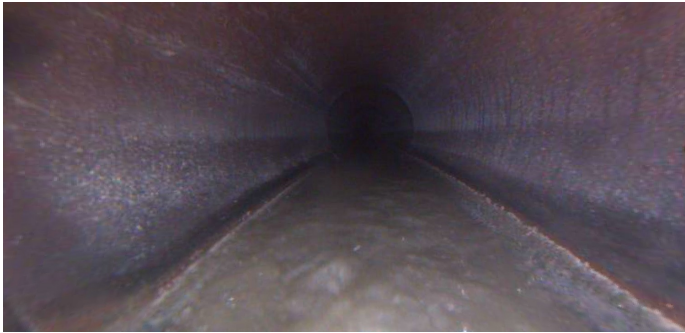
Code:	MWL
Description:	Water Level

Distance (ft):	.0
Structural Grade:	0
O&M Grade:	0
Clock Start/From:	
Clock To:	
1st Value:	
2nd Value:	
Value Percent:	20.000
Continuous Index:	
Within 8" of Joint:	NO
Remarks:

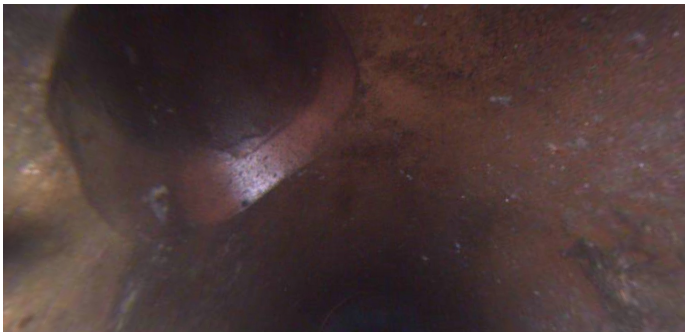
Code:	TF
Description:	Tap Factory

Distance (ft):	31.1
Structural Grade:	0
O&M Grade:	0
Clock Start/From:	11
Clock To:	
1st Value:	4.000
2nd Value:	
Value Percent:	
Continuous Index:	
Within 8" of Joint:	
Remarks:

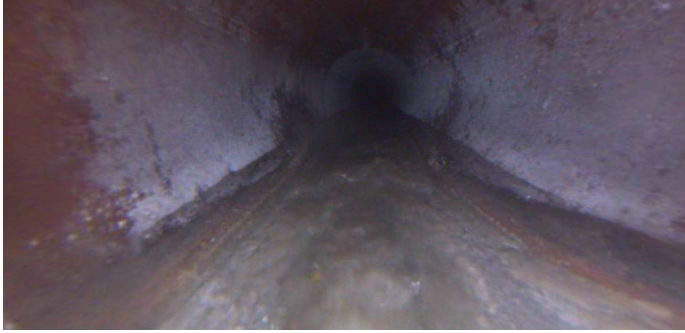
Code: **MWL**
Description: **Water Level**

Distance (ft): **48.4**
Structural Grade: **0**
O&M Grade: **0**
Clock Start/From:
Clock To:
1st Value:
2nd Value:
Value Percent: **10.000**
Continuous Index:
Within 8" of Joint: **NO**
Remarks:

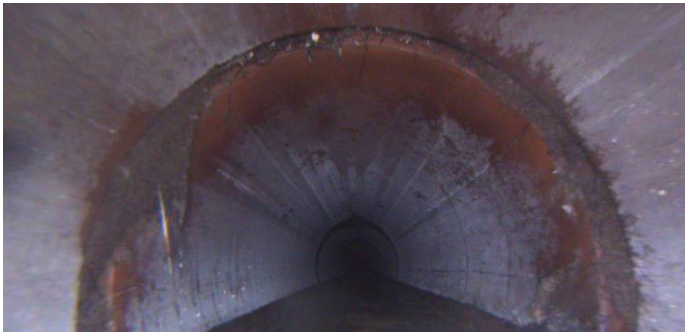
Code: **RFJ**
Description: **Roots Fine Joint**

Distance (ft): **63.0**
Structural Grade: **0**
O&M Grade: **1**
Clock Start/From: **8**
Clock To: **4**
1st Value:
2nd Value:
Value Percent:
Continuous Index:
Within 8" of Joint: **YES**
Remarks:

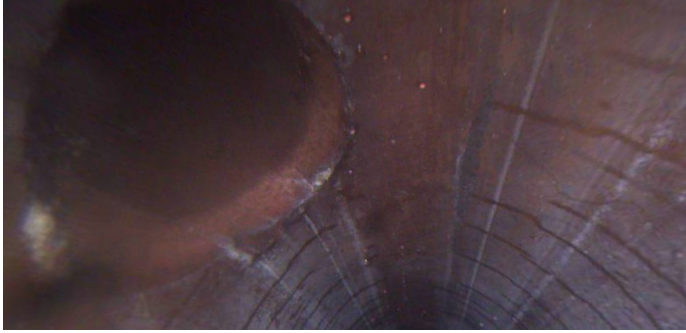
Code: **TF**
Description: **Tap Factory**

Distance (ft): **73.2**
Structural Grade: **0**
O&M Grade: **0**
Clock Start/From: **11**
Clock To:
1st Value: **4.000**
2nd Value:
Value Percent:
Continuous Index:
Within 8" of Joint:
Remarks:

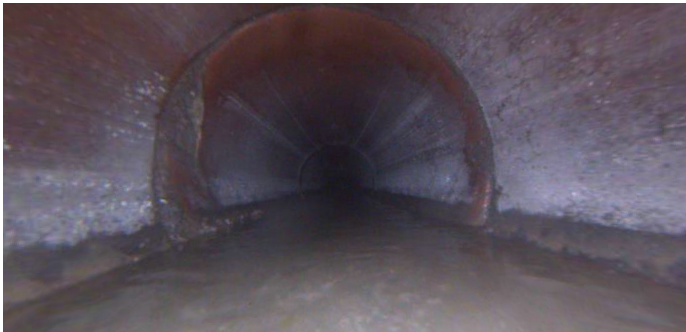
Code: **RFJ**
Description: **Roots Fine Joint**

Distance (ft): **80.7**
Structural Grade: **0**
O&M Grade: **1**
Clock Start/From: **8**
Clock To: **4**
1st Value:
2nd Value:
Value Percent:
Continuous Index:
Within 8" of Joint: **YES**
Remarks:

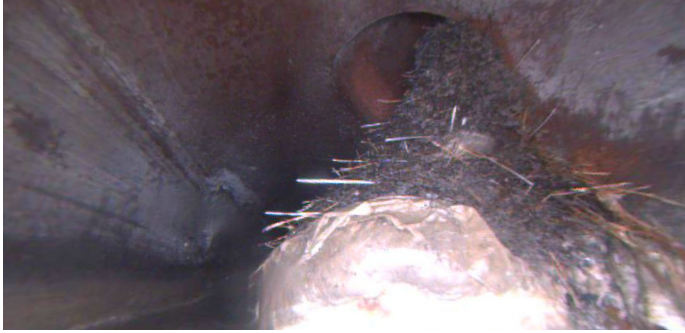
Code: **TFD**
Description: **Tap Factory Defective**

Distance (ft): **93.7**
Structural Grade: **0**
O&M Grade: **2**
Clock Start/From: **2**
Clock To:
1st Value: **4.000**
2nd Value:
Value Percent:
Continuous Index:
Within 8" of Joint:
Remarks: **ROOTS**

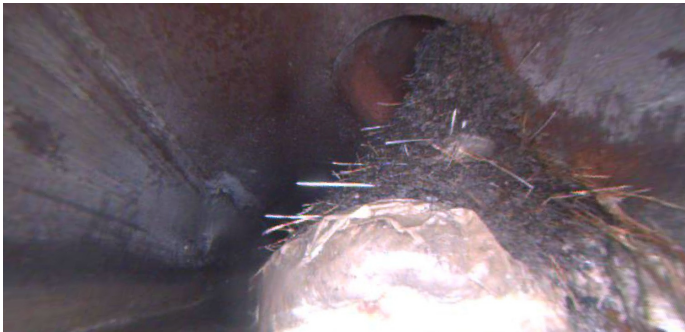
Code: **RML**
Description: **Roots Medium Lateral**

Distance (ft): **93.7**
Structural Grade: **0**
O&M Grade: **3**
Clock Start/From: **12**
Clock To: **6**
1st Value:
2nd Value:
Value Percent: **40.000**
Continuous Index:
Within 8" of Joint: **NO**
Remarks:

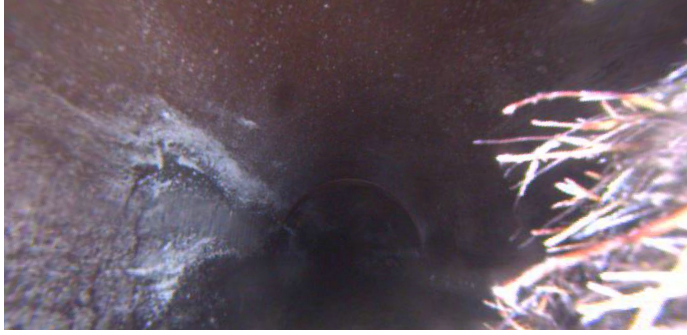
Code:	MSA
Description:	Abandoned Survey
Distance (ft):	94.8
Structural Grade:	0
O&M Grade:	0
Clock Start/From:	
Clock To:	
1st Value:	
2nd Value:	
Value Percent:	
Continuous Index:	
Within 8" of Joint:	NO
Remarks:	ROOTS
