Profile/Photo Observation Report

Street:	HIGH ST	Flow Control:	Not Controlled
City:	Hobart, IN	Year Renewed:	
Location:	Other	Tape/Media #:	
Purpose:	Not Known	Dia/Height:	10"
Use:	Sanitary	Material:	VCP
Drain Area:	NA	Lining:	
Category:	NA		
Comment:

Location Details:		Direction of Survey:	Downstream
US MH:	M-803-003	DS MH:	M-803-002
		Total Length Surveyed (ft):	94.8

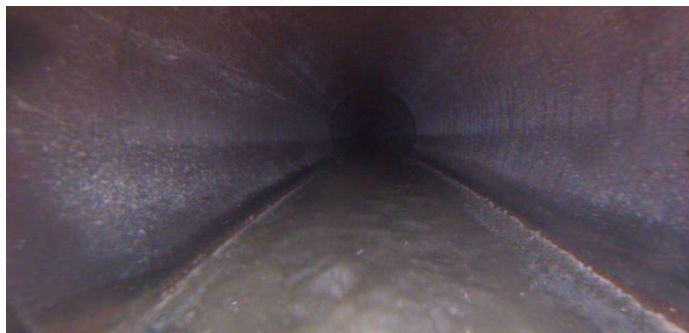
Code: **AMH**
 Description: **Manhole**
 Distance (ft): **.0**
 Structural Grade: **0**
 O&M Grade: **0**
 Clock Start/From:
 Clock To:
 1st Value:
 2nd Value:
 Value Percent:
 Continuous Index:
 Within 8" of Joint: **NO**
 Remarks: **M-803-003**

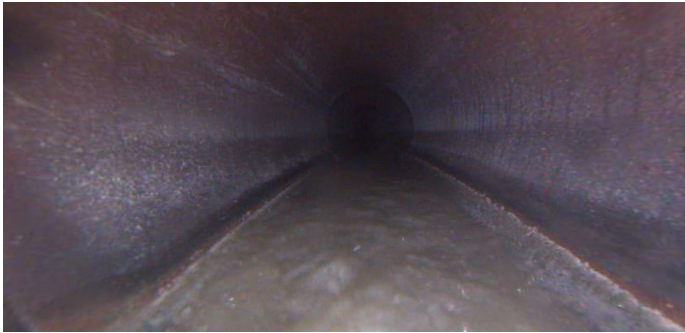
Code:	MWL
Description:	Water Level

Distance (ft):	.0
Structural Grade:	0
O&M Grade:	0
Clock Start/From:	
Clock To:	
1st Value:	
2nd Value:	
Value Percent:	20.000
Continuous Index:	
Within 8" of Joint:	NO
Remarks:

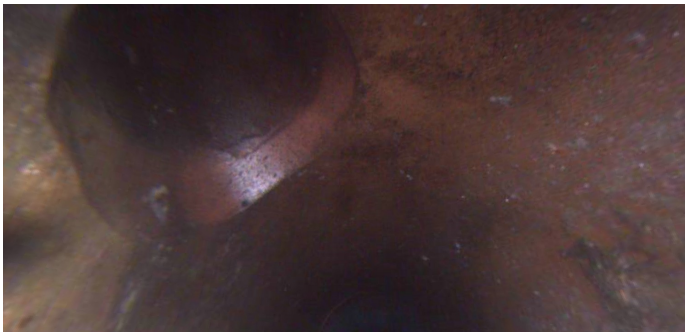
Code:	TF
Description:	Tap Factory

Distance (ft):	31.1
Structural Grade:	0
O&M Grade:	0
Clock Start/From:	11
Clock To:	
1st Value:	4.000
2nd Value:	
Value Percent:	
Continuous Index:	
Within 8" of Joint:	
Remarks:

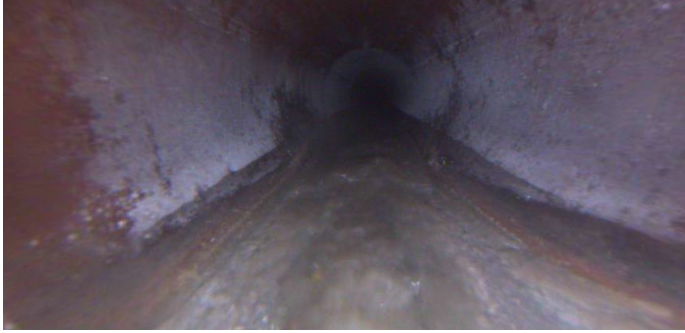
Code: **MWL**
Description: **Water Level**

Distance (ft): **48.4**
Structural Grade: **0**
O&M Grade: **0**
Clock Start/From:
Clock To:
1st Value:
2nd Value:
Value Percent: **10.000**
Continuous Index:
Within 8" of Joint: **NO**
Remarks:

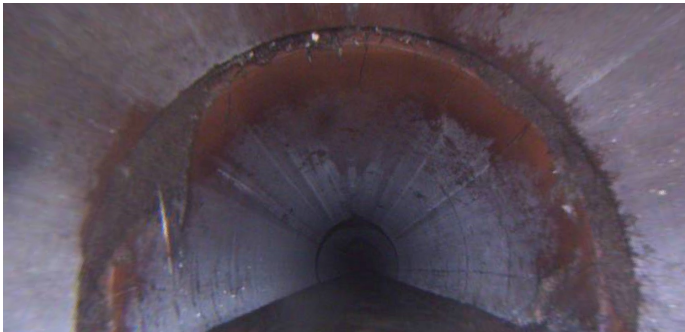
Code: **RFJ**
Description: **Roots Fine Joint**

Distance (ft): **63.0**
Structural Grade: **0**
O&M Grade: **1**
Clock Start/From: **8**
Clock To: **4**
1st Value:
2nd Value:
Value Percent:
Continuous Index:
Within 8" of Joint: **YES**
Remarks:

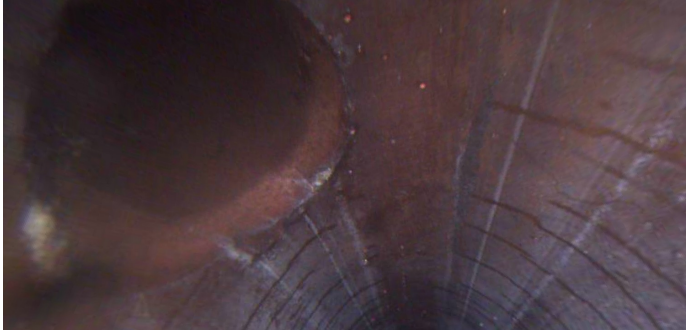
Code: **TF**
Description: **Tap Factory**

Distance (ft): **73.2**
Structural Grade: **0**
O&M Grade: **0**
Clock Start/From: **11**
Clock To:
1st Value: **4.000**
2nd Value:
Value Percent:
Continuous Index:
Within 8" of Joint:
Remarks:

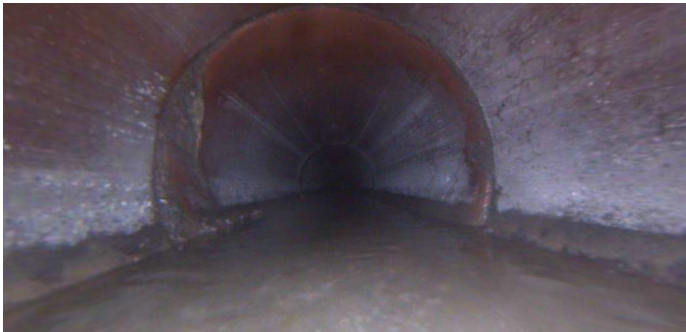
Code: **RFJ**
Description: **Roots Fine Joint**

Distance (ft): **80.7**
Structural Grade: **0**
O&M Grade: **1**
Clock Start/From: **8**
Clock To: **4**
1st Value:
2nd Value:
Value Percent:
Continuous Index:
Within 8" of Joint: **YES**
Remarks:

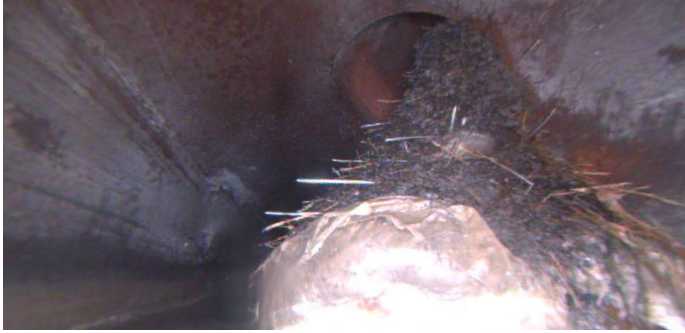
Code: **TFD**
Description: **Tap Factory Defective**

Distance (ft): **93.7**
Structural Grade: **0**
O&M Grade: **2**
Clock Start/From: **2**
Clock To:
1st Value: **4.000**
2nd Value:
Value Percent:
Continuous Index:
Within 8" of Joint:
Remarks: **ROOTS**

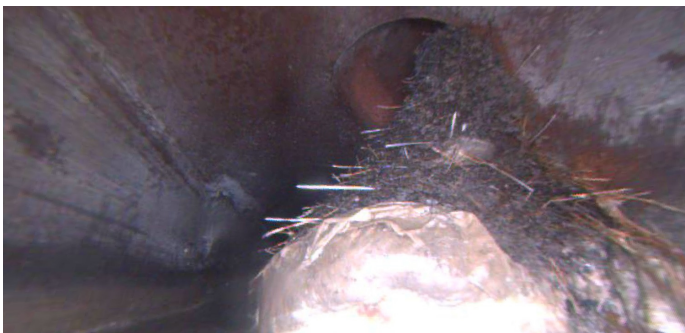
Code: **RML**
Description: **Roots Medium Lateral**

Distance (ft): **93.7**
Structural Grade: **0**
O&M Grade: **3**
Clock Start/From: **12**
Clock To: **6**
1st Value:
2nd Value:
Value Percent: **40.000**
Continuous Index:
Within 8" of Joint: **NO**
Remarks:

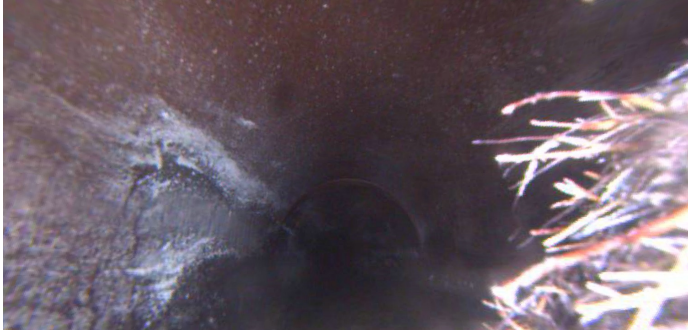
Code:	MSA
Description:	Abandoned Survey
Distance (ft):	94.8
Structural Grade:	0
O&M Grade:	0
Clock Start/From:	
Clock To:	
1st Value:	
2nd Value:	
Value Percent:	
Continuous Index:	
Within 8" of Joint:	NO
Remarks:	ROOTS
