Profile/Photo Observation Report

Date:	10/01/2018	Weather:		Coding:	PACP 6.0
Pipe Length (ft):	165.0	Owner:	NA	Pre Clean:	Not Known
P.O.#:		Surveyor:	Michael Carlino	PSR:	P-803-005-004
Customer:		Clean Date:	01/01/1900	Shape:	C

Street:	ALLEY BETWEEN HIGH ST & E NORT	Flow Control:	Not Controlled
City:	Hobart, IN	Year Renewed:	
Location:	Light Highway	Tape/Media #:	
Purpose:	Routine Assessment	Dia/Height:	12"
Use:	Sanitary	Material:	VCP
Drain Area:	NA	Lining:	
Category:	NA		
Comment:

Location Details:		Direction of Survey:	Downstream
US MH:	M-803-004	DS MH:	M-803-005
		Total Length Surveyed (ft):	34.2

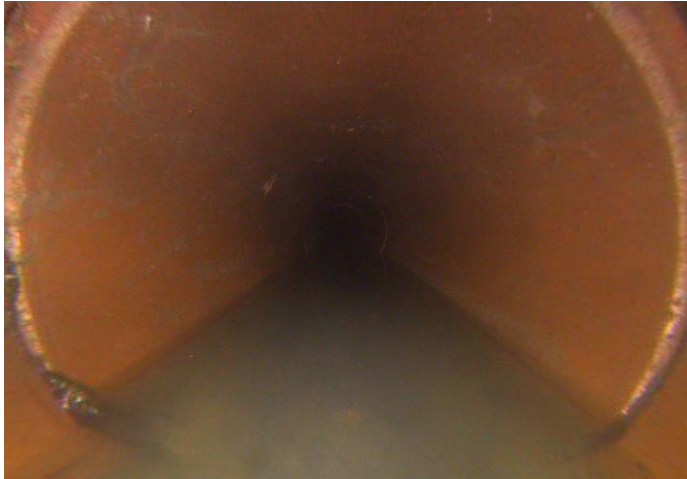
Code: **MWL**
Description: **Water Level**

Distance (ft): **.0**
Structural Grade: **0**
O&M Grade: **0**
Clock Start/From:
Clock To:
1st Value:
2nd Value:
Value Percent: **10.000**
Continuous Index:
Within 8" of Joint: **NO**
Remarks:

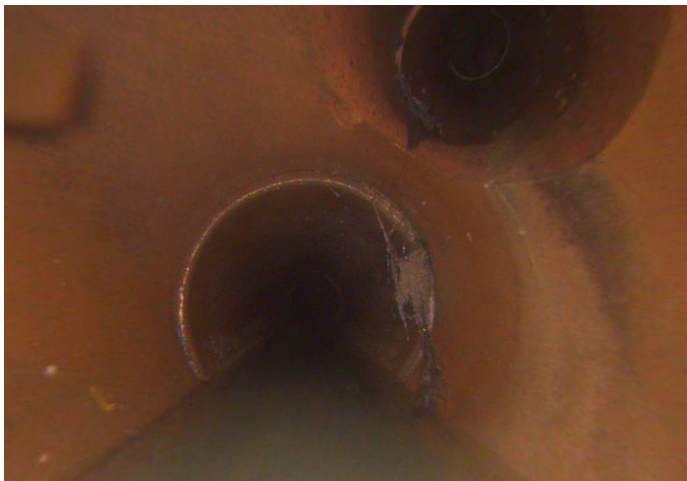
Code: **TF**
Description: **Tap Factory**

Distance (ft): **11.9**
Structural Grade: **0**
O&M Grade: **0**
Clock Start/From: **1**
Clock To:
1st Value: **6.000**
2nd Value:
Value Percent:
Continuous Index:
Within 8" of Joint:
Remarks:

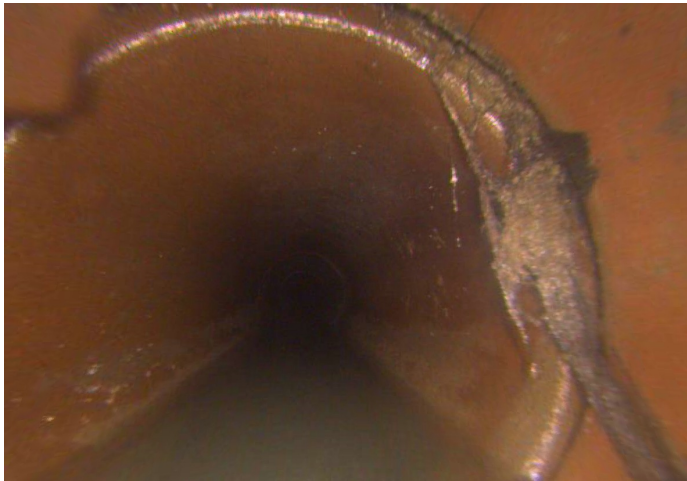
Code: **RFJ**
Description: **Roots Fine Joint**

Distance (ft): **12.7**
Structural Grade: **0**
O&M Grade: **1**
Clock Start/From: **2**
Clock To:
1st Value:
2nd Value:
Value Percent:
Continuous Index:
Within 8" of Joint: **YES**
Remarks:

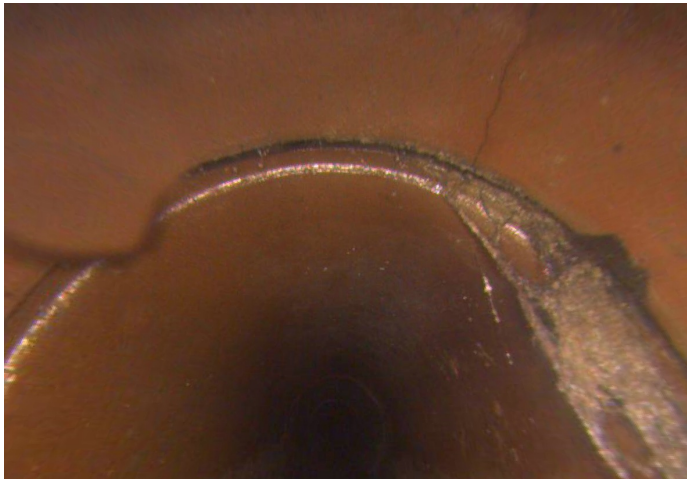
Code: **CL**
Description: **Crack Longitudinal**

Distance (ft): **12.7**
Structural Grade: **2**
O&M Grade: **0**
Clock Start/From: **1**
Clock To:
1st Value:
2nd Value:
Value Percent:
Continuous Index:
Within 8" of Joint: **YES**
Remarks:

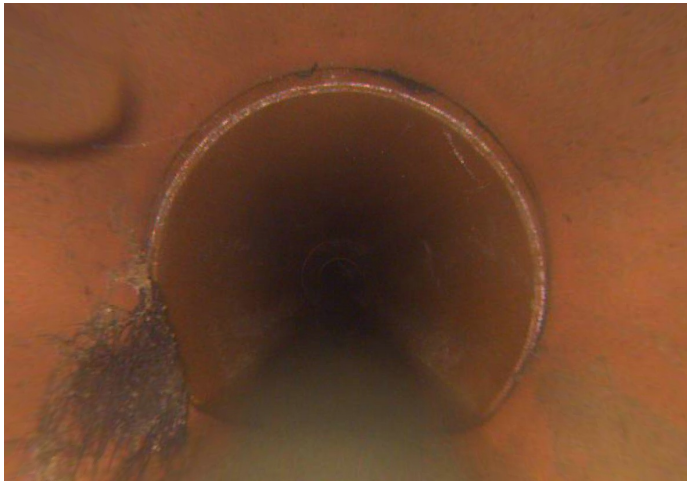
Code: **RFJ**
Description: **Roots Fine Joint**

Distance (ft): **18.2**
Structural Grade: **0**
O&M Grade: **1**
Clock Start/From: **8**
Clock To:
1st Value:
2nd Value:
Value Percent:
Continuous Index:
Within 8" of Joint: **YES**
Remarks:

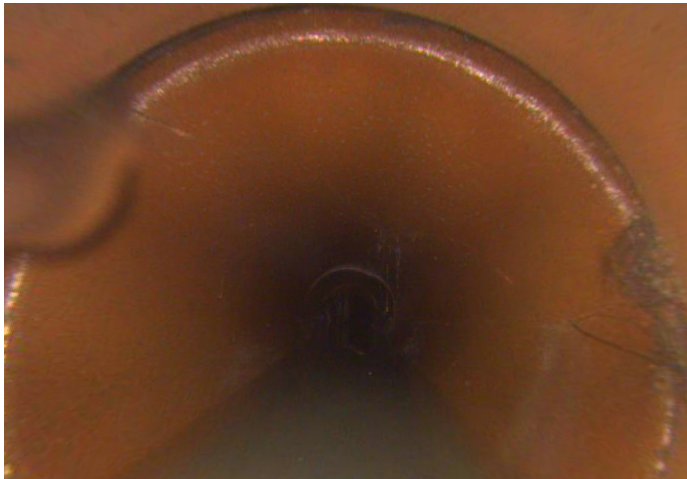
Code: **FM**
Description: **Fracture Multiple**

Distance (ft): **27.2**
Structural Grade: **4**
O&M Grade: **0**
Clock Start/From: **11**
Clock To: **3**
1st Value:
2nd Value:
Value Percent:
Continuous Index:
Within 8" of Joint:
Remarks:

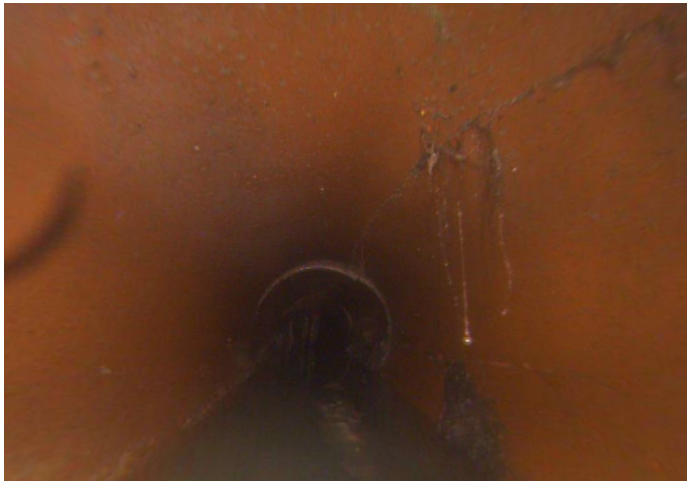
Code: **RFB**
Description: **Roots Fine Barrel**

Distance (ft): **28.3**
Structural Grade: **0**
O&M Grade: **2**
Clock Start/From: **12**
Clock To:
1st Value:
2nd Value:
Value Percent:
Continuous Index:
Within 8" of Joint: **NO**
Remarks:

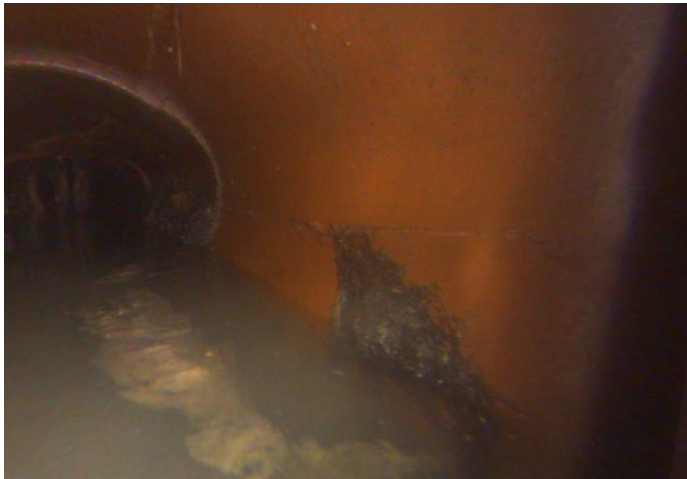
Code: **FL**
Description: **Fracture Longitudinal**

Distance (ft): **28.9**
Structural Grade: **3**
O&M Grade: **0**
Clock Start/From: **3**
Clock To:
1st Value:
2nd Value:
Value Percent:
Continuous Index:
Within 8" of Joint:
Remarks:

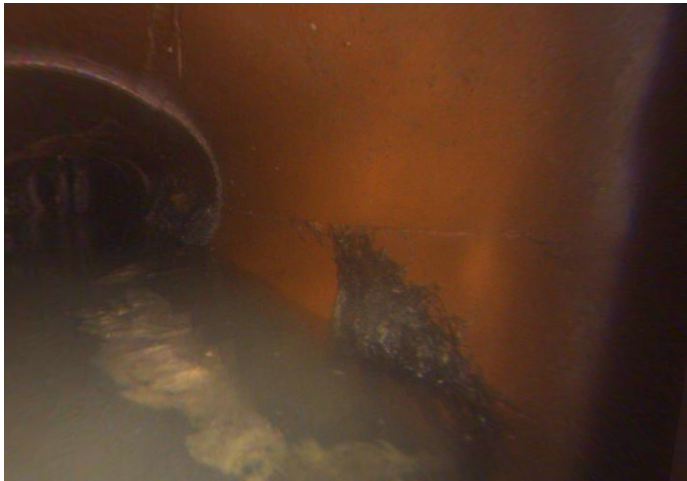
Code: **RFB**
Description: **Roots Fine Barrel**

Distance (ft): **28.9**
Structural Grade: **0**
O&M Grade: **2**
Clock Start/From: **3**
Clock To:
1st Value:
2nd Value:
Value Percent:
Continuous Index:
Within 8" of Joint: **NO**
Remarks:

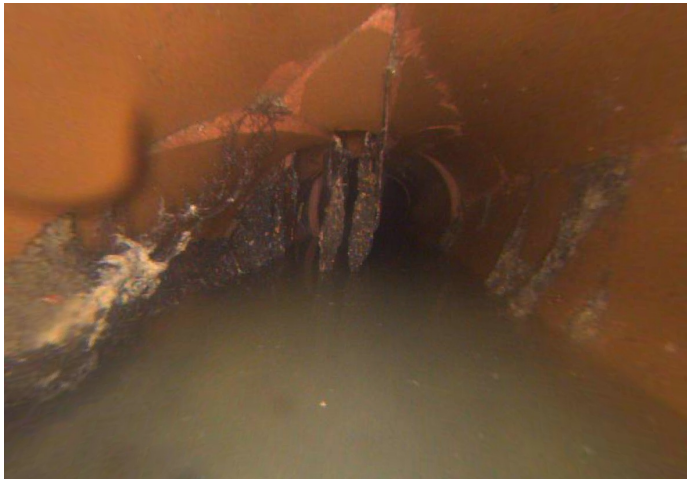
Code: **D**
Description: **Deformed**

Distance (ft): **31.4**
Structural Grade: **5**
O&M Grade: **0**
Clock Start/From:
Clock To:
1st Value:
2nd Value:
Value Percent: **25.000**
Continuous Index:
Within 8" of Joint: **NO**
Remarks:

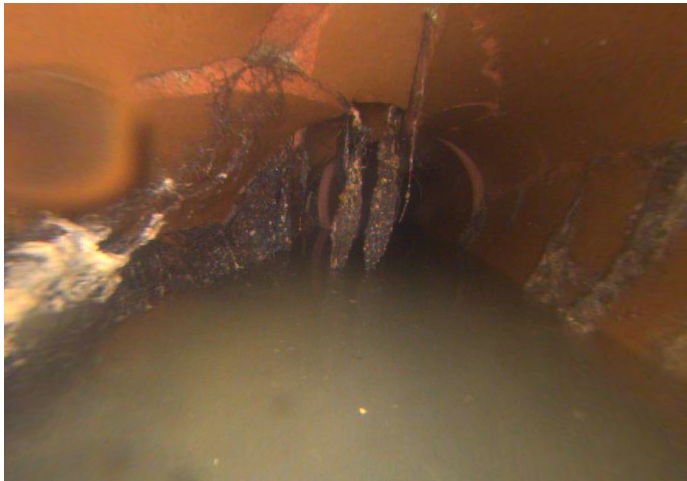
Code: **RMB**
Description: **Roots Medium Barrel**

Distance (ft): **31.5**
Structural Grade: **0**
O&M Grade: **4**
Clock Start/From: **9**
Clock To: **2**
1st Value:
2nd Value:
Value Percent: **10.000**
Continuous Index:
Within 8" of Joint: **NO**
Remarks:

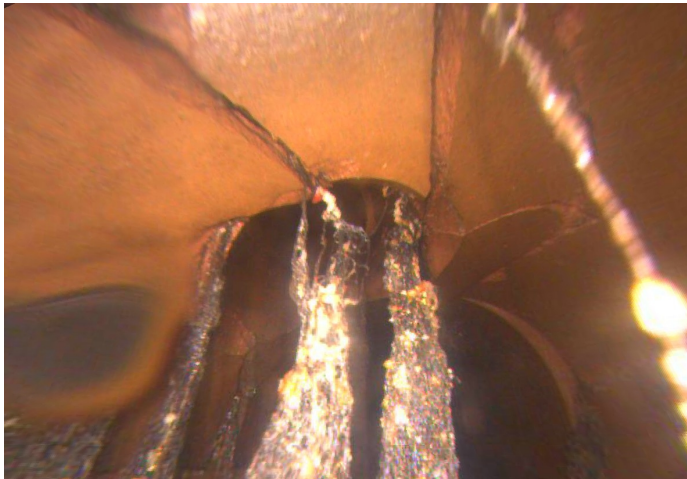
Code: **TFD**
Description: **Tap Factory Defective**

Distance (ft): **32.1**
Structural Grade: **0**
O&M Grade: **2**
Clock Start/From: **11**
Clock To:
1st Value: **6.000**
2nd Value:
Value Percent:
Continuous Index:
Within 8" of Joint:
Remarks: **D**

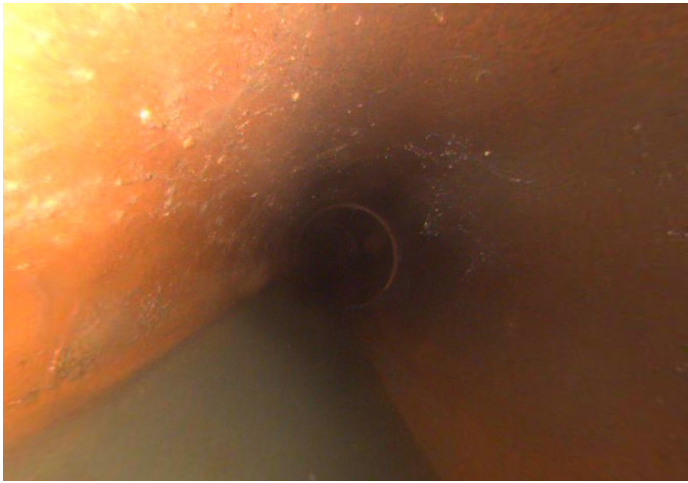
Code:	MSA
Description:	Abandoned Survey
Distance (ft):	34.2
Structural Grade:	0
O&M Grade:	0
Clock Start/From:	
Clock To:	
1st Value:	
2nd Value:	
Value Percent:	
Continuous Index:	
Within 8" of Joint:	NO
Remarks:	D
