## Profile/Photo Observation Report

Street:	<b>41st. Ave.</b>	Flow Control:	<b>Not Controlled</b>
City:	<b>Hobart, IN</b>	Year Renewed:	
Location:	<b>Light Highway</b>	Tape/Media #:	
Purpose:	<b>Routine Assessment</b>	Dia/Height:	<b>12"</b>
Use:	<b>Sanitary</b>	Material:	<b>VCP</b>
Drain Area:	<b>NA</b>	Lining:	
Category:	<b>NA</b>		
Comment:

Location Details:		Direction of Survey:	<b>Downstream</b>
US MH:	<b>M-803-004</b>	DS MH:	<b>M-803-005</b>
		Total Length Surveyed (ft):	<b>34.2</b>

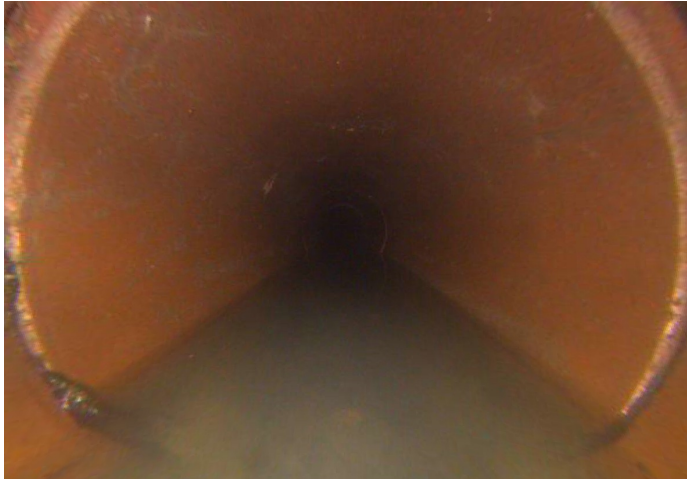
Code: **MWL**  
Description: **Water Level**

Distance (ft): **.0**  
Structural Grade: **0**  
O&M Grade: **0**  
Clock Start/From:  
Clock To:  
1st Value:  
2nd Value:  
Value Percent: **10.000**  
Continuous Index:  
Within 8" of Joint: **NO**  
Remarks:

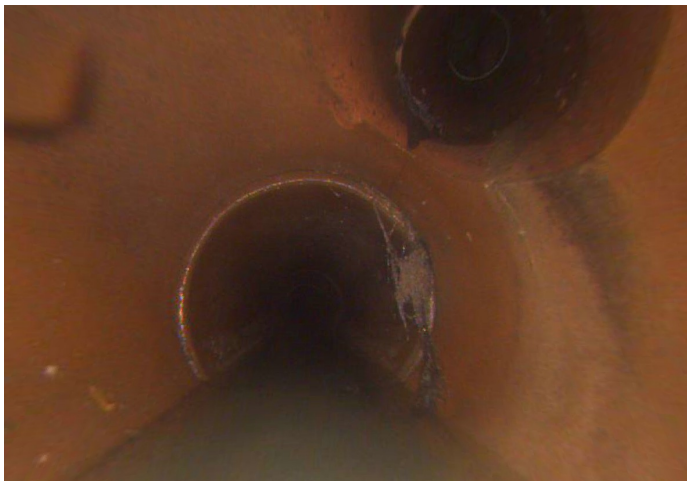
Code: **TF**  
Description: **Tap Factory**

Distance (ft): **11.9**  
Structural Grade: **0**  
O&M Grade: **0**  
Clock Start/From: **1**  
Clock To:  
1st Value: **6.000**  
2nd Value:  
Value Percent:  
Continuous Index:  
Within 8" of Joint:  
Remarks:

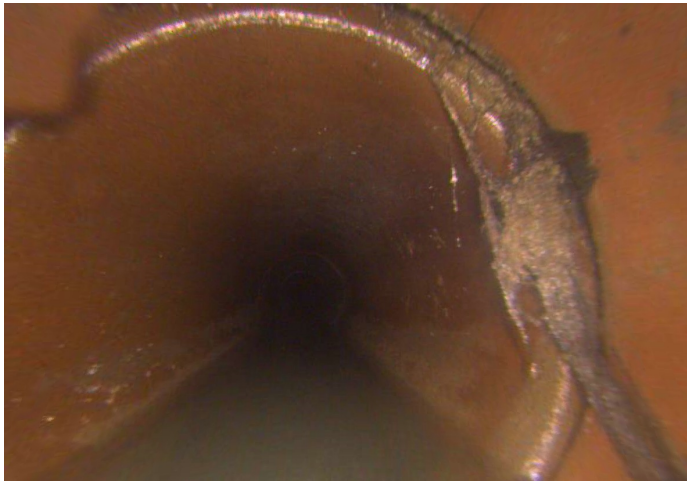
Code: **RFJ**  
Description: **Roots Fine Joint**

Distance (ft): **12.7**  
Structural Grade: **0**  
O&M Grade: **1**  
Clock Start/From: **2**  
Clock To:  
1st Value:  
2nd Value:  
Value Percent:  
Continuous Index:  
Within 8" of Joint: **YES**  
Remarks:

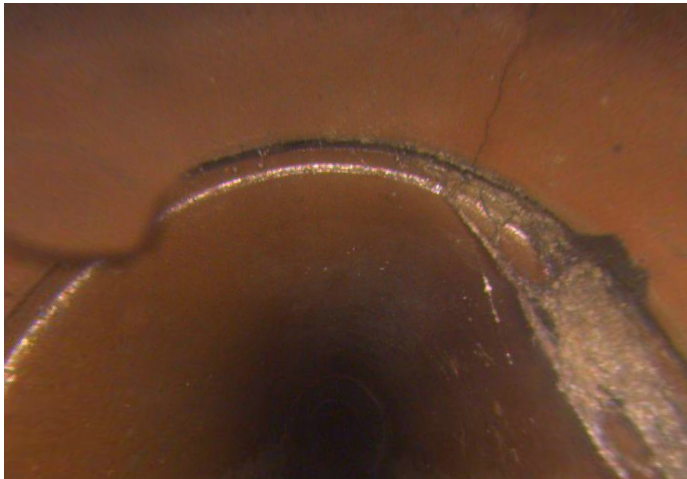
Code: **CL**  
Description: **Crack Longitudinal**

Distance (ft): **12.7**  
Structural Grade: **2**  
O&M Grade: **0**  
Clock Start/From: **1**  
Clock To:  
1st Value:  
2nd Value:  
Value Percent:  
Continuous Index:  
Within 8" of Joint: **YES**  
Remarks:

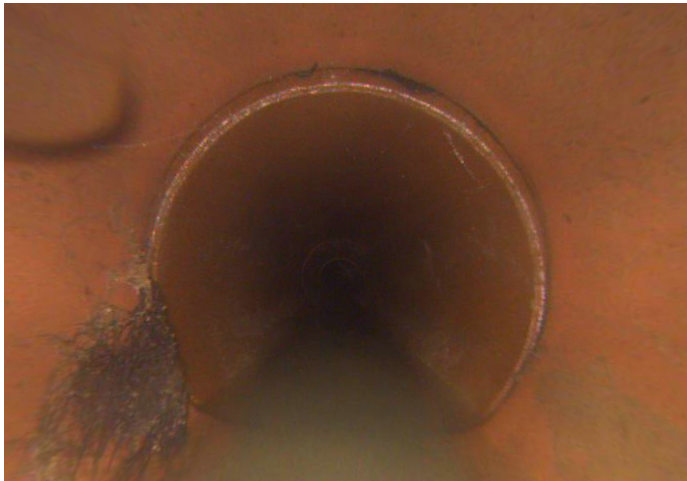
Code: **RFJ**  
Description: **Roots Fine Joint**

Distance (ft): **18.2**  
Structural Grade: **0**  
O&M Grade: **1**  
Clock Start/From: **8**  
Clock To:  
1st Value:  
2nd Value:  
Value Percent:  
Continuous Index:  
Within 8" of Joint: **YES**  
Remarks:

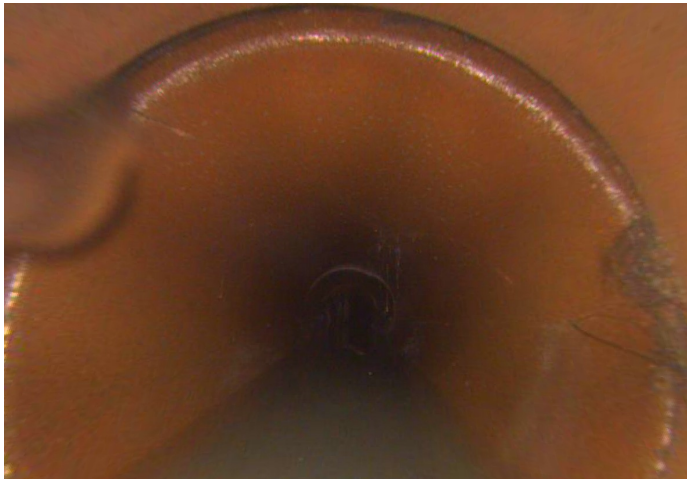
Code: **FM**  
Description: **Fracture Multiple**

Distance (ft): **27.2**  
Structural Grade: **4**  
O&M Grade: **0**  
Clock Start/From: **11**  
Clock To: **3**  
1st Value:  
2nd Value:  
Value Percent:  
Continuous Index:  
Within 8" of Joint:  
Remarks:

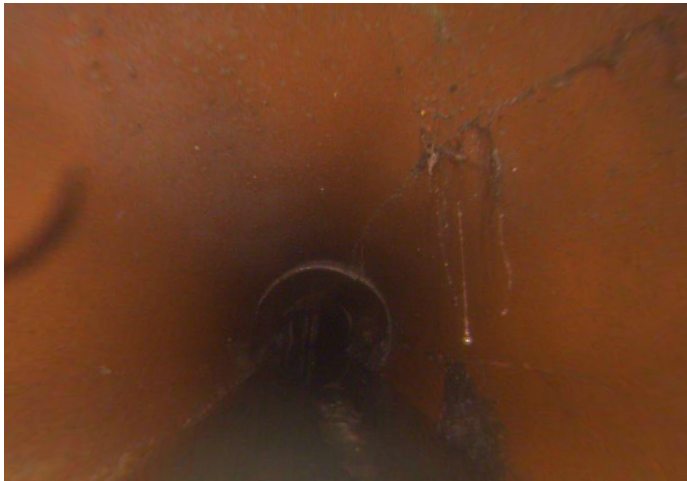
Code: **RFB**  
Description: **Roots Fine Barrel**

Distance (ft): **28.3**  
Structural Grade: **0**  
O&M Grade: **2**  
Clock Start/From: **12**  
Clock To:  
1st Value:  
2nd Value:  
Value Percent:  
Continuous Index:  
Within 8" of Joint: **NO**  
Remarks:

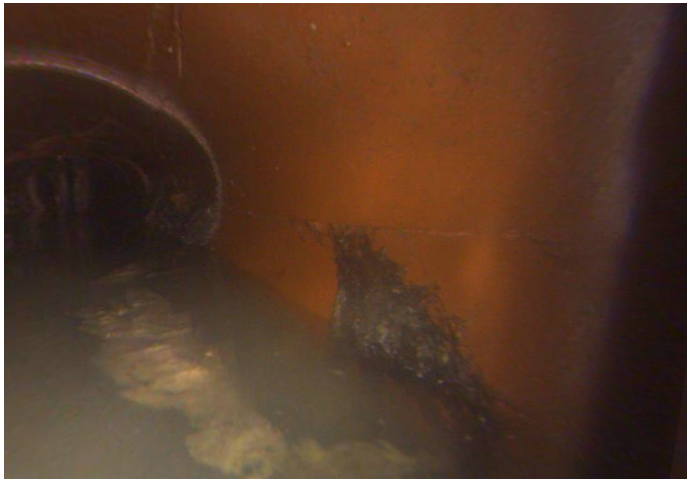
Code: **FL**  
Description: **Fracture Longitudinal**

Distance (ft): **28.9**  
Structural Grade: **3**  
O&M Grade: **0**  
Clock Start/From: **3**  
Clock To:  
1st Value:  
2nd Value:  
Value Percent:  
Continuous Index:  
Within 8" of Joint:  
Remarks:

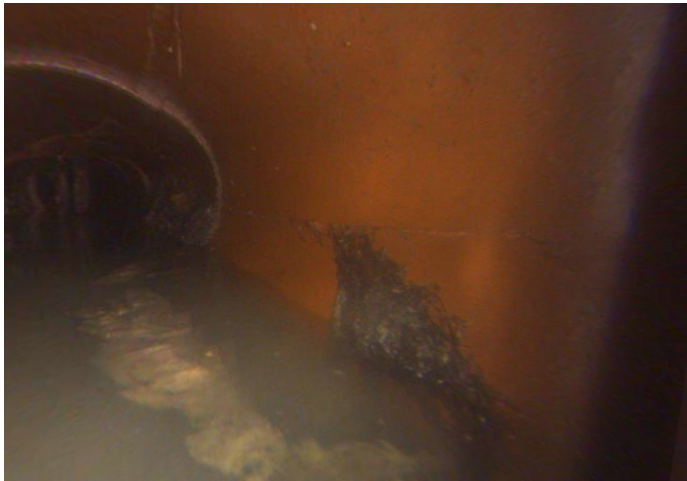
Code: **RFB**  
Description: **Roots Fine Barrel**

Distance (ft): **28.9**  
Structural Grade: **0**  
O&M Grade: **2**  
Clock Start/From: **3**  
Clock To:  
1st Value:  
2nd Value:  
Value Percent:  
Continuous Index:  
Within 8" of Joint: **NO**  
Remarks:

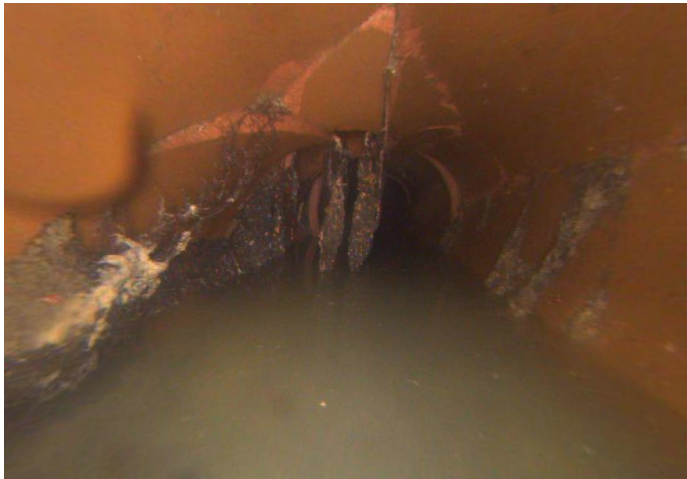
Code: **D**  
Description: **Deformed**

Distance (ft): **31.4**  
Structural Grade: **5**  
O&M Grade: **0**  
Clock Start/From:  
Clock To:  
1st Value:  
2nd Value:  
Value Percent: **25.000**  
Continuous Index:  
Within 8" of Joint: **NO**  
Remarks:

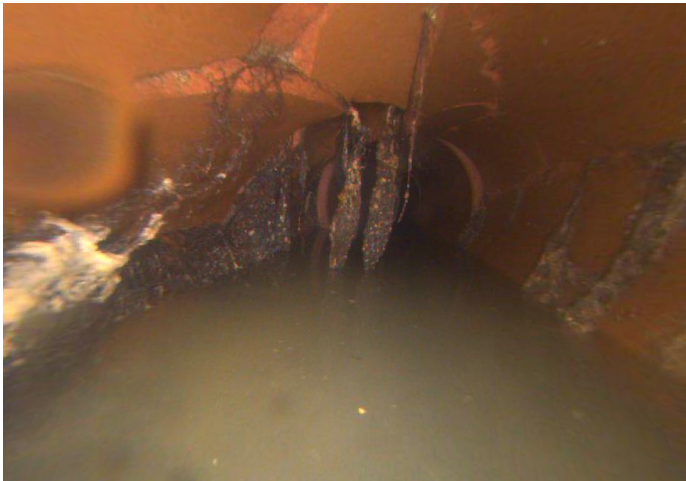
Code: **RMB**  
Description: **Roots Medium Barrel**

Distance (ft): **31.5**  
Structural Grade: **0**  
O&M Grade: **4**  
Clock Start/From: **9**  
Clock To: **2**  
1st Value:  
2nd Value:  
Value Percent: **10.000**  
Continuous Index:  
Within 8" of Joint: **NO**  
Remarks:

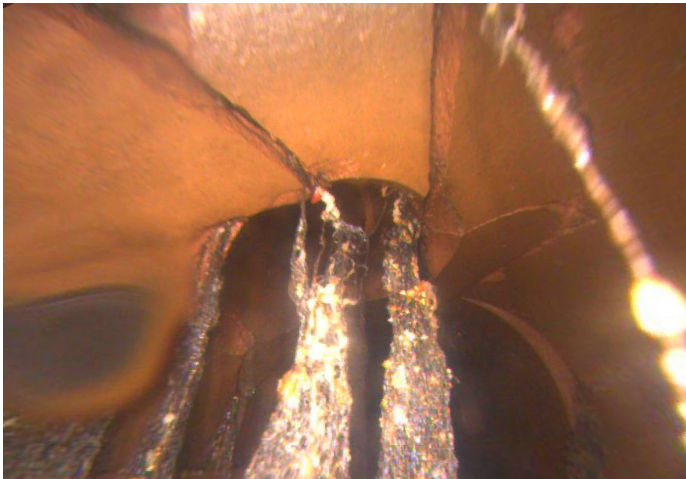
Code: **TFD**  
Description: **Tap Factory Defective**

Distance (ft): **32.1**  
Structural Grade: **0**  
O&M Grade: **2**  
Clock Start/From: **11**  
Clock To:  
1st Value: **6.000**  
2nd Value:  
Value Percent:  
Continuous Index:  
Within 8" of Joint:  
Remarks: **D**

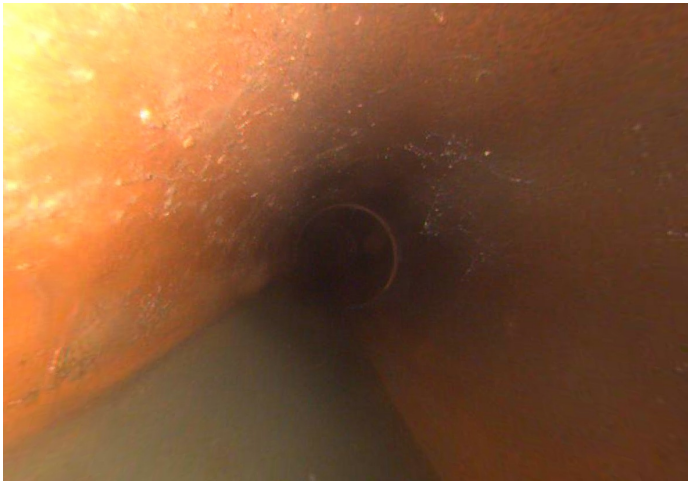
Code:	<b>MSA</b>
Description:	<b>Abandoned Survey</b>
Distance (ft):	<b>34.2</b>
Structural Grade:	<b>0</b>
O&M Grade:	<b>0</b>
Clock Start/From:	
Clock To:	
1st Value:	
2nd Value:	
Value Percent:	
Continuous Index:	
Within 8" of Joint:	<b>NO</b>
Remarks:	<b>D</b>
