## Profile/Photo Observation Report

Street:	<b>ALLEY BETWEEN HIGH ST &amp; E NORT</b>	Flow Control:	<b>Not Controlled</b>
City:	<b>Hobart, IN</b>	Year Renewed:	
Location:	<b>Light Highway</b>	Tape/Media #:	
Purpose:	<b>Routine Assessment</b>	Dia/Height:	<b>12"</b>
Use:	<b>Sanitary</b>	Material:	<b>VCP</b>
Drain Area:	<b>NA</b>	Lining:	
Category:	<b>NA</b>		
Comment:

Location Details:		Direction of Survey:	<b>Upstream</b>
US MH:	<b>M-803-004</b>	DS MH:	<b>M-803-005</b>
		Total Length Surveyed (ft):	<b>6.9</b>

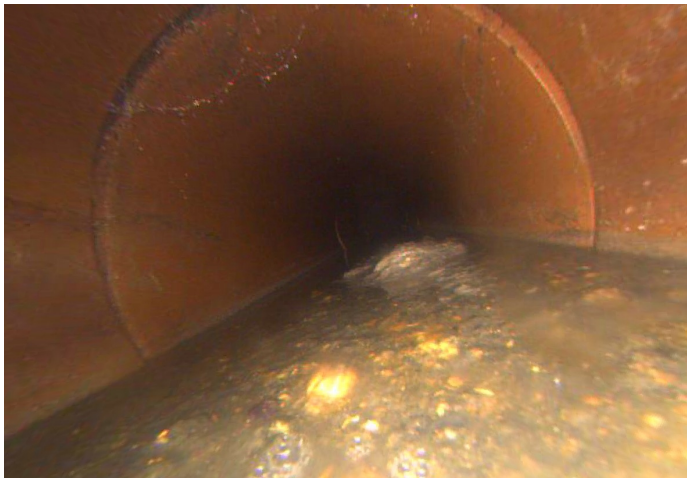
Code: **AMH**  
Description: **Manhole**

Distance (ft): **.0**  
Structural Grade: **0**  
O&M Grade: **0**  
Clock Start/From:  
Clock To:  
1st Value:  
2nd Value:  
Value Percent:  
Continuous Index:  
Within 8" of Joint: **NO**  
Remarks: **M-803-005**

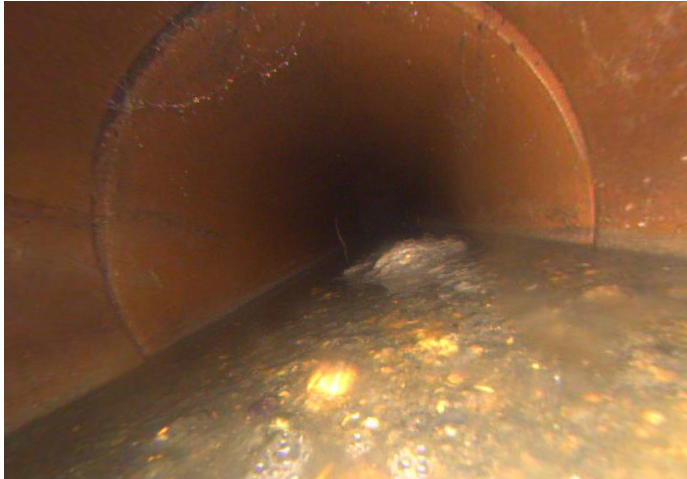
Code: **MWL**  
Description: **Water Level**

Distance (ft): **.0**  
Structural Grade: **0**  
O&M Grade: **0**  
Clock Start/From:  
Clock To:  
1st Value:  
2nd Value:  
Value Percent: **25.000**  
Continuous Index:  
Within 8" of Joint: **NO**  
Remarks:

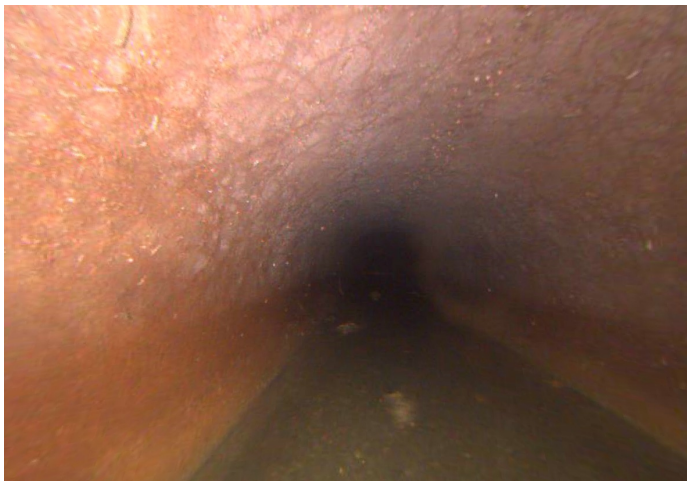
Code: **MSA**  
Description: **Abandoned Survey**

Distance (ft): **6.9**  
Structural Grade: **0**  
O&M Grade: **0**  
Clock Start/From:  
Clock To:  
1st Value:  
2nd Value:  
Value Percent:  
Continuous Index:  
Within 8" of Joint: **NO**  
Remarks: **Possible Debris**
