Profile/Photo Observation Report

Street:	41st. Ave.	Flow Control:	Not Controlled
City:	Hobart, IN	Year Renewed:	
Location:	Light Highway	Tape/Media #:	
Purpose:	Routine Assessment	Dia/Height:	12"
Use:	Sanitary	Material:	VCP
Drain Area:	NA	Lining:	
Category:	NA		
Comment:

Location Details:		Direction of Survey:	Upstream
US MH:	M-803-004	DS MH:	M-803-005
		Total Length Surveyed (ft):	6.9

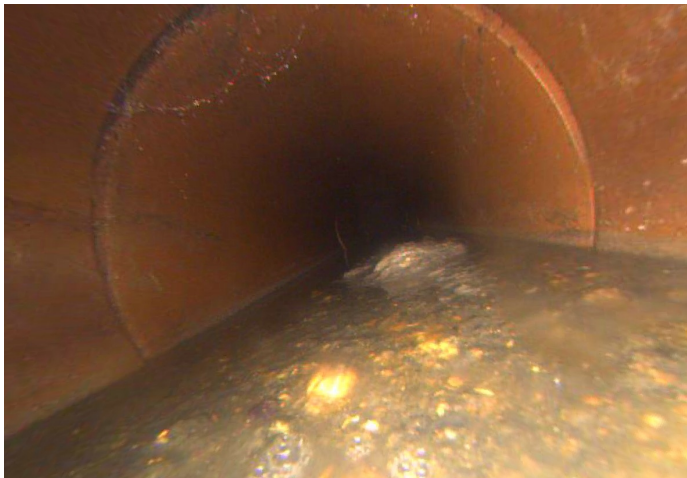
Code: **AMH**
Description: **Manhole**

Distance (ft): **.0**
Structural Grade: **0**
O&M Grade: **0**
Clock Start/From:
Clock To:
1st Value:
2nd Value:
Value Percent:
Continuous Index:
Within 8" of Joint: **NO**
Remarks: **M-803-005**

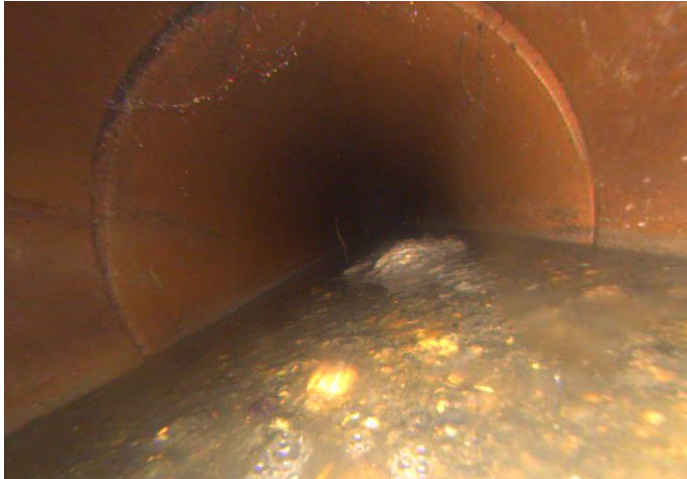
Code: **MWL**
Description: **Water Level**

Distance (ft): **.0**
Structural Grade: **0**
O&M Grade: **0**
Clock Start/From:
Clock To:
1st Value:
2nd Value:
Value Percent: **25.000**
Continuous Index:
Within 8" of Joint: **NO**
Remarks:

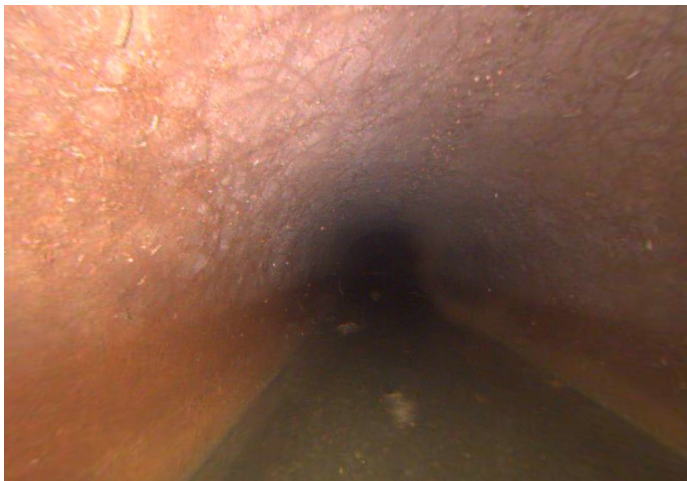
Code: **MSA**
Description: **Abandoned Survey**

Distance (ft): **6.9**
Structural Grade: **0**
O&M Grade: **0**
Clock Start/From:
Clock To:
1st Value:
2nd Value:
Value Percent:
Continuous Index:
Within 8" of Joint: **NO**
Remarks: **Possible Debris**
