Profile/Photo Observation Report

Date:	03/28/2018	Weather:		Coding:	PACP 6.0
Pipe Length (ft):	164.9	Owner:	NA	Pre Clean:	Not Known
P.O.#:		Surveyor:	Selasie Honu	PSR:	P-803-014-005
Customer:		Clean Date:	01/01/1900	Shape:	C

Street:	E NORTH ST	Flow Control:	Not Controlled
City:	Hobart, IN	Year Renewed:	
Location:	Other	Tape/Media #:	
Purpose:	Not Known	Dia/Height:	10"
Use:	Sanitary	Material:	VCP
Drain Area:	NA	Lining:	
Category:	NA		
Comment:

Location Details:		Direction of Survey:	Upstream
US MH:	M-803-005	DS MH:	M-803-014
		Total Length Surveyed (ft):	159.5

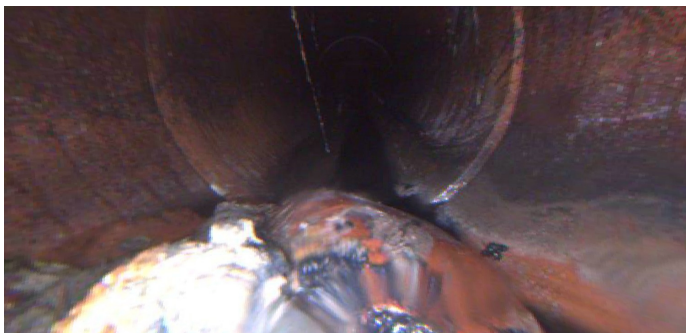
Code: **AMH**
Description: **Manhole**

Distance (ft): **.0**
Structural Grade: **0**
O&M Grade: **0**
Clock Start/From:
Clock To:
1st Value:
2nd Value:
Value Percent:
Continuous Index:
Within 8" of Joint: **NO**
Remarks: **M-803-014**

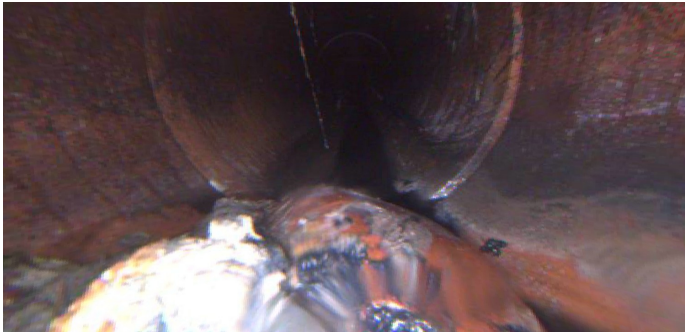
Code:	MWL
Description:	Water Level

Distance (ft):	.0
Structural Grade:	0
O&M Grade:	0
Clock Start/From:	
Clock To:	
1st Value:	
2nd Value:	
Value Percent:	5.000
Continuous Index:	
Within 8" of Joint:	NO
Remarks:

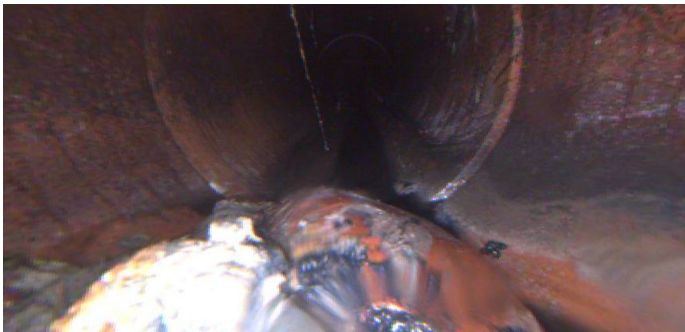
Code:	DSZ
Description:	Deposits Settled Other

Distance (ft):	.0
Structural Grade:	0
O&M Grade:	3
Clock Start/From:	6
Clock To:	
1st Value:	
2nd Value:	
Value Percent:	15.000
Continuous Index:	
Within 8" of Joint:	NO
Remarks:	mixed material

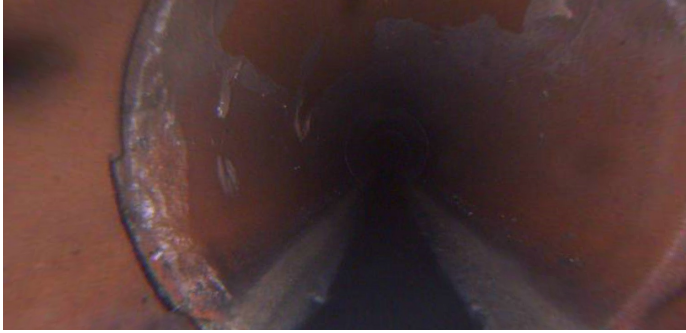
Code: **SSS**
Description: **Surface Spalling**

Distance (ft): **13.1**
Structural Grade: **2**
O&M Grade: **0**
Clock Start/From: **7**
Clock To: **11**
1st Value:
2nd Value:
Value Percent:
Continuous Index:
Within 8" of Joint: **YES**
Remarks:

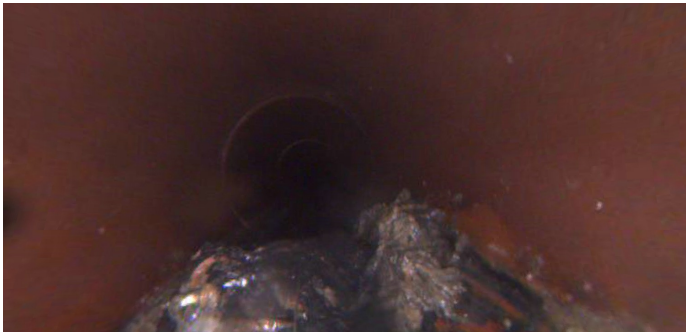
Code: **DSZ**
Description: **Deposits Settled Other**

Distance (ft): **60.6**
Structural Grade: **0**
O&M Grade: **2**
Clock Start/From: **5**
Clock To: **7**
1st Value:
2nd Value:
Value Percent: **10.000**
Continuous Index:
Within 8" of Joint: **NO**
Remarks: **misc**

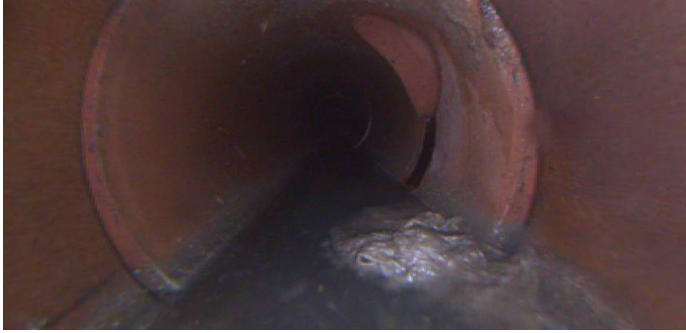
Code: **IS**
Description: **Infil Stain**

Distance (ft): **66.8**
Structural Grade: **0**
O&M Grade: **0**
Clock Start/From: **3**
Clock To: **4**
1st Value:
2nd Value:
Value Percent:
Continuous Index:
Within 8" of Joint:
Remarks:

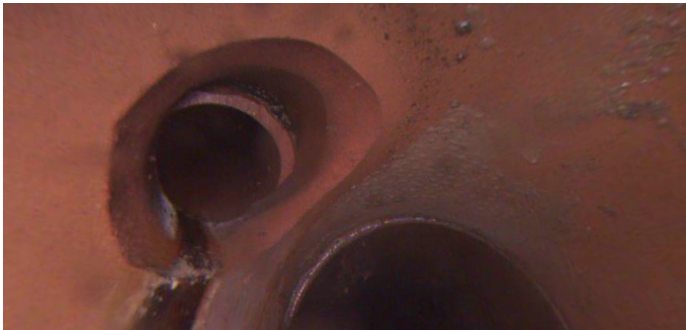
Code: **TFA**
Description: **Tap Factory Active**

Distance (ft): **68.7**
Structural Grade: **0**
O&M Grade: **0**
Clock Start/From: **2**
Clock To:
1st Value: **4.000**
2nd Value:
Value Percent:
Continuous Index:
Within 8" of Joint:
Remarks:

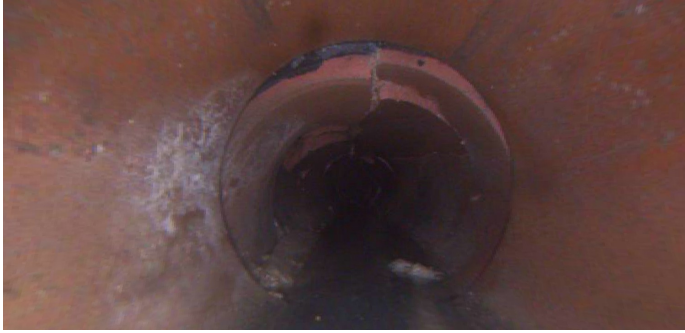
Code: **B**
Description: **Broken**

Distance (ft): **96.4**
Structural Grade: **5**
O&M Grade: **0**
Clock Start/From: **7**
Clock To: **5**
1st Value:
2nd Value:
Value Percent:
Continuous Index: **S01**
Within 8" of Joint: **YES**
Remarks:

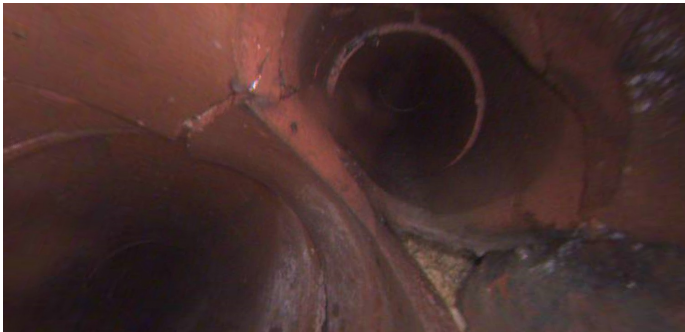
Code: **TFD**
Description: **Tap Factory Defective**

Distance (ft): **98.5**
Structural Grade: **0**
O&M Grade: **2**
Clock Start/From: **10**
Clock To:
1st Value: **4.000**
2nd Value:
Value Percent:
Continuous Index:
Within 8" of Joint:
Remarks: **Fractured**

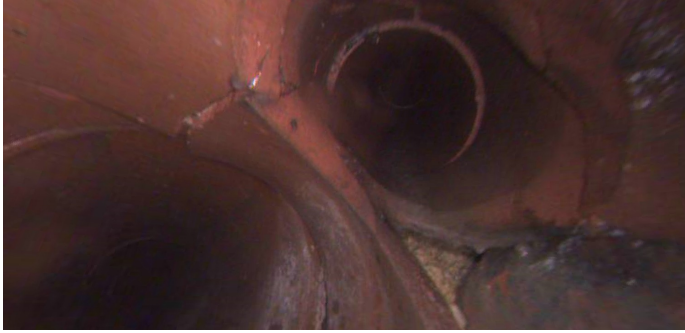
Code: **HSV**
Description: **Hole Soil Visible**

Distance (ft): **98.5**
Structural Grade: **5**
O&M Grade: **0**
Clock Start/From: **9**
Clock To:
1st Value:
2nd Value:
Value Percent:
Continuous Index:
Within 8" of Joint:
Remarks:

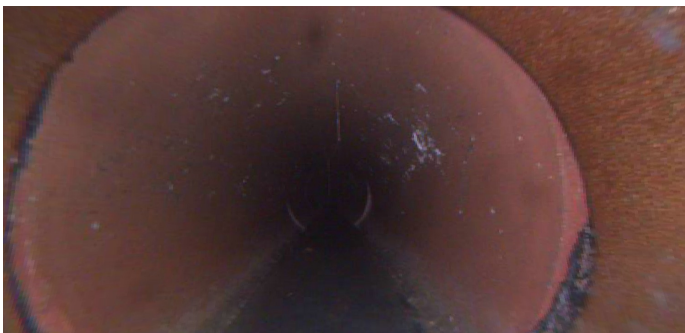
Code: **B**
Description: **Broken**

Distance (ft): **102.8**
Structural Grade: **5**
O&M Grade: **0**
Clock Start/From: **7**
Clock To: **5**
1st Value:
2nd Value:
Value Percent:
Continuous Index: **F01**
Within 8" of Joint: **YES**
Remarks:

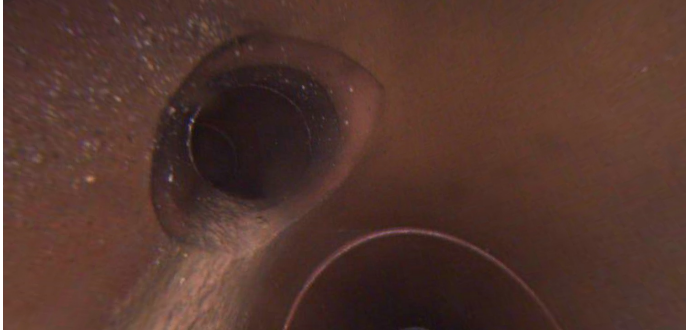
Code: **TF**
Description: **Tap Factory**

Distance (ft): **116.4**
Structural Grade: **0**
O&M Grade: **0**
Clock Start/From: **2**
Clock To:
1st Value: **4.000**
2nd Value:
Value Percent:
Continuous Index:
Within 8" of Joint:
Remarks:

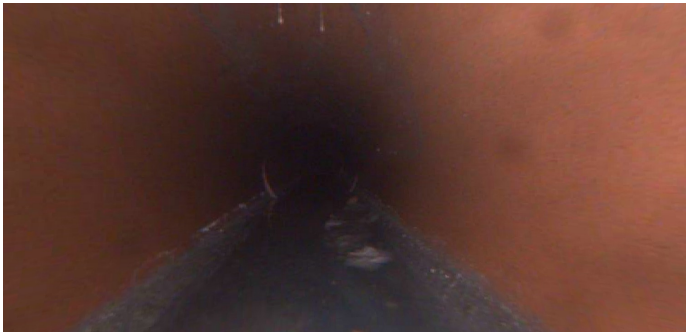
Code: **CM**
Description: **Crack Multiple**

Distance (ft): **126.8**
Structural Grade: **3**
O&M Grade: **0**
Clock Start/From: **9**
Clock To: **3**
1st Value:
2nd Value:
Value Percent:
Continuous Index: **S02**
Within 8" of Joint:
Remarks:

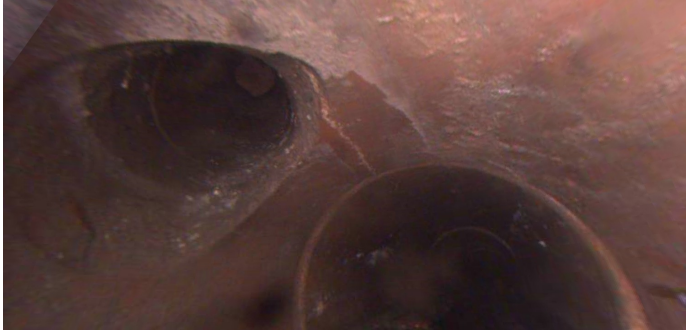
Code: **TF**
Description: **Tap Factory**

Distance (ft): **151.9**
Structural Grade: **0**
O&M Grade: **0**
Clock Start/From: **2**
Clock To:
1st Value: **4.000**
2nd Value:
Value Percent:
Continuous Index:
Within 8" of Joint:
Remarks:

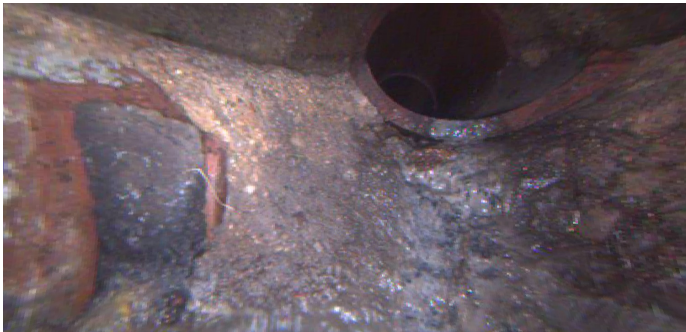
Code: **CM**
Description: **Crack Multiple**

Distance (ft): **159.5**
Structural Grade: **3**
O&M Grade: **0**
Clock Start/From: **9**
Clock To: **3**
1st Value:
2nd Value:
Value Percent:
Continuous Index: **F02**
Within 8" of Joint:
Remarks:

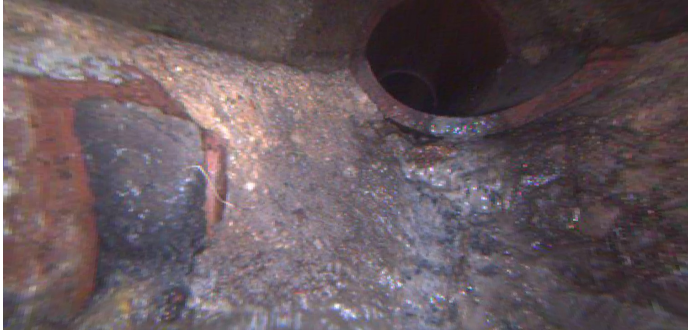
Code:	AMH
Description:	Manhole
Distance (ft):	159.5
Structural Grade:	0
O&M Grade:	0
Clock Start/From:	
Clock To:	
1st Value:	
2nd Value:	
Value Percent:	
Continuous Index:	
Within 8" of Joint:	NO
Remarks:	M-803-005
