## Profile/Photo Observation Report

Date:	<b>03/28/2018</b>	Weather:		Coding:	<b>PACP 6.0</b>
Pipe Length (ft):	<b>164.9</b>	Owner:	<b>NA</b>	Pre Clean:	<b>Not Known</b>
P.O.#:		Surveyor:	<b>Selasie Honu</b>	PSR:	<b>P-803-014-005</b>
Customer:		Clean Date:	<b>01/01/1900</b>	Shape:	<b>C</b>

Street:	<b>N LIBERTY</b>	Flow Control:	<b>Not Controlled</b>
City:	<b>Hobart, IN</b>	Year Renewed:	
Location:	<b>Other</b>	Tape/Media #:	
Purpose:	<b>Not Known</b>	Dia/Height:	<b>10"</b>
Use:	<b>Sanitary</b>	Material:	<b>VCP</b>
Drain Area:	<b>NA</b>	Lining:	
Category:	<b>NA</b>		
Comment:

Location Details:		Direction of Survey:	<b>Upstream</b>
US MH:	<b>M-803-005</b>	DS MH:	<b>M-803-014</b>
		Total Length Surveyed (ft):	<b>159.5</b>

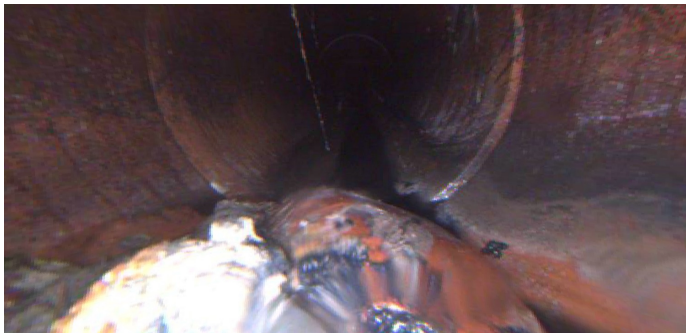
Code: **AMH**  
Description: **Manhole**

Distance (ft): **.0**  
Structural Grade: **0**  
O&M Grade: **0**  
Clock Start/From:  
Clock To:  
1st Value:  
2nd Value:  
Value Percent:  
Continuous Index:  
Within 8" of Joint: **NO**  
Remarks: **M-803-014**

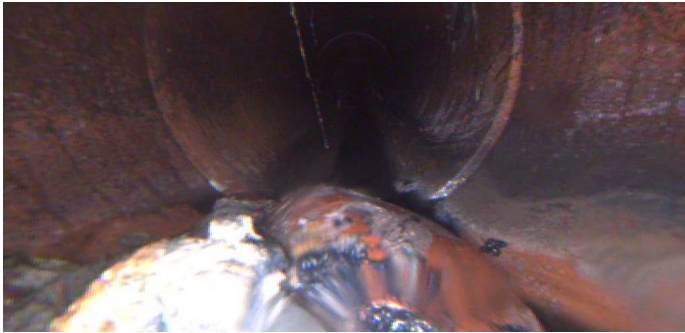
Code:	<b>MWL</b>
Description:	<b>Water Level</b>

Distance (ft):	<b>.0</b>
Structural Grade:	<b>0</b>
O&M Grade:	<b>0</b>
Clock Start/From:	
Clock To:	
1st Value:	
2nd Value:	
Value Percent:	<b>5.000</b>
Continuous Index:	
Within 8" of Joint:	<b>NO</b>
Remarks:

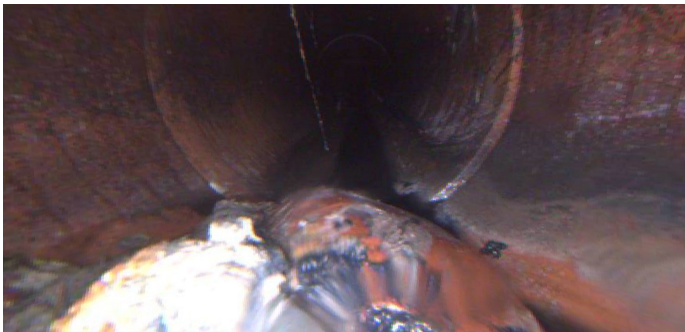
Code:	<b>DSZ</b>
Description:	<b>Deposits Settled Other</b>

Distance (ft):	<b>.0</b>
Structural Grade:	<b>0</b>
O&M Grade:	<b>3</b>
Clock Start/From:	<b>6</b>
Clock To:	
1st Value:	
2nd Value:	
Value Percent:	<b>15.000</b>
Continuous Index:	
Within 8" of Joint:	<b>NO</b>
Remarks:	<b>mixed material</b>

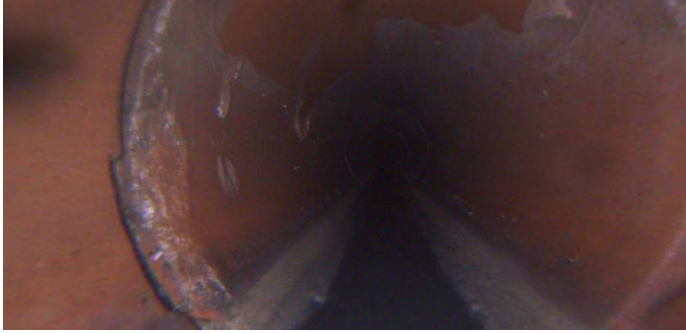
Code: **SSS**  
Description: **Surface Spalling**

Distance (ft): **13.1**  
Structural Grade: **2**  
O&M Grade: **0**  
Clock Start/From: **7**  
Clock To: **11**  
1st Value:  
2nd Value:  
Value Percent:  
Continuous Index:  
Within 8" of Joint: **YES**  
Remarks:

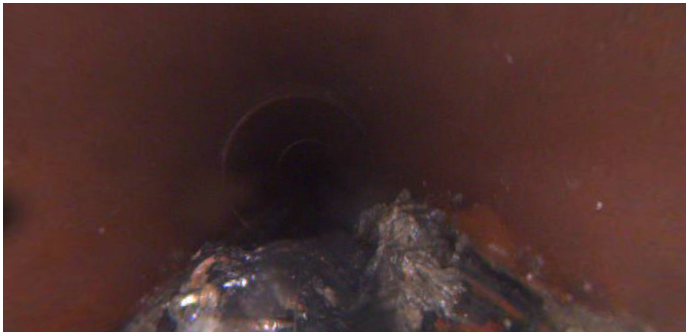
Code: **DSZ**  
Description: **Deposits Settled Other**

Distance (ft): **60.6**  
Structural Grade: **0**  
O&M Grade: **2**  
Clock Start/From: **5**  
Clock To: **7**  
1st Value:  
2nd Value:  
Value Percent: **10.000**  
Continuous Index:  
Within 8" of Joint: **NO**  
Remarks: **misc**

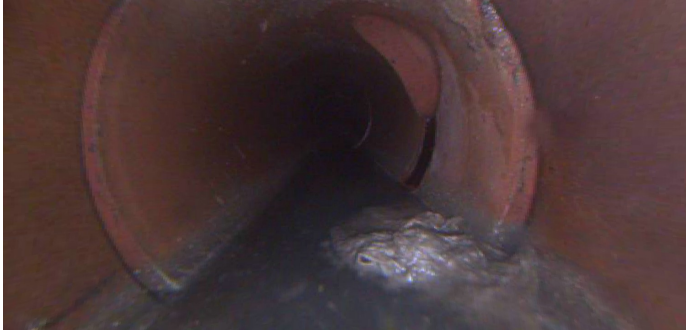
Code: **IS**  
Description: **Infil Stain**

Distance (ft): **66.8**  
Structural Grade: **0**  
O&M Grade: **0**  
Clock Start/From: **3**  
Clock To: **4**  
1st Value:  
2nd Value:  
Value Percent:  
Continuous Index:  
Within 8" of Joint:  
Remarks:

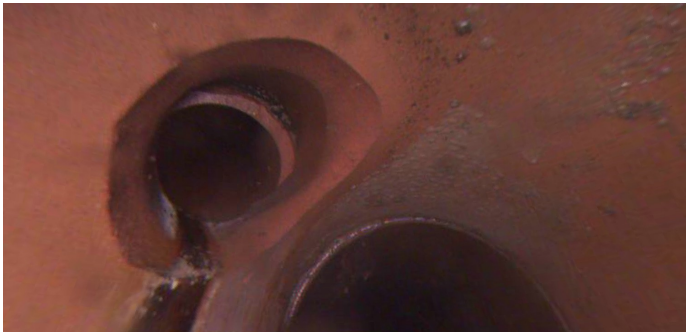
Code: **TFA**  
Description: **Tap Factory Active**

Distance (ft): **68.7**  
Structural Grade: **0**  
O&M Grade: **0**  
Clock Start/From: **2**  
Clock To:  
1st Value: **4.000**  
2nd Value:  
Value Percent:  
Continuous Index:  
Within 8" of Joint:  
Remarks:

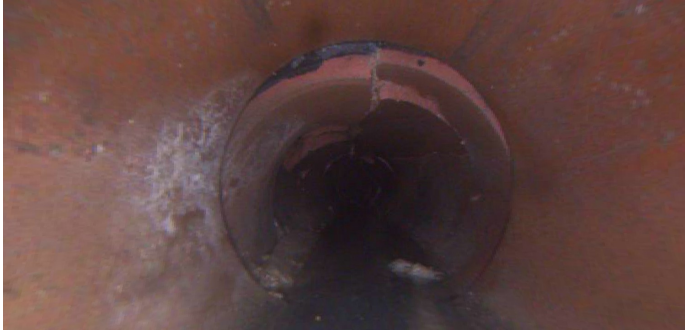
Code: **B**  
Description: **Broken**

Distance (ft): **96.4**  
Structural Grade: **5**  
O&M Grade: **0**  
Clock Start/From: **7**  
Clock To: **5**  
1st Value:  
2nd Value:  
Value Percent:  
Continuous Index: **S01**  
Within 8" of Joint: **YES**  
Remarks:

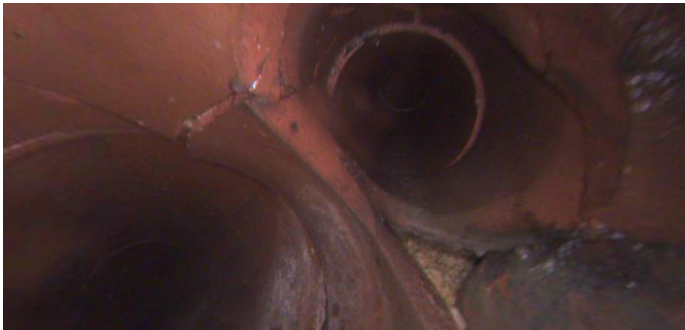
Code: **TFD**  
Description: **Tap Factory Defective**

Distance (ft): **98.5**  
Structural Grade: **0**  
O&M Grade: **2**  
Clock Start/From: **10**  
Clock To:  
1st Value: **4.000**  
2nd Value:  
Value Percent:  
Continuous Index:  
Within 8" of Joint:  
Remarks: **Fractured**

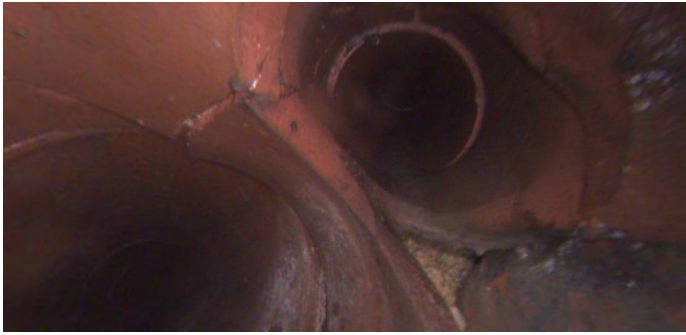
Code: **HSV**  
Description: **Hole Soil Visible**

Distance (ft): **98.5**  
Structural Grade: **5**  
O&M Grade: **0**  
Clock Start/From: **9**  
Clock To:  
1st Value:  
2nd Value:  
Value Percent:  
Continuous Index:  
Within 8" of Joint:  
Remarks:

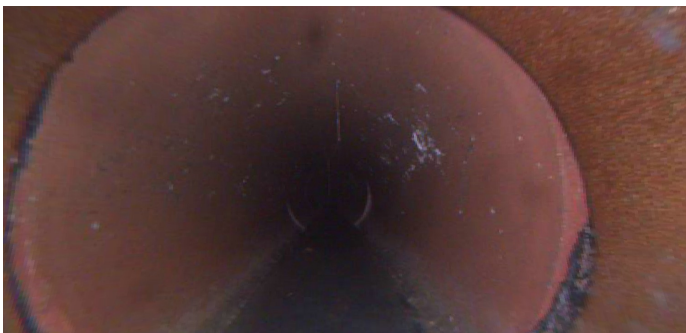
Code: **B**  
Description: **Broken**

Distance (ft): **102.8**  
Structural Grade: **5**  
O&M Grade: **0**  
Clock Start/From: **7**  
Clock To: **5**  
1st Value:  
2nd Value:  
Value Percent:  
Continuous Index: **F01**  
Within 8" of Joint: **YES**  
Remarks:

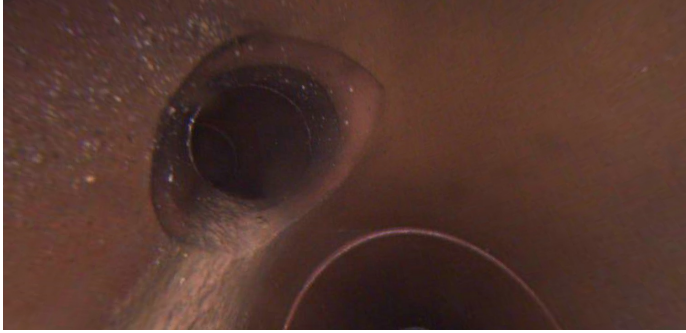
Code: **TF**  
Description: **Tap Factory**

Distance (ft): **116.4**  
Structural Grade: **0**  
O&M Grade: **0**  
Clock Start/From: **2**  
Clock To:  
1st Value: **4.000**  
2nd Value:  
Value Percent:  
Continuous Index:  
Within 8" of Joint:  
Remarks:

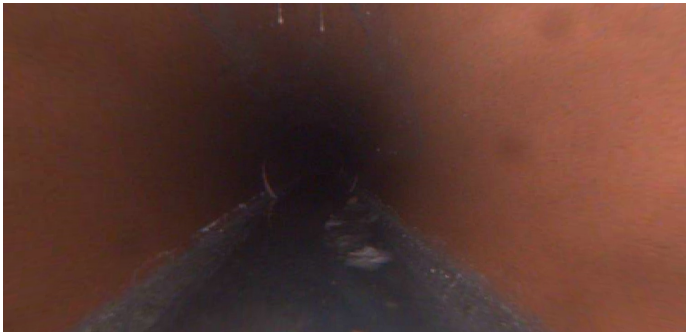
Code: **CM**  
Description: **Crack Multiple**

Distance (ft): **126.8**  
Structural Grade: **3**  
O&M Grade: **0**  
Clock Start/From: **9**  
Clock To: **3**  
1st Value:  
2nd Value:  
Value Percent:  
Continuous Index: **S02**  
Within 8" of Joint:  
Remarks:

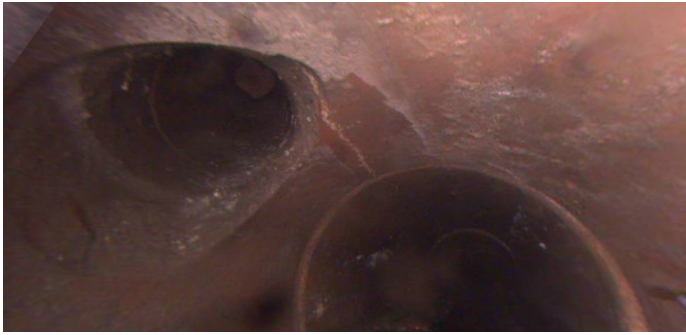
Code: **TF**  
Description: **Tap Factory**

Distance (ft): **151.9**  
Structural Grade: **0**  
O&M Grade: **0**  
Clock Start/From: **2**  
Clock To:  
1st Value: **4.000**  
2nd Value:  
Value Percent:  
Continuous Index:  
Within 8" of Joint:  
Remarks:

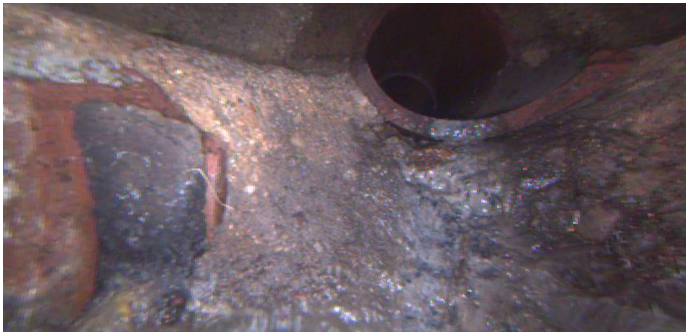
Code: **CM**  
Description: **Crack Multiple**

Distance (ft): **159.5**  
Structural Grade: **3**  
O&M Grade: **0**  
Clock Start/From: **9**  
Clock To: **3**  
1st Value:  
2nd Value:  
Value Percent:  
Continuous Index: **F02**  
Within 8" of Joint:  
Remarks:

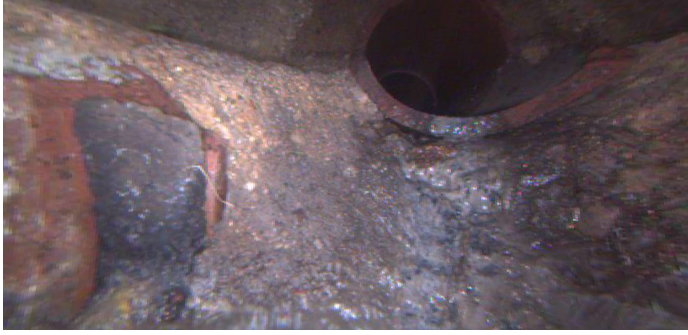
Code:	<b>AMH</b>
Description:	<b>Manhole</b>
Distance (ft):	<b>159.5</b>
Structural Grade:	<b>0</b>
O&M Grade:	<b>0</b>
Clock Start/From:	
Clock To:	
1st Value:	
2nd Value:	
Value Percent:	
Continuous Index:	
Within 8" of Joint:	<b>NO</b>
Remarks:	<b>M-803-005</b>
