## Profile/Photo Observation Report

Street:	<b>E NORTH ST</b>	Flow Control:	<b>Not Controlled</b>
City:	<b>Hobart, IN</b>	Year Renewed:	
Location:	<b>Other</b>	Tape/Media #:	
Purpose:	<b>Not Known</b>	Dia/Height:	<b>10"</b>
Use:	<b>Sanitary</b>	Material:	<b>VCP</b>
Drain Area:	<b>NA</b>	Lining:	
Category:	<b>NA</b>		
Comment:

Location Details:		Direction of Survey:	<b>Downstream</b>
US MH:	<b>M-803-007</b>	DS MH:	<b>M-803-003</b>
		Total Length Surveyed (ft):	<b>161.7</b>

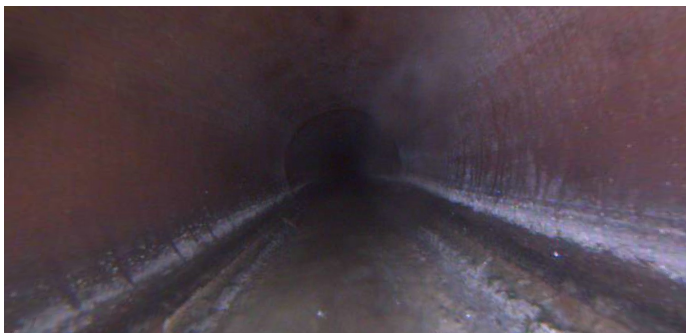
Code: **AMH**  
Description: **Manhole**

Distance (ft): **.0**  
Structural Grade: **0**  
O&M Grade: **0**  
Clock Start/From:  
Clock To:  
1st Value:  
2nd Value:  
Value Percent:  
Continuous Index:  
Within 8" of Joint: **NO**  
Remarks: **M-803-007**

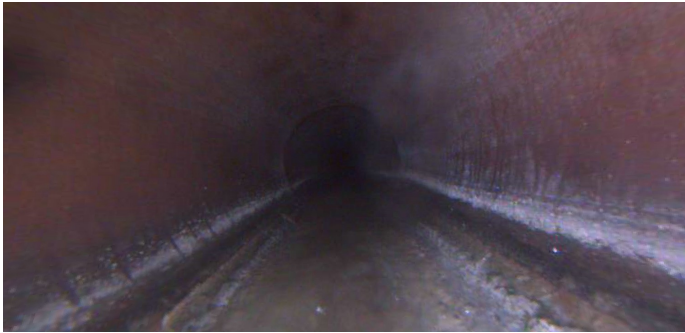
Code:	<b>MWL</b>
Description:	<b>Water Level</b>

Distance (ft):	<b>.0</b>
Structural Grade:	<b>0</b>
O&M Grade:	<b>0</b>
Clock Start/From:	
Clock To:	
1st Value:	
2nd Value:	
Value Percent:	<b>10.000</b>
Continuous Index:	
Within 8" of Joint:	<b>NO</b>
Remarks:

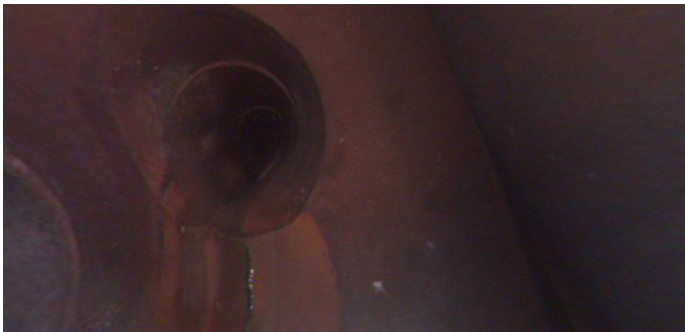
Code:	<b>TF</b>
Description:	<b>Tap Factory</b>

Distance (ft):	<b>49.6</b>
Structural Grade:	<b>0</b>
O&M Grade:	<b>0</b>
Clock Start/From:	<b>10</b>
Clock To:	
1st Value:	<b>4.000</b>
2nd Value:	
Value Percent:	
Continuous Index:	
Within 8" of Joint:	
Remarks:

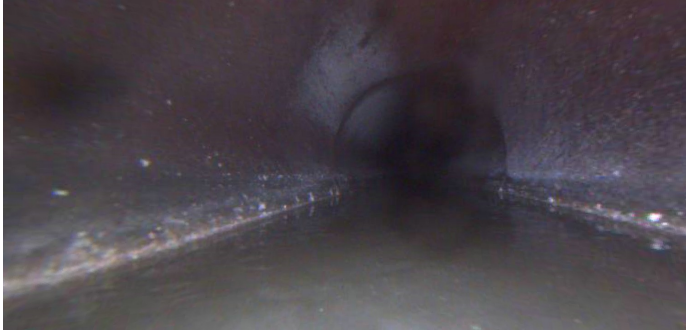
Code: **MWL**  
Description: **Water Level**

Distance (ft): **49.6**  
Structural Grade: **0**  
O&M Grade: **0**  
Clock Start/From:  
Clock To:  
1st Value:  
2nd Value:  
Value Percent: **40.000**  
Continuous Index:  
Within 8" of Joint: **NO**  
Remarks:

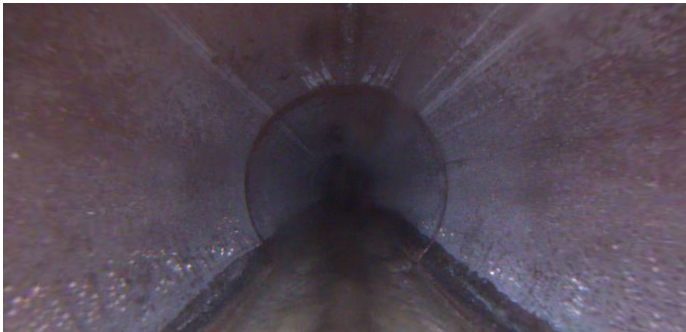
Code: **MWL**  
Description: **Water Level**

Distance (ft): **79.8**  
Structural Grade: **0**  
O&M Grade: **0**  
Clock Start/From:  
Clock To:  
1st Value:  
2nd Value:  
Value Percent: **5.000**  
Continuous Index:  
Within 8" of Joint: **NO**  
Remarks:

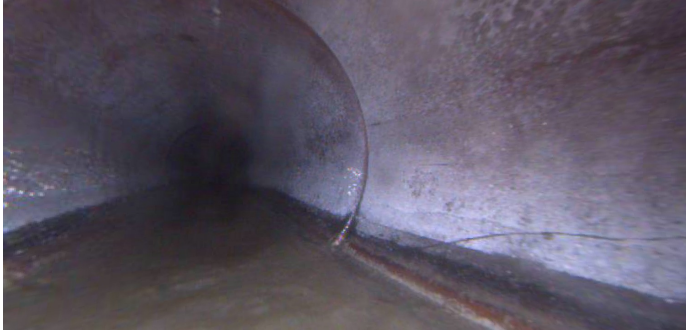
Code: **CS**  
Description: **Crack Spiral**

Distance (ft): **86.3**  
Structural Grade: **2**  
O&M Grade: **0**  
Clock Start/From: **4**  
Clock To: **5**  
1st Value:  
2nd Value:  
Value Percent:  
Continuous Index:  
Within 8" of Joint: **YES**  
Remarks:

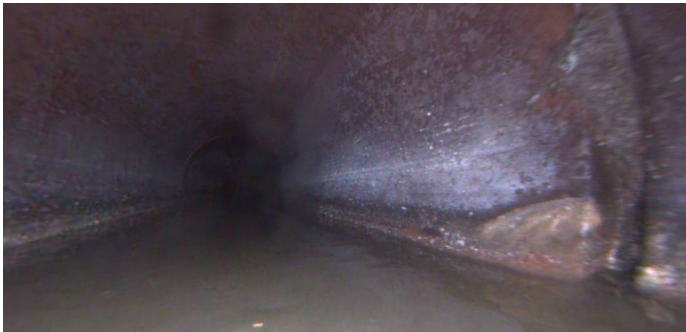
Code: **FL**  
Description: **Fracture Longitudinal**

Distance (ft): **104.8**  
Structural Grade: **3**  
O&M Grade: **0**  
Clock Start/From: **4**  
Clock To:  
1st Value:  
2nd Value:  
Value Percent:  
Continuous Index:  
Within 8" of Joint: **YES**  
Remarks:

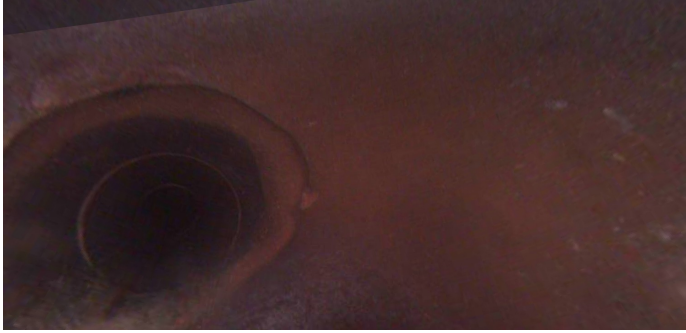
Code: **TF**  
Description: **Tap Factory**

Distance (ft): **115.4**  
Structural Grade: **0**  
O&M Grade: **0**  
Clock Start/From: **1**  
Clock To:  
1st Value: **4.000**  
2nd Value:  
Value Percent:  
Continuous Index:  
Within 8" of Joint:  
Remarks:

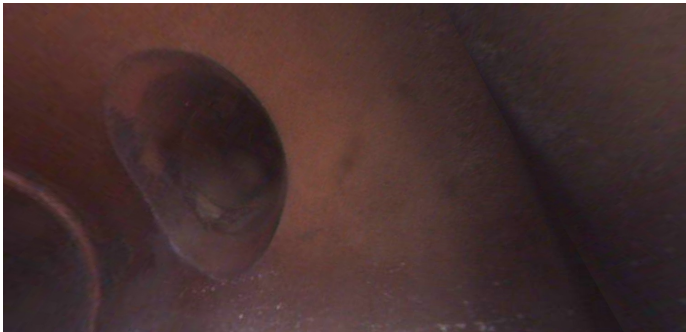
Code: **TF**  
Description: **Tap Factory**

Distance (ft): **139.6**  
Structural Grade: **0**  
O&M Grade: **0**  
Clock Start/From: **10**  
Clock To:  
1st Value: **4.000**  
2nd Value:  
Value Percent:  
Continuous Index:  
Within 8" of Joint:  
Remarks:

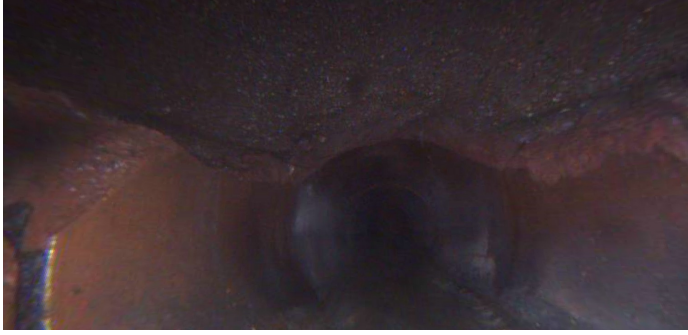
Code:	AMH
Description:	Manhole
Distance (ft):	161.7
Structural Grade:	0
O&M Grade:	0
Clock Start/From:	
Clock To:	
1st Value:	
2nd Value:	
Value Percent:	
Continuous Index:	
Within 8" of Joint:	NO
Remarks:	M-803-003
