Profile/Photo Observation Report

Date:	03/29/2018	Weather:		Coding:	PACP 6.0
Pipe Length (ft):	164.4	Owner:	NA	Pre Clean:	Not Known
P.O.#:		Surveyor:	Jen Costello	PSR:	P-803-007-003
Customer:		Clean Date:	01/01/1900	Shape:	C

Location Details:		Direction of Survey:	Downstream
US MH:	M-803-007	DS MH:	M-803-003
		Total Length Surveyed (ft):	161.7

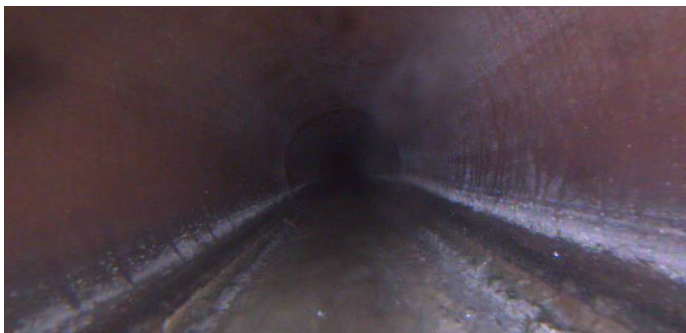
Code: **AMH**
Description: **Manhole**

Distance (ft): **.0**
Structural Grade: **0**
O&M Grade: **0**
Clock Start/From:
Clock To:
1st Value:
2nd Value:
Value Percent:
Continuous Index:
Within 8" of Joint: **NO**
Remarks: **M-803-007**

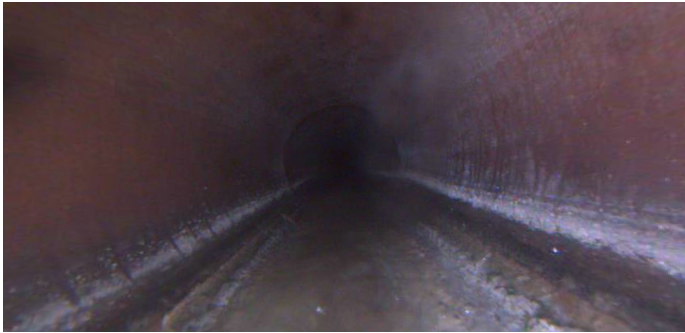
Code:	MWL
Description:	Water Level

Distance (ft):	.0
Structural Grade:	0
O&M Grade:	0
Clock Start/From:	
Clock To:	
1st Value:	
2nd Value:	
Value Percent:	10.000
Continuous Index:	
Within 8" of Joint:	NO
Remarks:

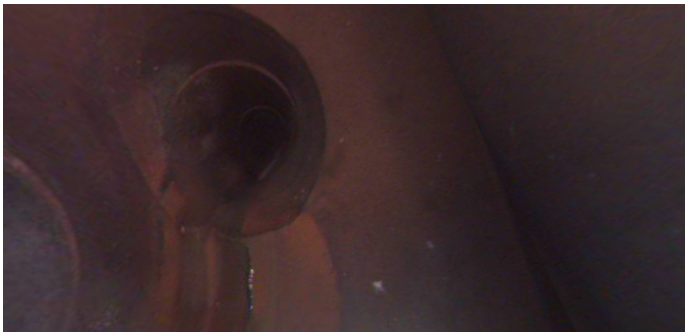
Code:	TF
Description:	Tap Factory

Distance (ft):	49.6
Structural Grade:	0
O&M Grade:	0
Clock Start/From:	10
Clock To:	
1st Value:	4.000
2nd Value:	
Value Percent:	
Continuous Index:	
Within 8" of Joint:	
Remarks:

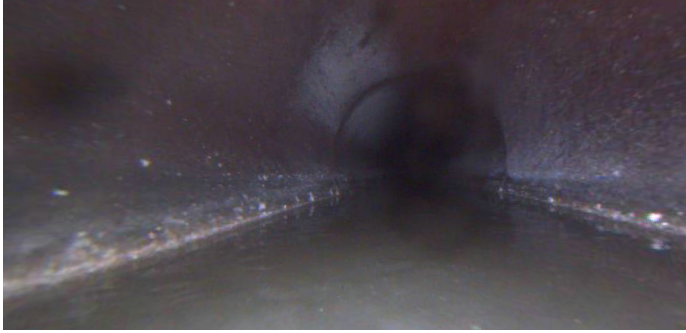
Code: **MWL**
Description: **Water Level**

Distance (ft): **49.6**
Structural Grade: **0**
O&M Grade: **0**
Clock Start/From:
Clock To:
1st Value:
2nd Value:
Value Percent: **40.000**
Continuous Index:
Within 8" of Joint: **NO**
Remarks:

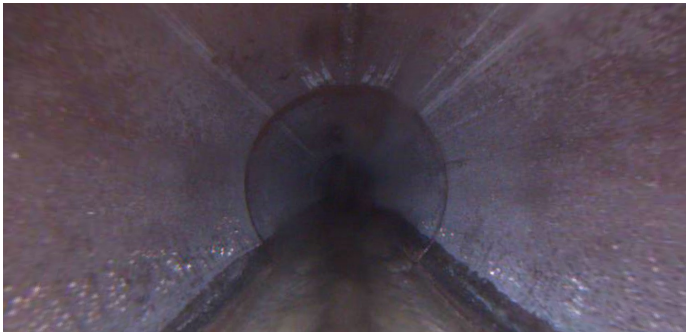
Code: **MWL**
Description: **Water Level**

Distance (ft): **79.8**
Structural Grade: **0**
O&M Grade: **0**
Clock Start/From:
Clock To:
1st Value:
2nd Value:
Value Percent: **5.000**
Continuous Index:
Within 8" of Joint: **NO**
Remarks:

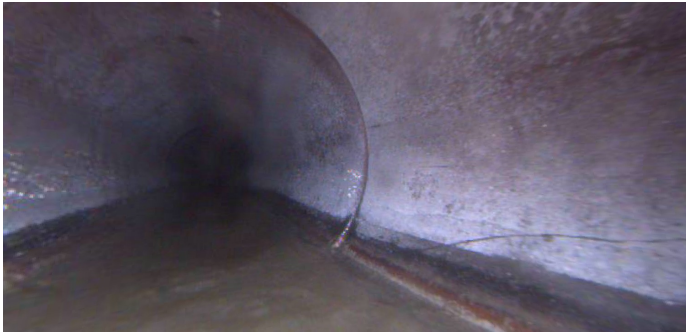
Code: **CS**
Description: **Crack Spiral**

Distance (ft): **86.3**
Structural Grade: **2**
O&M Grade: **0**
Clock Start/From: **4**
Clock To: **5**
1st Value:
2nd Value:
Value Percent:
Continuous Index:
Within 8" of Joint: **YES**
Remarks:

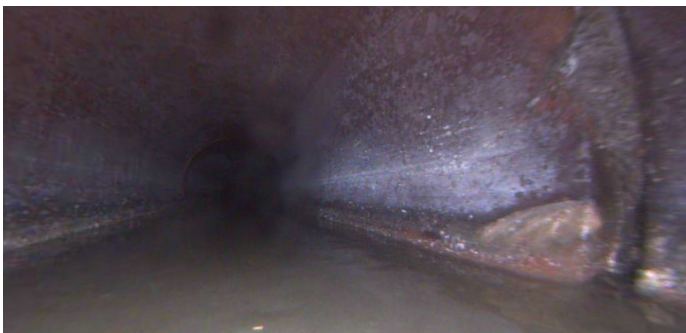
Code: **FL**
Description: **Fracture Longitudinal**

Distance (ft): **104.8**
Structural Grade: **3**
O&M Grade: **0**
Clock Start/From: **4**
Clock To:
1st Value:
2nd Value:
Value Percent:
Continuous Index:
Within 8" of Joint: **YES**
Remarks:

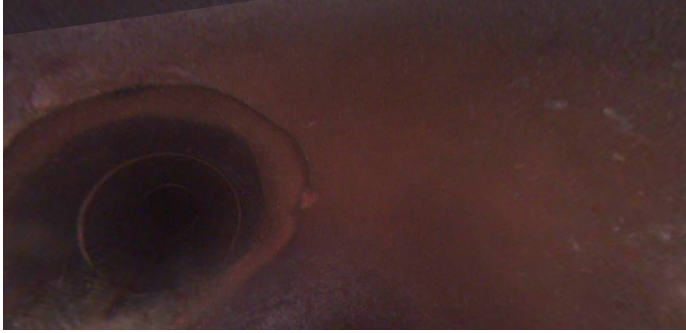
Code: **TF**
Description: **Tap Factory**

Distance (ft): **115.4**
Structural Grade: **0**
O&M Grade: **0**
Clock Start/From: **1**
Clock To:
1st Value: **4.000**
2nd Value:
Value Percent:
Continuous Index:
Within 8" of Joint:
Remarks:

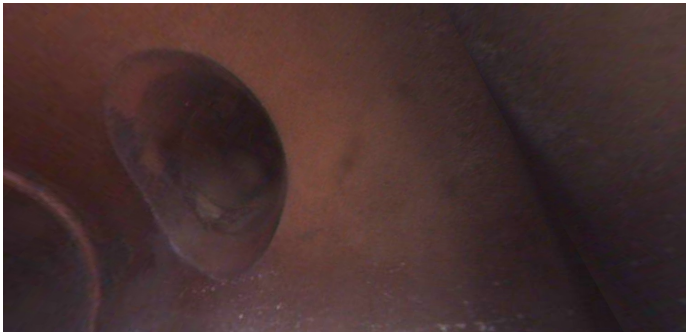
Code: **TF**
Description: **Tap Factory**

Distance (ft): **139.6**
Structural Grade: **0**
O&M Grade: **0**
Clock Start/From: **10**
Clock To:
1st Value: **4.000**
2nd Value:
Value Percent:
Continuous Index:
Within 8" of Joint:
Remarks:

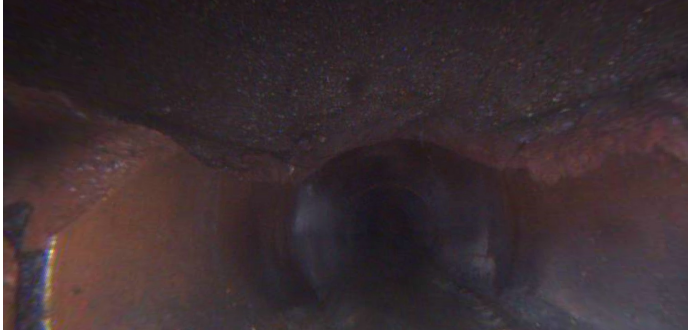
Code:	AMH
Description:	Manhole
Distance (ft):	161.7
Structural Grade:	0
O&M Grade:	0
Clock Start/From:	
Clock To:	
1st Value:	
2nd Value:	
Value Percent:	
Continuous Index:	
Within 8" of Joint:	NO
Remarks:	M-803-003
