Profile/Photo Observation Report

Street:	E NORTH ST	Flow Control:	Not Controlled
City:	Hobart, IN	Year Renewed:	
Location:	Other	Tape/Media #:	
Purpose:	Not Known	Dia/Height:	10"
Use:	Sanitary	Material:	VCP
Drain Area:	NA	Lining:	
Category:	NA		
Comment:

Location Details:		Direction of Survey:	Downstream
US MH:	M-803-008	DS MH:	M-803-007
		Total Length Surveyed (ft):	65.8

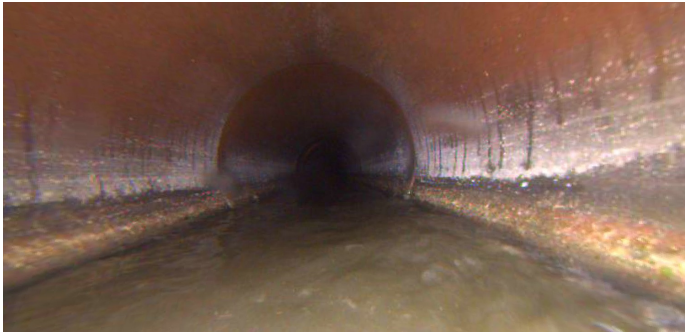
Code:	MWL
Description:	Water Level

Distance (ft):	.0
Structural Grade:	0
O&M Grade:	0
Clock Start/From:	
Clock To:	
1st Value:	
2nd Value:	
Value Percent:	40.000
Continuous Index:	
Within 8" of Joint:	NO
Remarks:

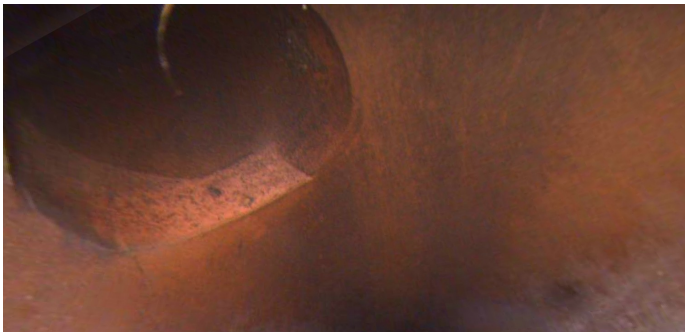
Code:	TF
Description:	Tap Factory

Distance (ft):	6.3
Structural Grade:	0
O&M Grade:	0
Clock Start/From:	11
Clock To:	
1st Value:	4.000
2nd Value:	
Value Percent:	
Continuous Index:	
Within 8" of Joint:	
Remarks:

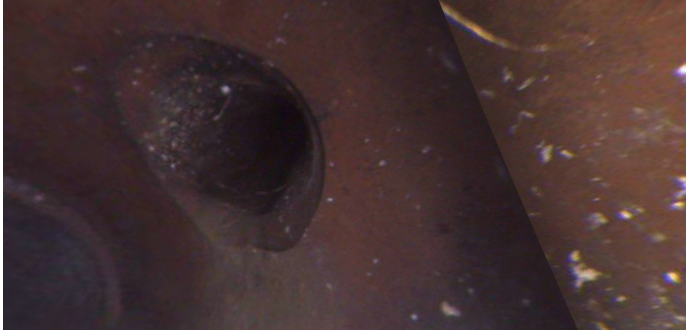
Code: **TF**
Description: **Tap Factory**

Distance (ft): **33.9**
Structural Grade: **0**
O&M Grade: **0**
Clock Start/From: **10**
Clock To:
1st Value: **4.000**
2nd Value:
Value Percent:
Continuous Index:
Within 8" of Joint:
Remarks:

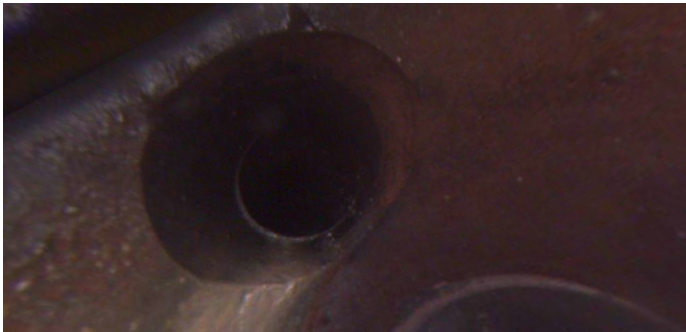
Code: **TF**
Description: **Tap Factory**

Distance (ft): **36.7**
Structural Grade: **0**
O&M Grade: **0**
Clock Start/From: **1**
Clock To:
1st Value: **4.000**
2nd Value:
Value Percent:
Continuous Index:
Within 8" of Joint:
Remarks:

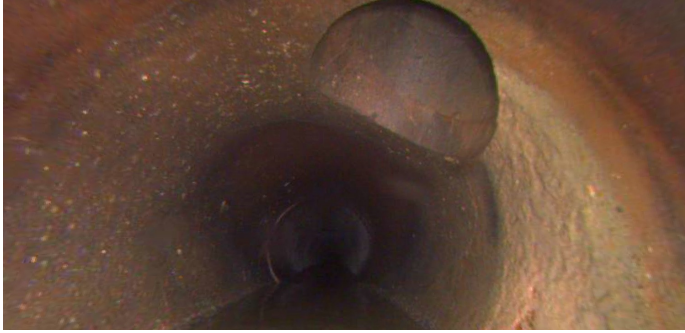
Code: **TF**
Description: **Tap Factory**

Distance (ft): **65.8**
Structural Grade: **0**
O&M Grade: **0**
Clock Start/From: **1**
Clock To:
1st Value: **4.000**
2nd Value:
Value Percent:
Continuous Index:
Within 8" of Joint:
Remarks:

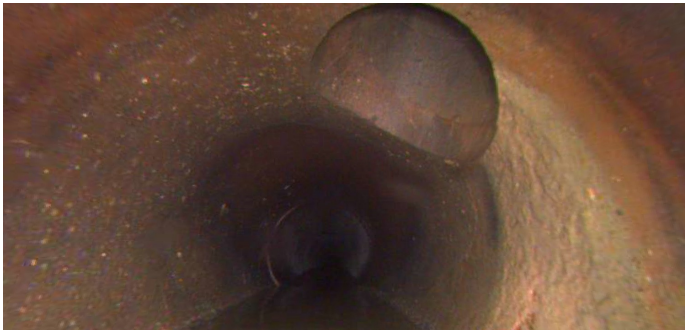
Code: **MSA**
Description: **Abandoned Survey**

Distance (ft): **65.8**
Structural Grade: **0**
O&M Grade: **0**
Clock Start/From:
Clock To:
1st Value:
2nd Value:
Value Percent:
Continuous Index:
Within 8" of Joint: **NO**
Remarks: **UNKNOWN**
