## Profile/Photo Observation Report

| P.O.#: | | Surveyor: | <b>Jen Costello</b> | PSR: | <b>P-803-008-007</b> |

| Street: | <b>ALLEY</b> | Flow Control: | <b>Not Controlled</b> |
| City: | <b>Hobart, IN</b> | Year Renewed: | |

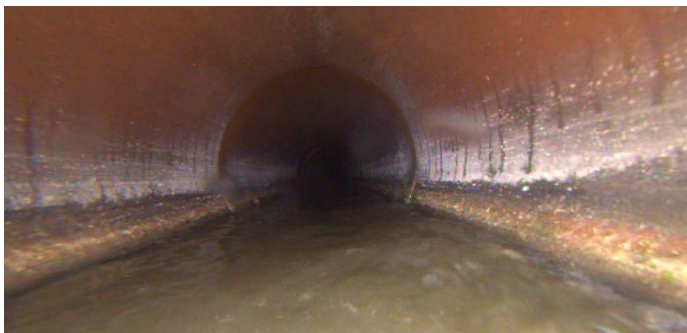
Code: **AMH**  
 Description: **Manhole**

Distance (ft): **.0**  
 Structural Grade: **0**  
 O&M Grade: **0**  
 Clock Start/From:  
 Clock To:  
 1st Value:  
 2nd Value:  
 Value Percent:  
 Continuous Index:  
 Within 8" of Joint: **NO**  
 Remarks: **M-803-008**

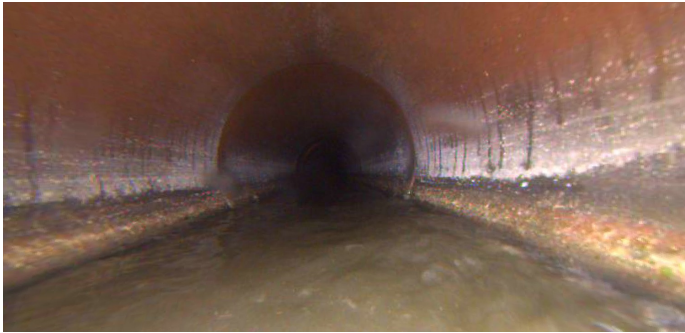
| Code: | <b>MWL</b> |
| Description: | <b>Water Level</b> |

| Distance (ft): | <b>.0</b> |
| Value Percent: | <b>40.000</b> |

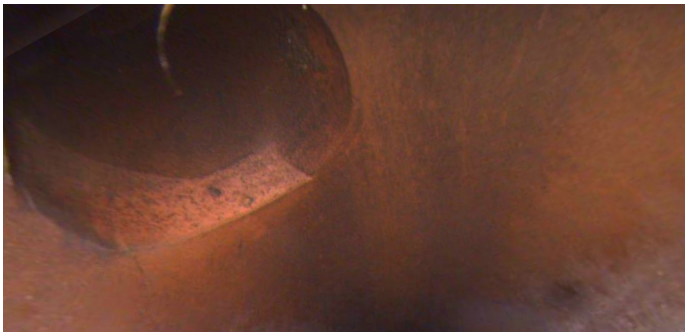
| Code: | <b>TF</b> |
| Description: | <b>Tap Factory</b> |

| Distance (ft): | <b>6.3</b> |
| Clock Start/From: | <b>11</b> |
| 1st Value: | <b>4.000</b> |

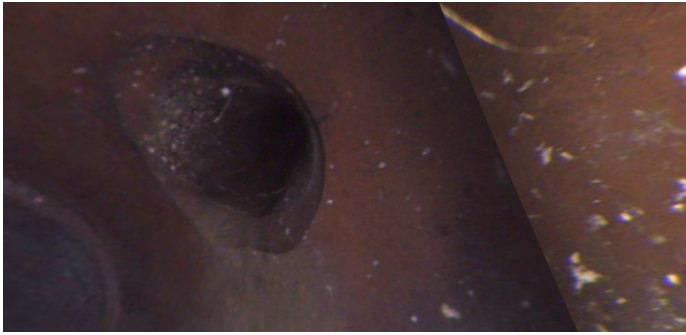
Code: **TF**  
Description: **Tap Factory**

Distance (ft): **33.9**  
Structural Grade: **0**  
O&M Grade: **0**  
Clock Start/From: **10**  
Clock To:  
1st Value: **4.000**  
2nd Value:  
Value Percent:  
Continuous Index:  
Within 8" of Joint:  
Remarks:

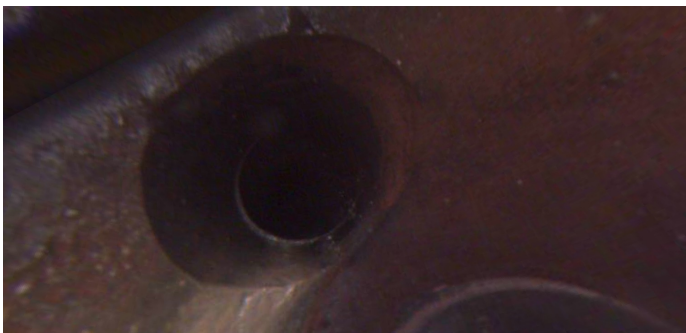
Code: **TF**  
Description: **Tap Factory**

Distance (ft): **36.7**  
Structural Grade: **0**  
O&M Grade: **0**  
Clock Start/From: **1**  
Clock To:  
1st Value: **4.000**  
2nd Value:  
Value Percent:  
Continuous Index:  
Within 8" of Joint:  
Remarks:

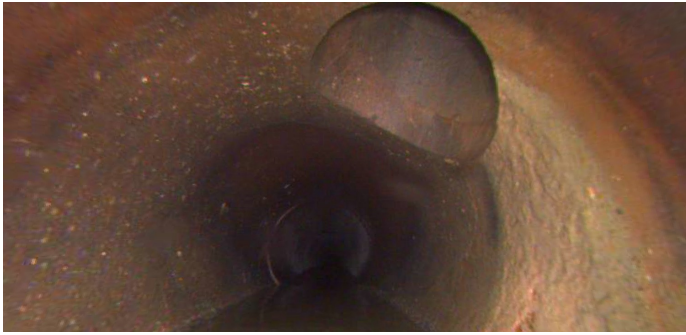
Code: **TF**  
Description: **Tap Factory**

Distance (ft): **65.8**  
Structural Grade: **0**  
O&M Grade: **0**  
Clock Start/From: **1**  
Clock To:  
1st Value: **4.000**  
2nd Value:  
Value Percent:  
Continuous Index:  
Within 8" of Joint:  
Remarks:

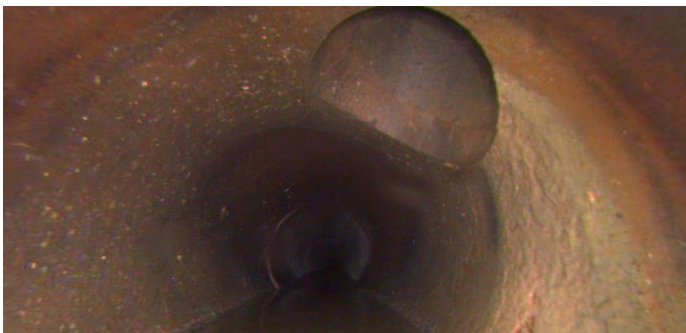
Code: **MSA**  
Description: **Abandoned Survey**

Distance (ft): **65.8**  
Structural Grade: **0**  
O&M Grade: **0**  
Clock Start/From:  
Clock To:  
1st Value:  
2nd Value:  
Value Percent:  
Continuous Index:  
Within 8" of Joint: **NO**  
Remarks: **UNKNOWN**
