## Profile/Photo Observation Report

Street:	<b>41st. Ave.</b>	Flow Control:	<b>Not Controlled</b>
City:	<b>Hobart, IN</b>	Year Renewed:	
Location:	<b>Light Highway</b>	Tape/Media #:	
Purpose:	<b>Routine Assessment</b>	Dia/Height:	<b>12"</b>
Use:	<b>Sanitary</b>	Material:	<b>VCP</b>
Drain Area:	<b>NA</b>	Lining:	
Category:	<b>NA</b>		
Comment:

Location Details:		Direction of Survey:	<b>Upstream</b>
US MH:	<b>M-803-008</b>	DS MH:	<b>M-803-007</b>
		Total Length Surveyed (ft):	<b>61.7</b>

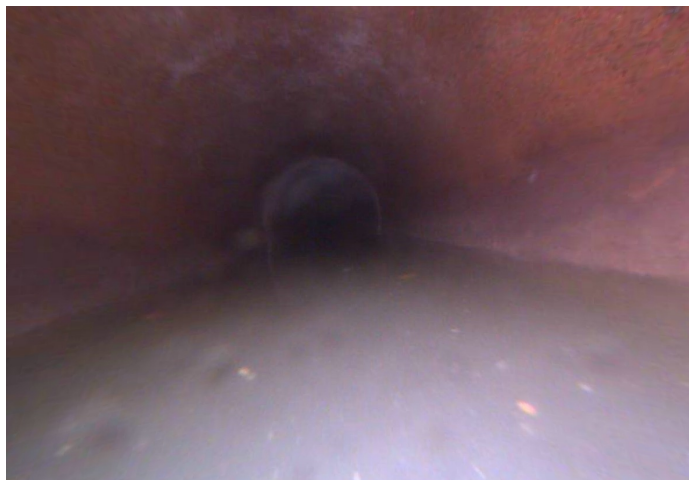
Code: **AMH**  
 Description: **Manhole**

Distance (ft): **.0**  
 Structural Grade: **0**  
 O&M Grade: **0**  
 Clock Start/From:  
 Clock To:  
 1st Value:  
 2nd Value:  
 Value Percent:  
 Continuous Index:  
 Within 8" of Joint: **NO**  
 Remarks: **M-803-007**

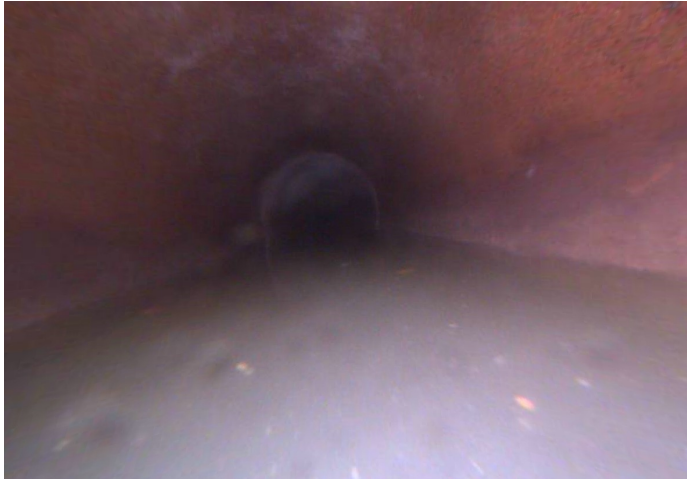
Code: **MWL**  
Description: **Water Level**

Distance (ft): **.0**  
Structural Grade: **0**  
O&M Grade: **0**  
Clock Start/From:  
Clock To:  
1st Value:  
2nd Value:  
Value Percent: **25.000**  
Continuous Index:  
Within 8" of Joint: **NO**  
Remarks:

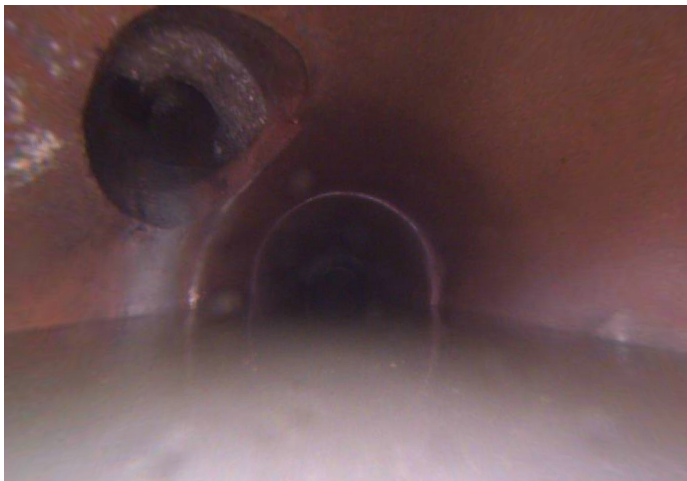
Code: **TF**  
Description: **Tap Factory**

Distance (ft): **50.0**  
Structural Grade: **0**  
O&M Grade: **0**  
Clock Start/From: **10**  
Clock To:  
1st Value: **6.000**  
2nd Value:  
Value Percent:  
Continuous Index:  
Within 8" of Joint:  
Remarks:

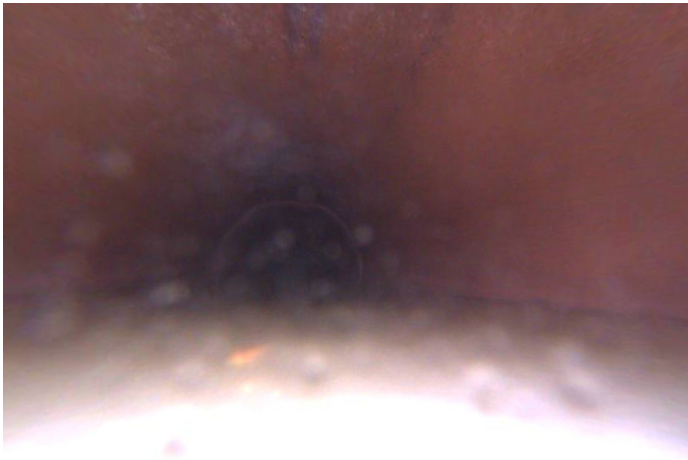
Code:	<b>MSA</b>
Description:	<b>Abandoned Survey</b>
Distance (ft):	<b>61.7</b>
Structural Grade:	<b>0</b>
O&M Grade:	<b>0</b>
Clock Start/From:	
Clock To:	
1st Value:	
2nd Value:	
Value Percent:	
Continuous Index:	
Within 8" of Joint:	<b>NO</b>
Remarks:	<b>Unknown</b>
